LESSONS LEARNED REPORT

CRANE REST CHOCK FELL 8 METRES

TYPE OF INCIDENT: NII
INCIDENT NO: INC/530/14/80
COUNTRY: UKCS
DATE OF INCIDENT: 09.09.14

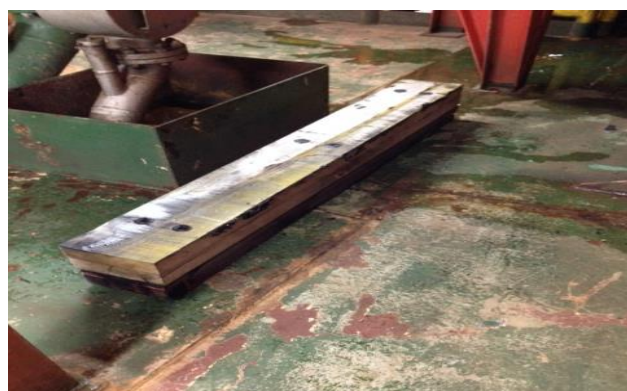
DURING THE START-UP PROCESS THE CRANE SLEWED TO THE RIGHT WITHOUT POSITIVE CLEARANCE (APPROX. < 2 METRES). THIS CAUSED THE CHOCKS TO BE DISLODGED FROM THE REST. ONE CHOCK REMAINED ON THE REST WHILST THE OTHER FELL 8 METRES TO THE BELOW AREA (CONSIDERED A FATALITY ON THE DROPS MATRIX).

CRANE REST CHOCK WHICH FELL

- DUE TO DESIGN, NO SECONDARY RETENTION OR ROBUST SECURING HELD THE CHOCKS IN PLACE.
- PROCEDURE AND LIFTING PLANS DID NOT STATE SPECIFIC REQUIREMENTS FOR GENERAL CRANE OPERATIONS.
- THE DROP WAS NOT IDENTIFIED IN A RECENT DROPS SURVEY NOR IS IT MENTIONED IN ANY SPECIFIC GUIDANCE.
- THESE ITEMS WERE NOT CONSIDERED AS BEING A DROPS RISK (OVERLOOKED). THEY CAN APPEAR TO BE FIXED WHEN CHECKED BY HAND DUE TO WEIGHT.
- OPERATOR DID NOT HAVE POSITIVE CLEARANCE BEFORE SLEWING.

- BOTH CHOCK RESTS HAVE BEEN MODIFIED TO PREVENT THE CHOCKS FROM FREE FALLING. OTHER POTENTIAL SCENARIOS INCLUDE:
 - IMPACT BY HEAD ACHE BALL.
 - IMPACT WITH A SUSPENDED CONTAINER.
 - WOOD DETERIORATION DUE TO WEATHER EXPOSURE.
- PROCEDURES HAVE BEEN UPDATED TO IMPLEMENT ADDITIONAL INFORMATION. RISK ASSESSMENTS AND LIFTING PLANS HAVE BEEN REVISED AND UPDATED.
- A SAFETY STAND DOWN TO DISCUSS THE INCIDENT AND RAISE AWARENESS.
- THIS LLR HAS BEEN ISSUED TO ENSURE OTHER UNITS CHECK THEIR CRANE RESTS AND INCLUDE IN DROP SURVEYS.

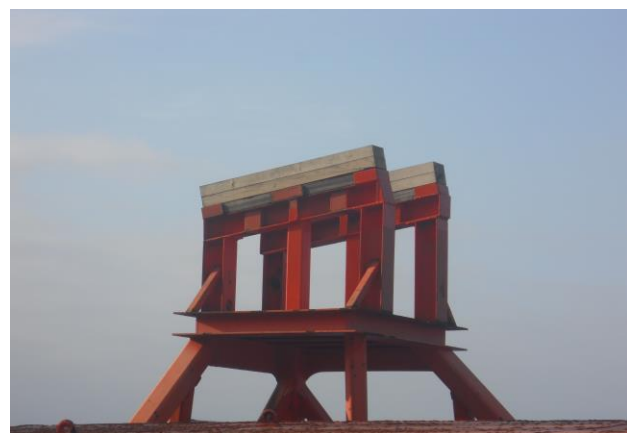
CRANE REST CHOCK AS NORMALLY SITUATED.
