# SPRING HANGER FAILURE

Near Miss (High Potential)

# HSE ALERT

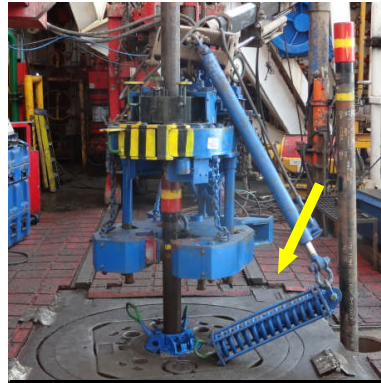
Position of failed Spring Hanger

The Back Up was then engaged and as the tong operator was about to make the connection to the required torque the spring hanger parted. Part of the spring hanger and the lift cylinder fell approximately 4 meters to the drill floor while the inner rod recoiled up the derrick and came to rest at the sheave located just below the crown. The tugger line from the reel side of the sheave coiled down to rest on the drill floor.

Both spring hanger and lift cylinder weighed approximately 50Kg each. The tong remained clamped on to the tubing by the Chromemaster and the Back Up. There was no injury to any personnel. Operations were stopped, the drill floor was made safe and the investigation was initiated. Although the investigation is ongoing, it appears that the failure is caused by severe corrosion of the spring hanger center rod.

- Advise all affected operations of the incident and emphasize the requirement to have a secondary retention sling in place between top and bottom plates of the spring hanger. At the same time ensure that a new risk assessment of the operation is completed taking into account potential snagging and other identified hazards.

- Quarantine all spring hangers pending a review of the individual inspection / testing history.  
Baker Hughes stipulates the following requirement:  
Visual every 6 months, MPI every 12 months and 1.5 x proof test every 2 years.

- Inspect and strip down all spring hangers:
  - Check condition of center and outer rods and replace as necessary.
  - Cut and remove stop tube from bottom spring hanger plate and replace with new, modified stop tube

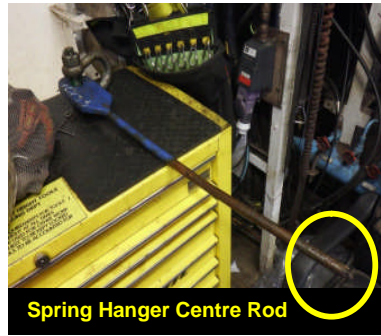
Spring Hanger Drawing No 1058

Spring Hanger Centre Rod

- Tubular Services Engineering department to review current spring hanger design and propose modifications to allow easy access for servicing and carrying out MPI inspection of critical areas.
- Tubular Services Engineering department to develop and issue design drawings and procedures in line with modified spring hanger design.

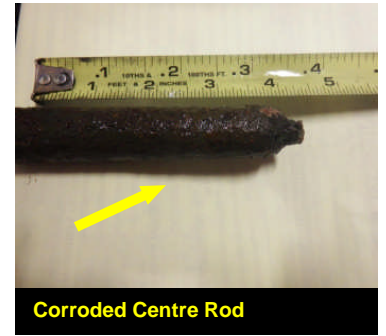
Corroded Centre Rod

- Rebuild spring hanger and ensure spring hanger is load tested and fully inspected in line with Tubular Services Workshop Maintenance Procedure.
- Review Enterprise Operational Control procedure and Life Rule! "Dropped Objects"
