Seawell Limited (UK)

# Seawell High Potential Incident

Derrick Drilling Machine (DDM) collision with stand of drill pipe – link tilt protection bar dropped to drill floor.

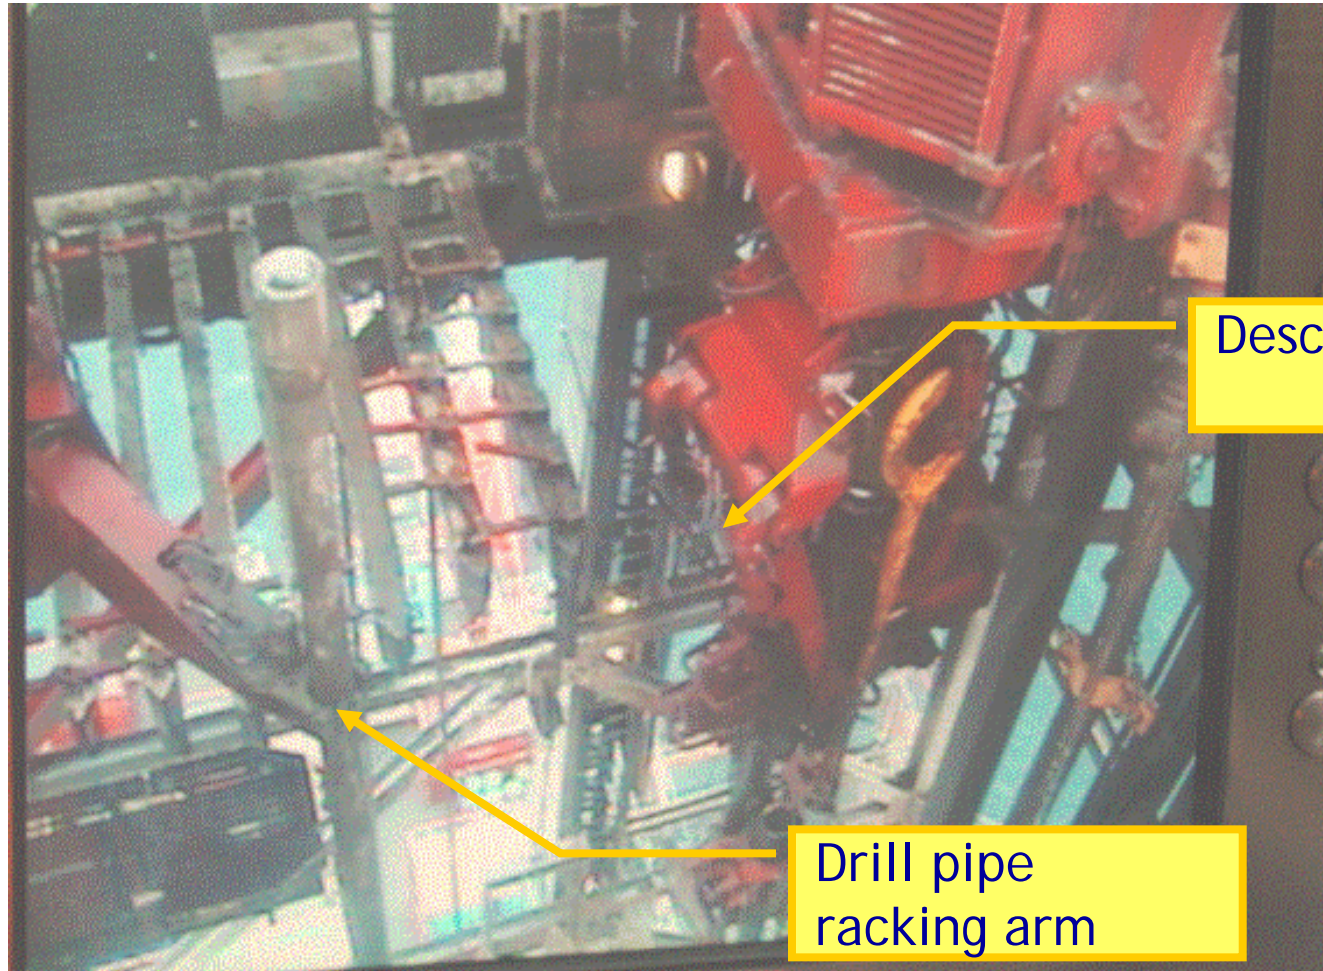
- At this time the DDM was being lowered as the Toolpusher (DDM operator) had viewed by remote camera, that the top of the stand had been pulled into the clear zone for the DDM to descend. The stand collided with a link-tilt protection bar on the DDM, shearing the bar mounting bolts.

Descending DDM

Drill pipe  
racking arm

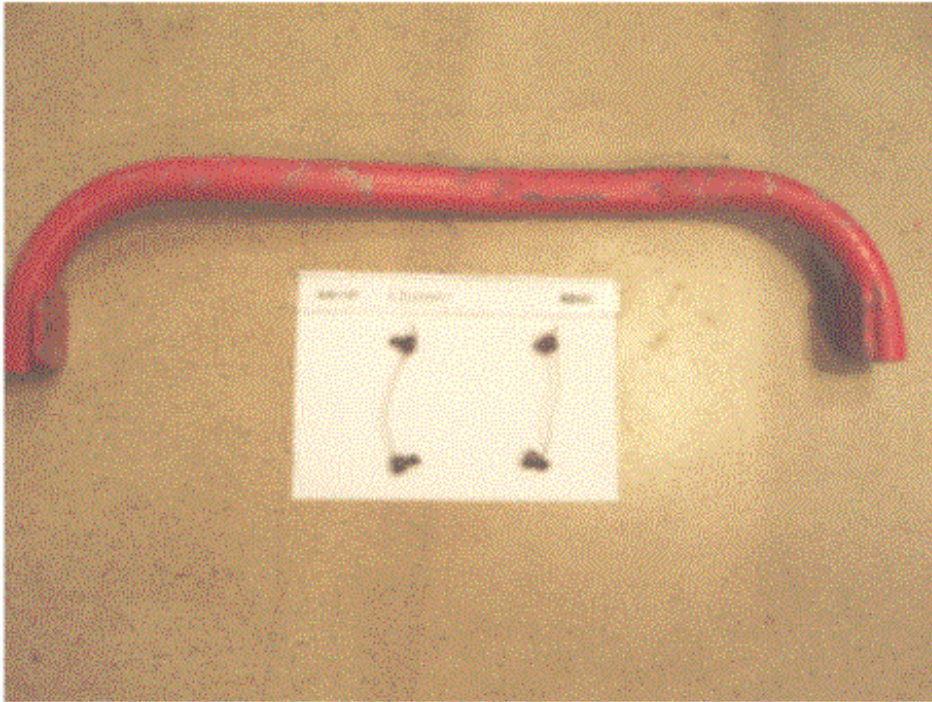
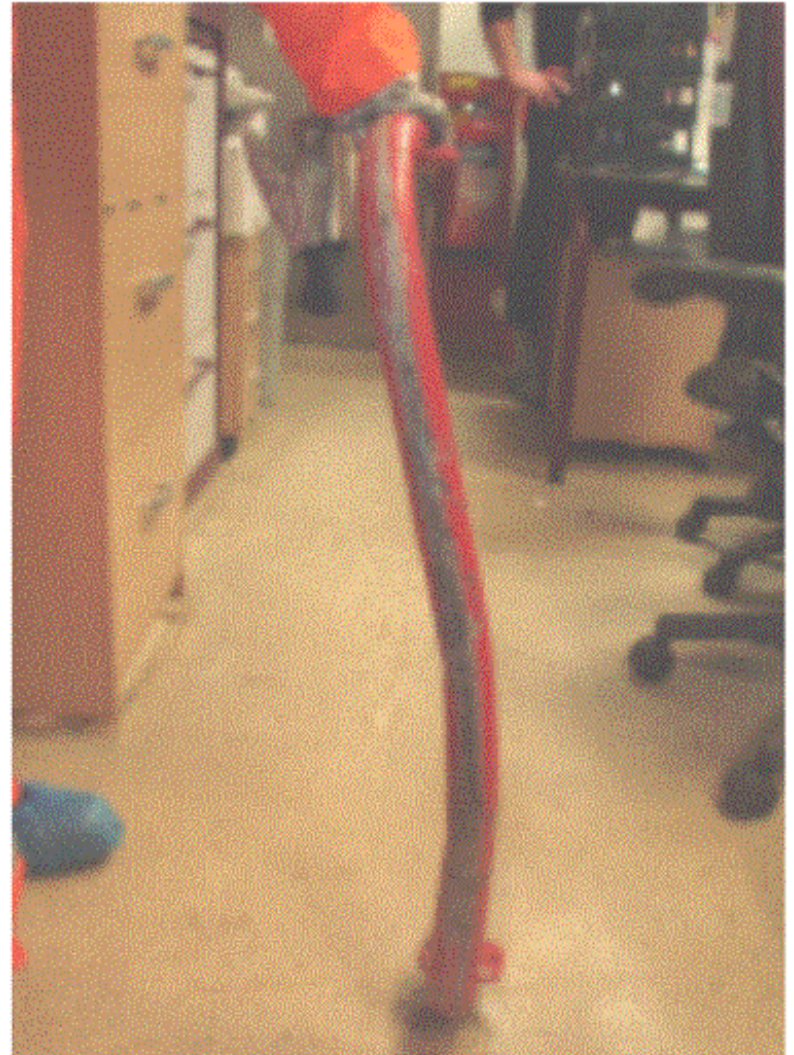
- The bar (4.25kg), and sheared securing bolts fell 94ft to the drill floor. The top of the stand came to rest against the pipe-rack fingers.
- No one was injured as all drill floor crew were positioned outside of the drill floor 'red zone' (no-go area when there is equipment equipment moving overhead).

•Guard bar (4.25kg) and sheared securing bolts (lock-wired)

Review secondary retention on protection bar

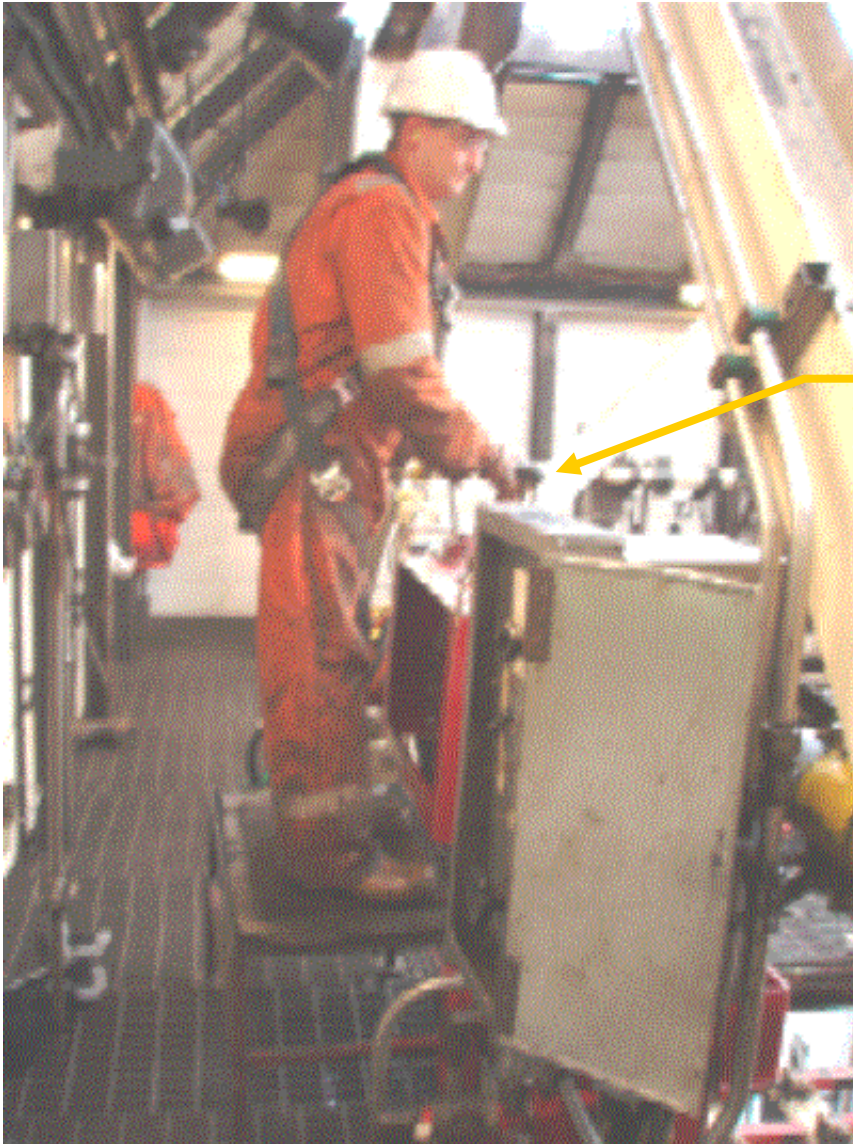
Bridge racker  
control levers

- The immediate cause of this incident was found to be human error-lapse. The acting Derrickman offered this without qualification, but could give no reason.
- Ergonomic layout of controls considered to be a major contributor to the incident. The close proximity of the 2 racking arm control handles, and the lack of physical differentiation between them. One of these operates the pipe-locking jaw of the racking arm (pull/push to open-close), while the other operates the stand-lift function
- Compliance to Red Zone work practices, were recognised by the investigation team as having prevented potential fatality.
- The Derrickman had been fulfilling this activity, since the start of his trip and was familiar with the equipment.

Carry out modifications to the twin control lever so as to clearly differentiate the stand lift and grab control levers

Review design to allow installation of secondary mechanism which requires actuation before grab open function can be operated. (Two action function)

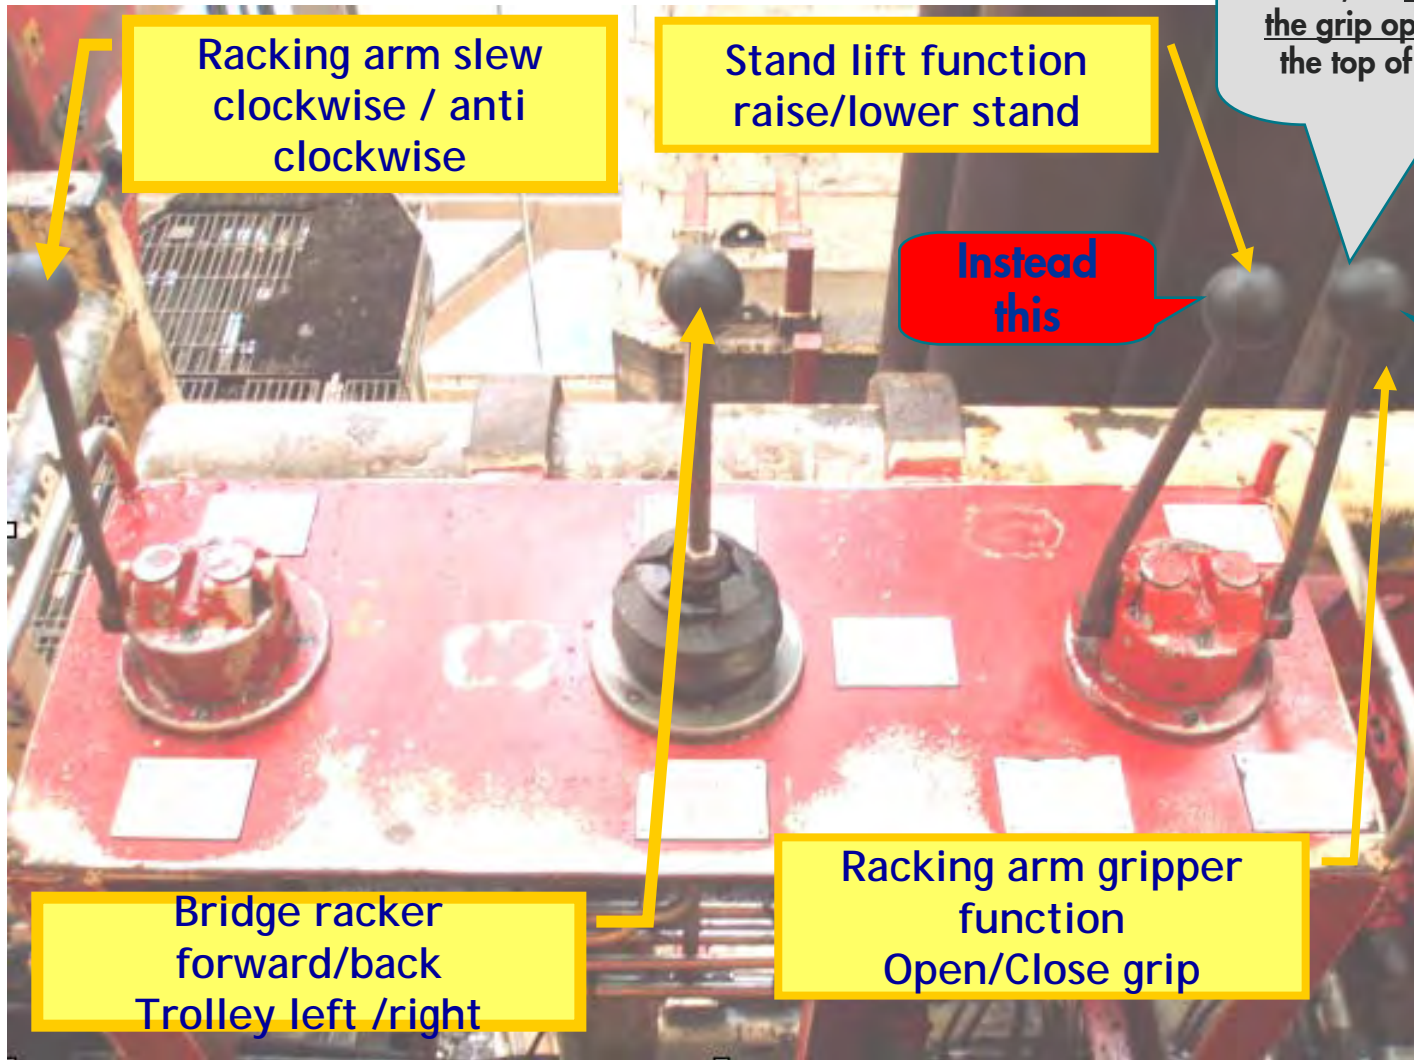
Derrickman pulled what he believed to be the stand lift lever, but inadvertently pulled the grip open lever, resulting in the top of the stand swinging free.

Instead this

This

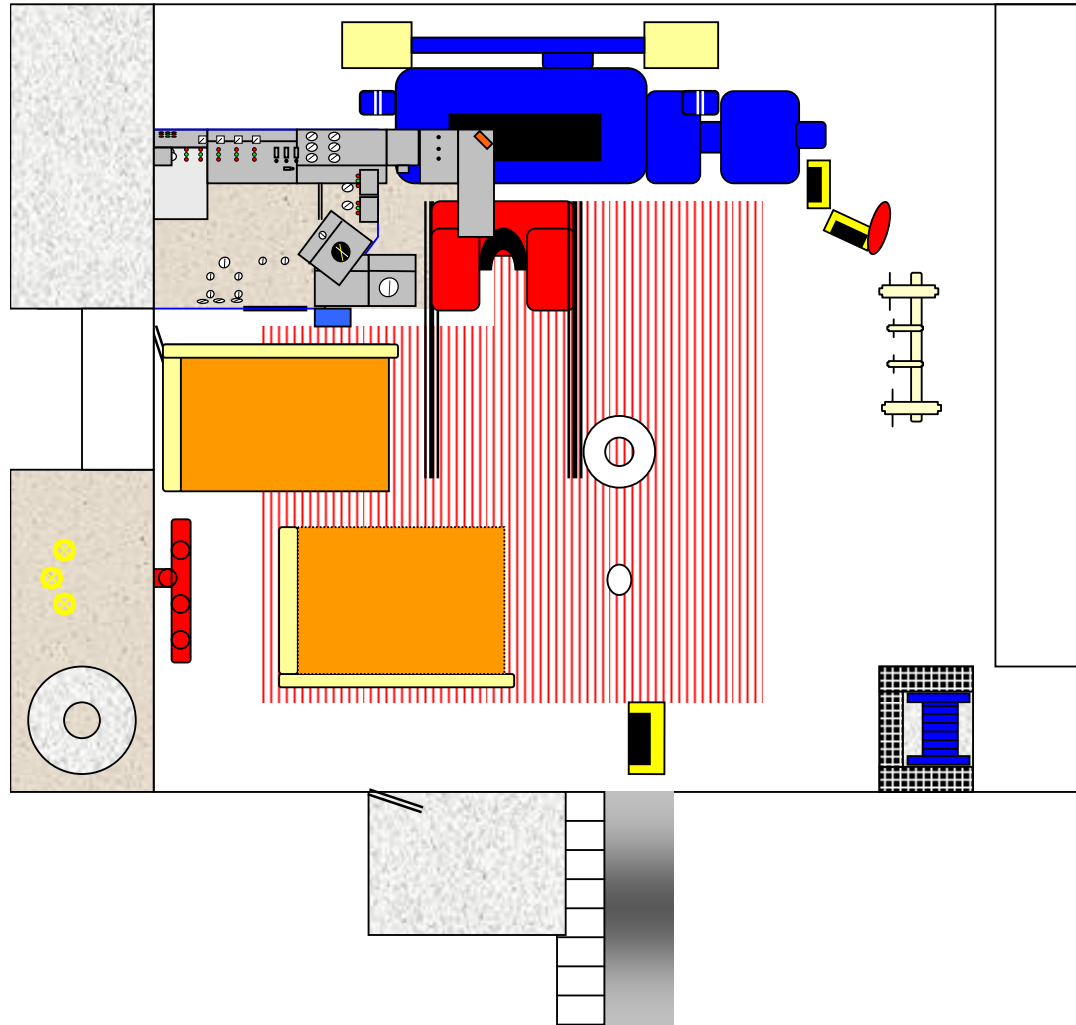
Work inside the red hatched area is restricted.

**No go area while performing drilling or tripping operations.**

Share Seawell Red Zone procedure with all rig Fleet (Considered Best Practice)
