Safe Rig project in StatoilHydro

Presentation by Vetli Tveiten

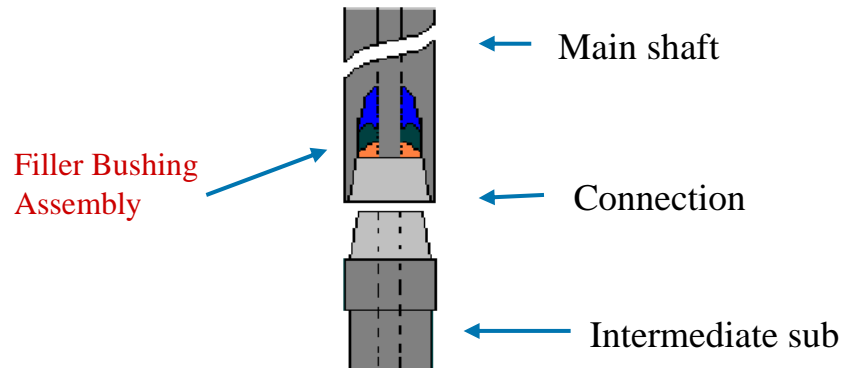
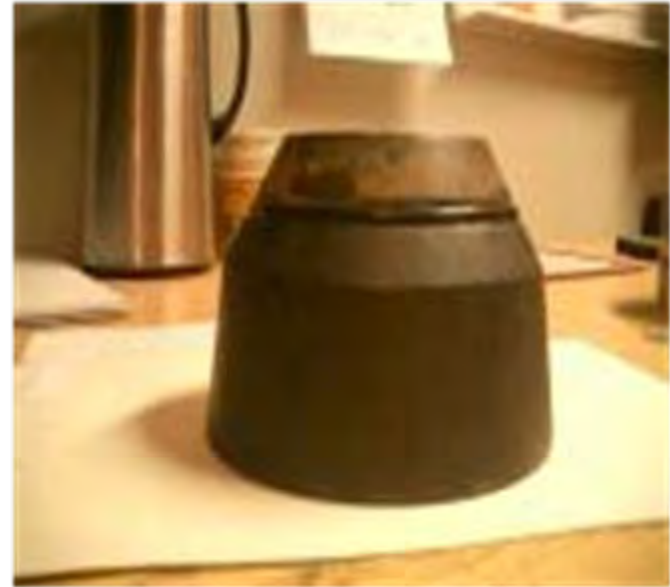
Falling object during maintenance of DDM

During annual maintenance of main shaft on DDM (derrick drilling machine), a "filler bushing" (5 kg) fell 12.49 meters down on the drill floor.

The filler bushing assembly is installed in the "box end" of the main shaft and a part of it was ignored in connection with preparation for maintenance.

- The filler bushing consists of 3 pieces, but only 2 of them were removed during disassembly.
- It was discovered that there were 2 different procedures which described the maintenance activities
- The direct cause of the incident, was the lack of details in the procedure that was used.

- Part of filler bushing, that fell down

- Make sure that procedures includes all necessary details.
- Make sure that correct procedures are available and are used!

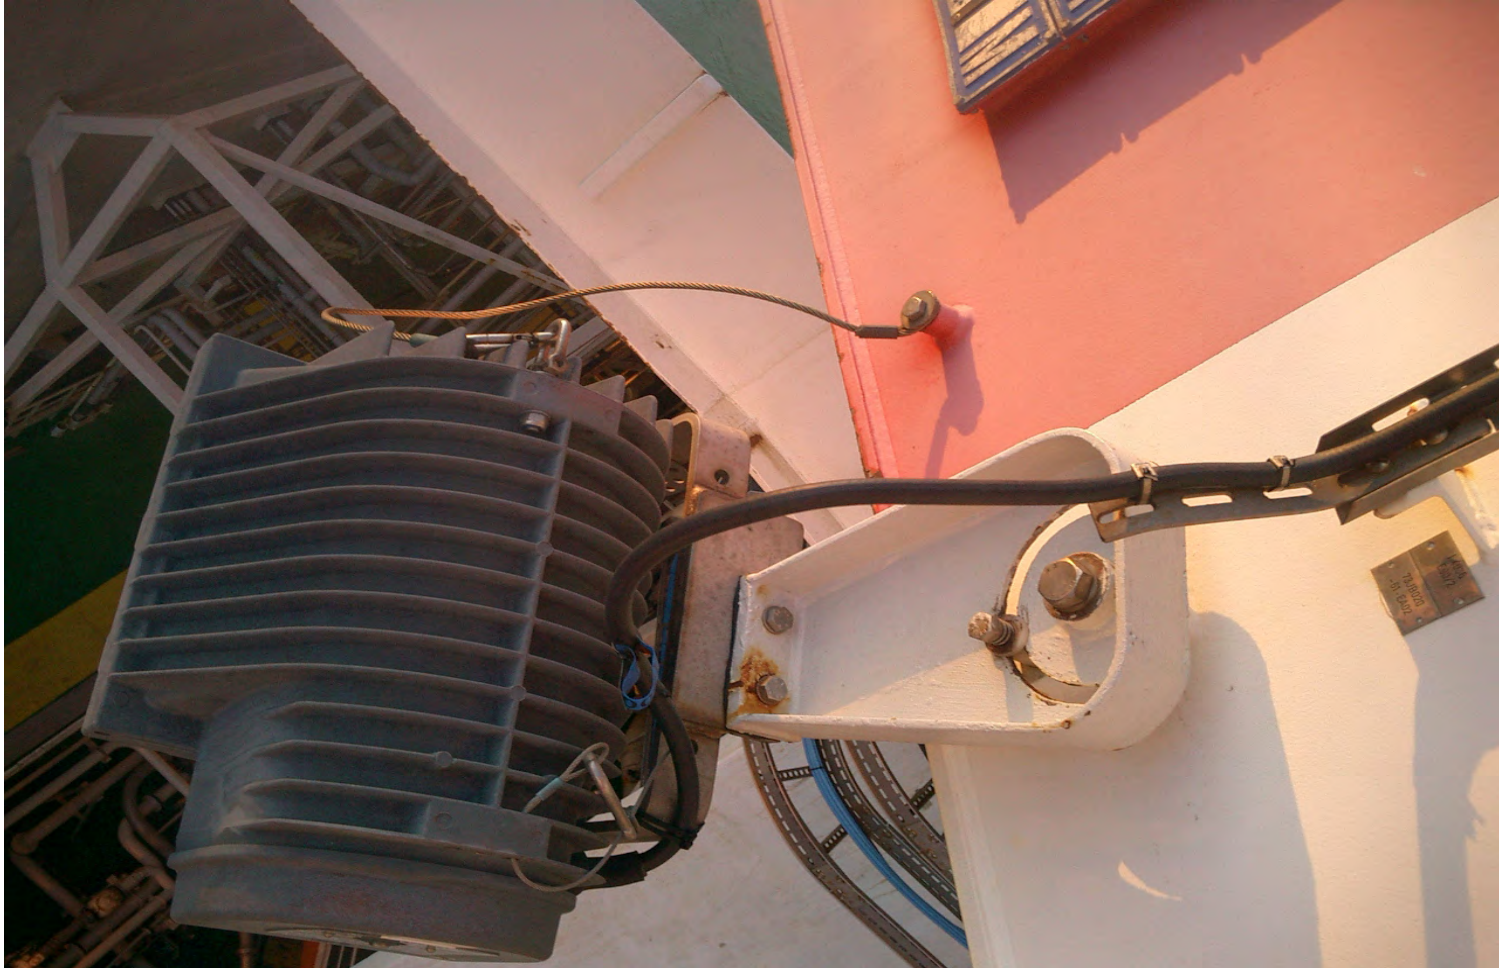
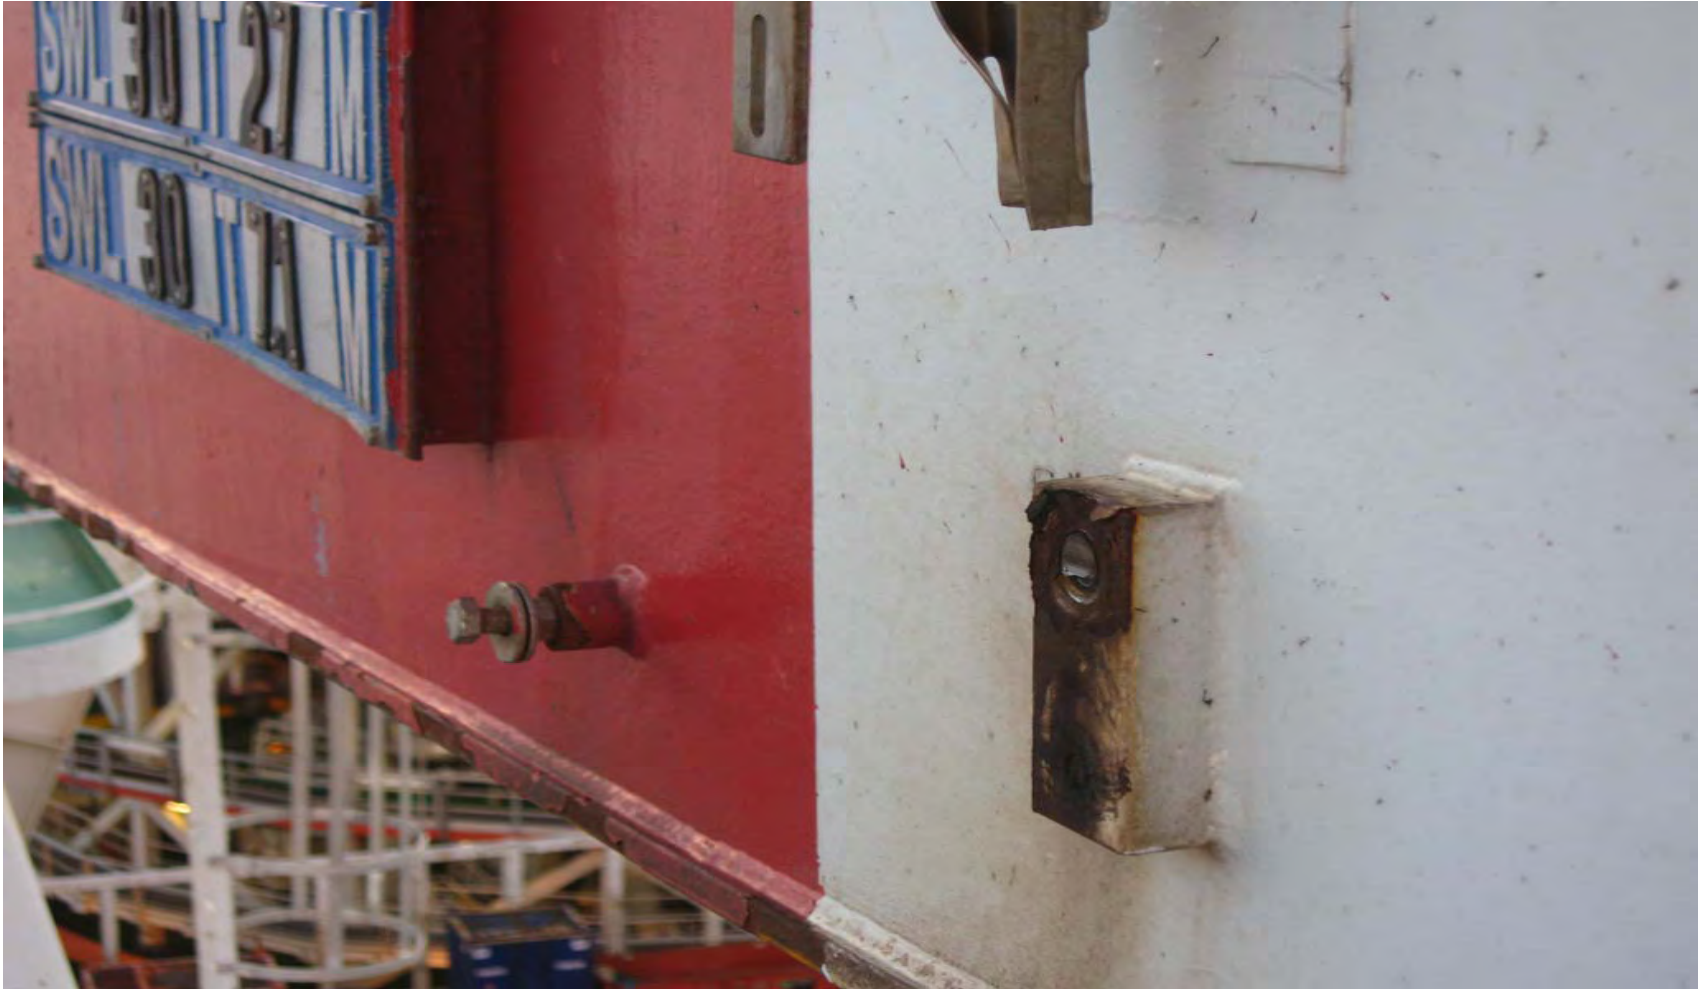
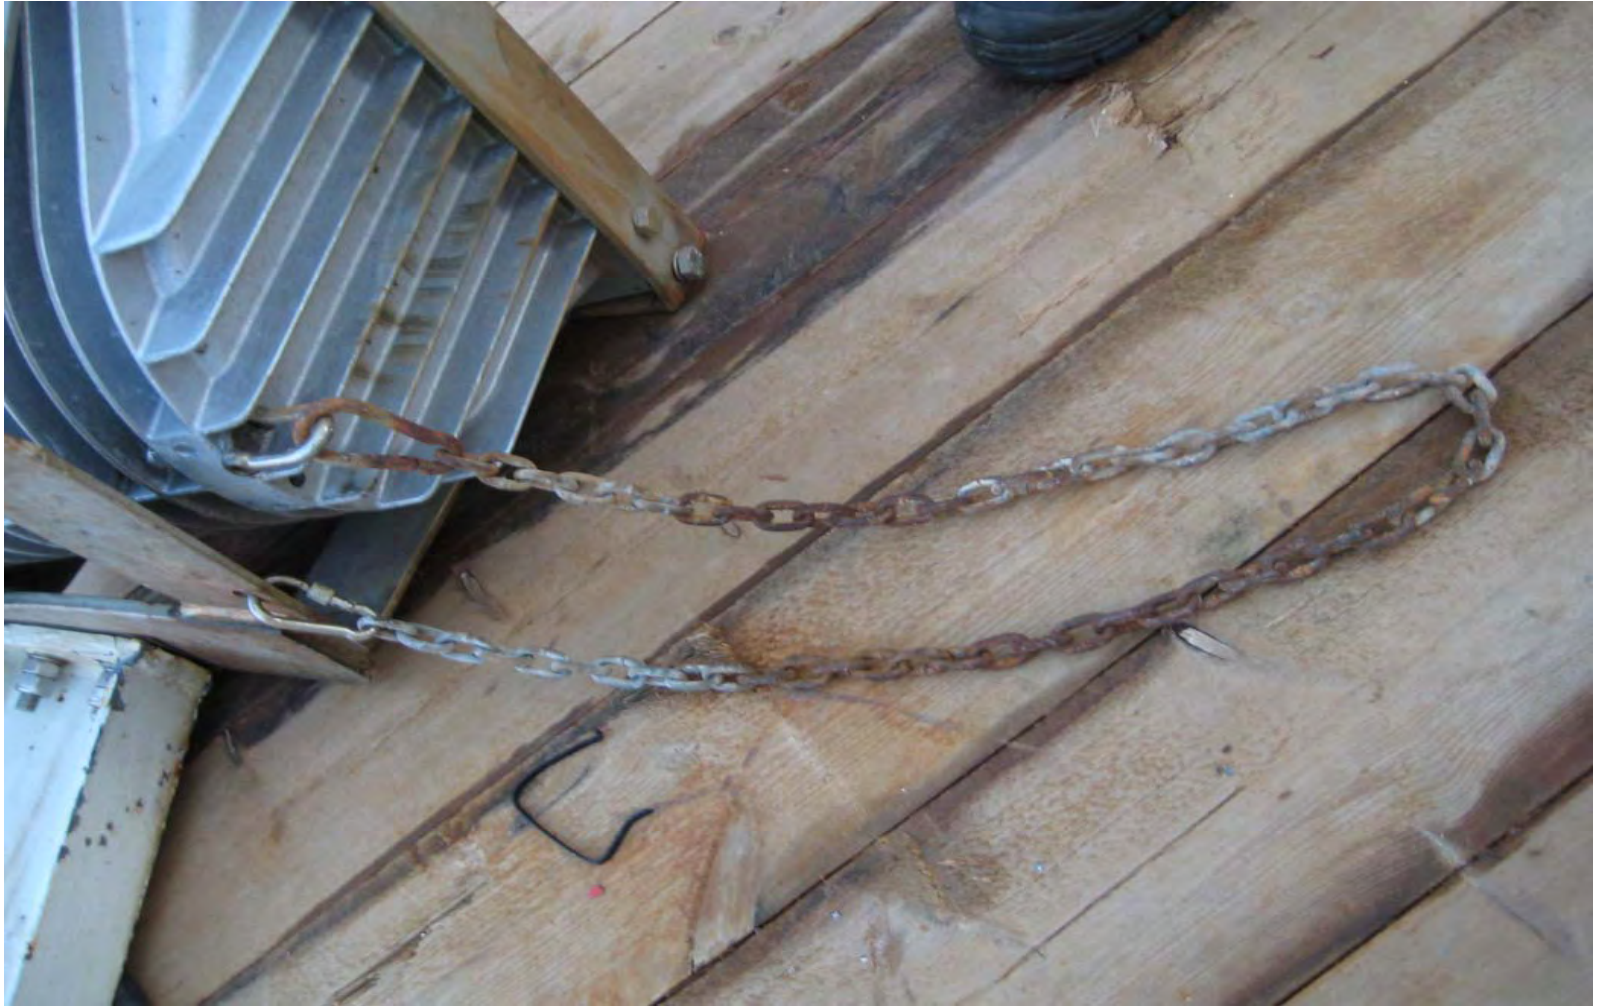
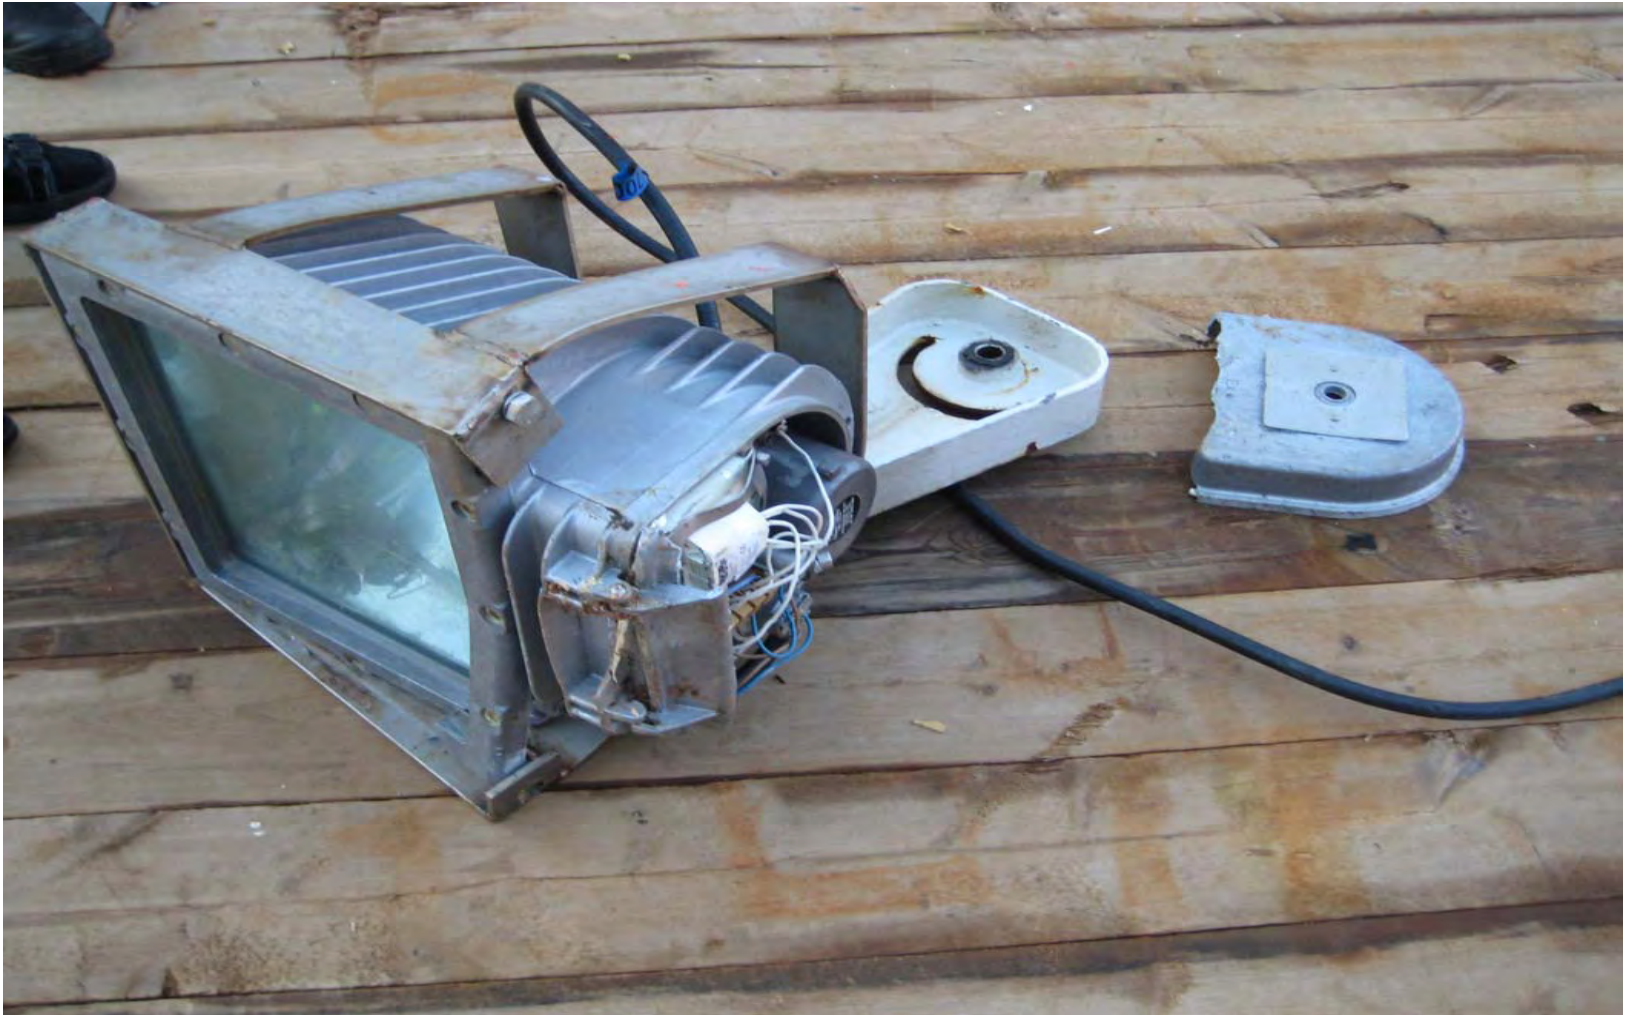
Flood light fell from crane boom

During work with the bunkering hose, the deck crane was used. The crane boom was swung out, and the flood light at the end of the boom fell down onto the deck of the supply vessel. There were two sailors on deck when the incident occurred. One of the sailors were only two meters away when the flood light hit the deck, but no personnel injuries. The weight of the flood light was approx 30 kg, height approx. 30 - 40 m. Energy 10290 joule.

- Fatigue fracture in the pivot/attachment bolt. Size M20 Stainless (Bolt was tested in a laboratory)
- Missing or incorrect installation of secondary retention
- No fatigue limit / life calculation during design
- Insufficient maintenance requirements from the manufacturer

NOTE! Crane boom camera pivot bolts found worn down to approx 30-40%

- Maintenance procedure to include change of bolt, at an interval
- New cranes to have a larger bolt
- Install the secondary retention according to Reliable Securing

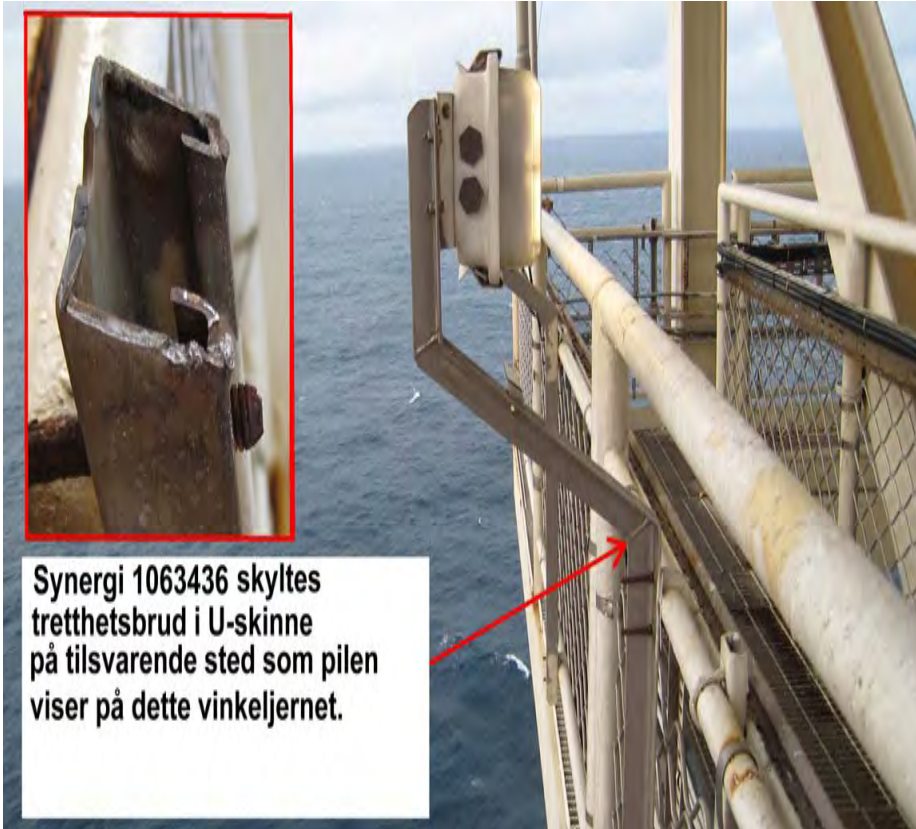
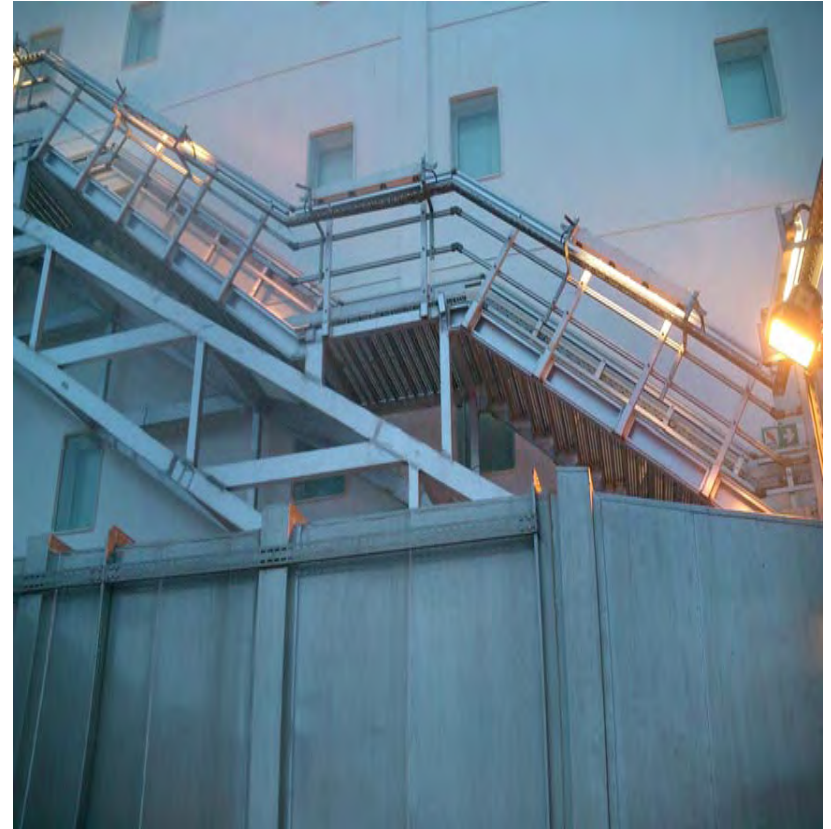
Falling lighting fixture

Around 0130 AM a loud bang was heard by a person in his cabin. Wind 60-75 knots. Inspection revealed that a 13 kg lighting fixture had fallen down from the gang-way below the heli-deck, down along the living quarters hit a stairway railing and a HVAC duct, where it was found.

- Strong winds, causing vibrations
- Fatigue in corroded welds on the supporting brackets (stainless steel)
- No secondary retention

- Welding procedure used, or lack of knowledge
- Missing secondary retention
- All equipment in weather exposed areas were inspected, repaired and fitted with secondary retention
- Maintenance procedures were updated

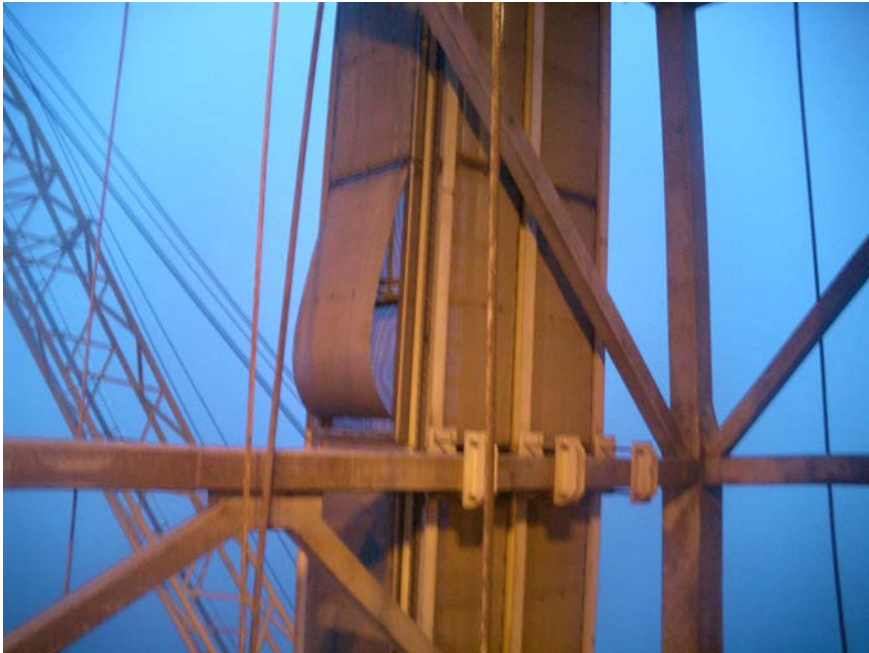
Outer mesh had become loose on 4 elements – potential dropped object

Not concluded - vibrations in derrick combined with insufficient welding possible cause

Loose heat shield mesh

Inspections of heat shields with welded mesh. Secure loose meshes temporary until permanent solution is identified.

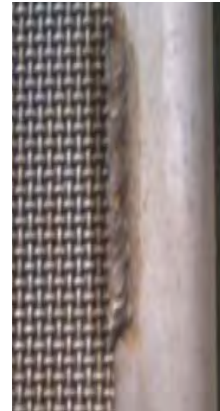
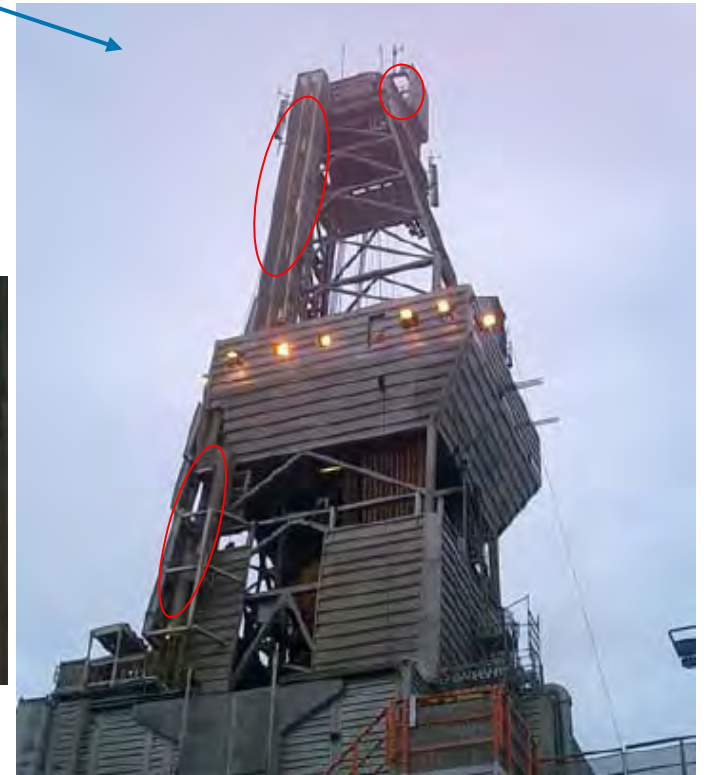
Areas protected by heat shields

Detail:
Welded mesh

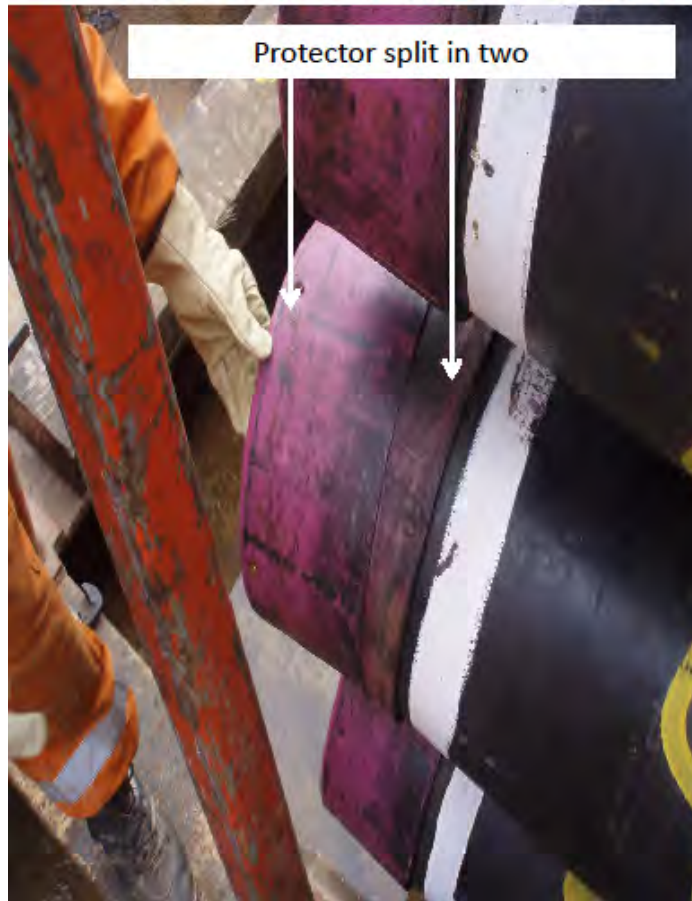
WHEN OFF LOADING 13 3/8" CASING FROM SUPPLY VESSEL. DECK CREW OBSERVED THAT SOMETHING WAS WRONG WITH ONE OF THE PROTECTORS.

THEY HAD A LOOK AT THE PROTECTOR AND SAW THAT THE IRON COVER OF THE PROTECTOR WAS LOOSE. THIS PROTECTOR IS MADE OF ONE PART PLASTIC INSIDE AND ONE STEEL COVER OUT SIDE, AND FOR SOME REASON THEY HAD COME APART. SEE PHOTO NR 2.

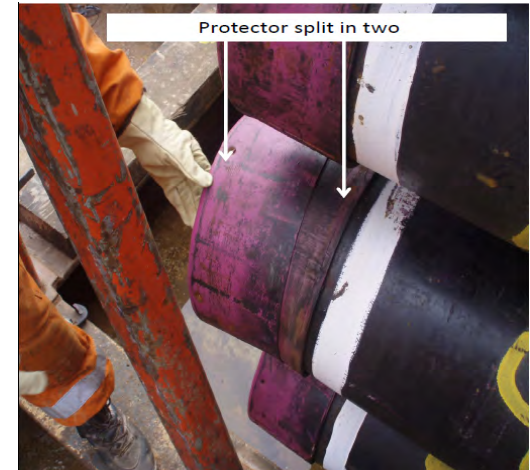
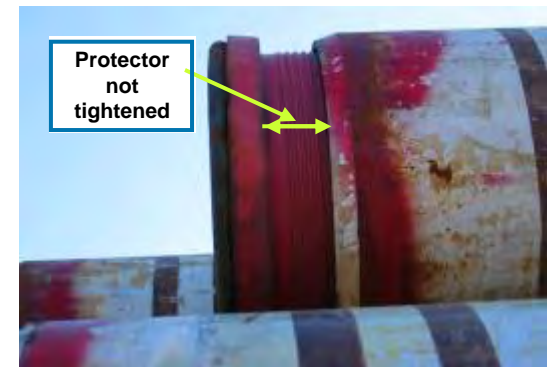
Protectors on Casing

From time to time there are incidents with loose protectors, and even protectors that fall off during handling to and from vessels. Pin end protectors consist of two parts, the inner part made from plastic and an outer part made from steel. These can part/ split in two.

Box end protectors are only one piece plastic, which are often knocked loose, or insufficiently installed.

Loose steel part: 1,5kg, up to 25 m, potential 368 joule

The main reason seems to be the handling of the casings, that causes the protectors to be knocked loose, break or fall off.

Control procedures (quality control) on-shore?

Look at the possibility for new solutions?

Light- weight protectors?

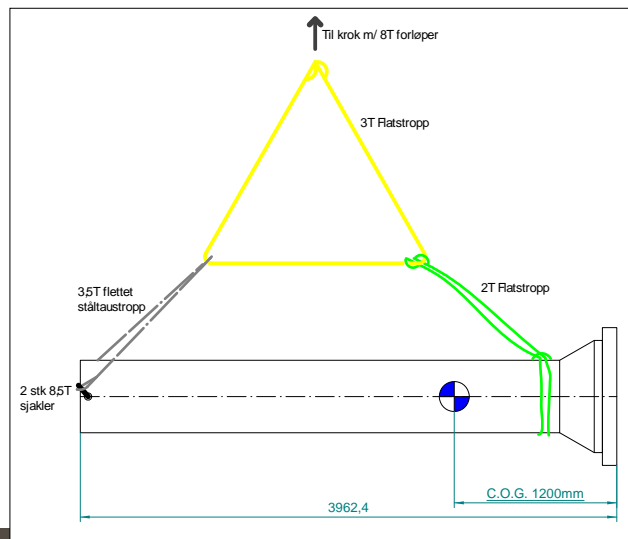
Skisse av utført rigging

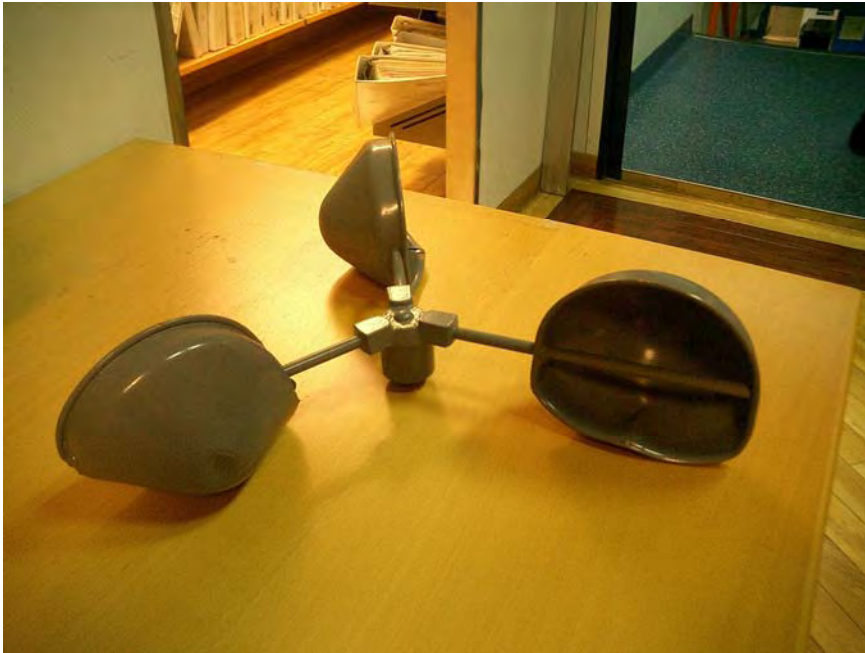
Wind socks and wind gauge rotor

1 kg, 20 m, 196 joule

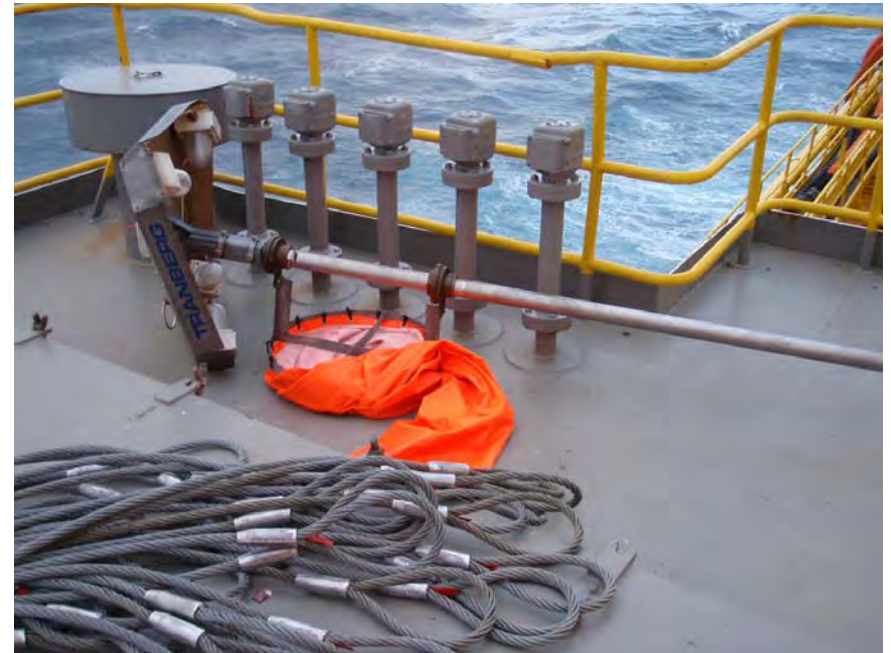
50 kg, 10 m, 4900 joule
