EXPRO

Potential Dropped Object -13
September 2017

UK Area

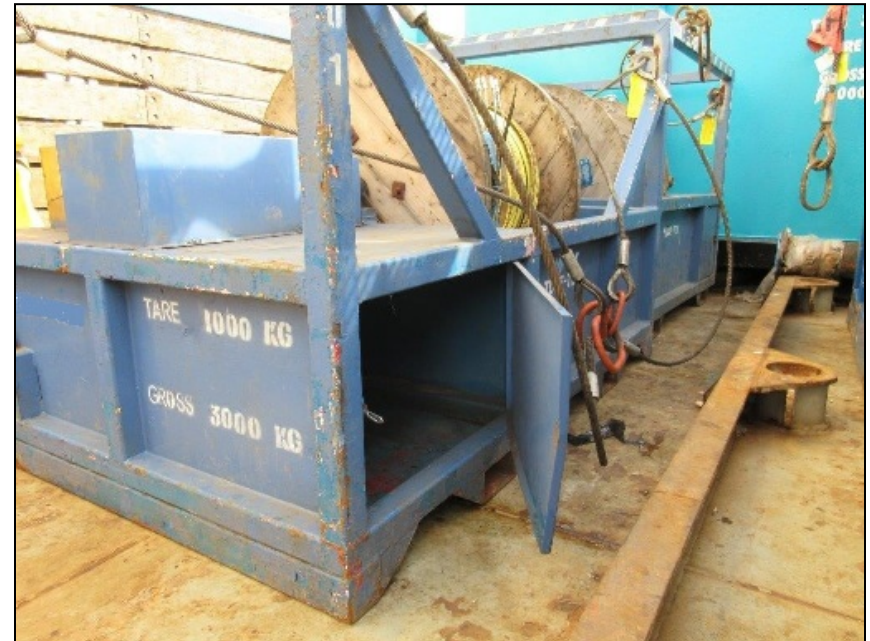
- Spooler units have compartments for accessing mechanism.
- These compartments can also be used for storage.
- Doors checked at Expro Base and the Docks before being loaded onto the supply boat.
- Doors were adjudged to be securely closed with an antiluce drop catch.

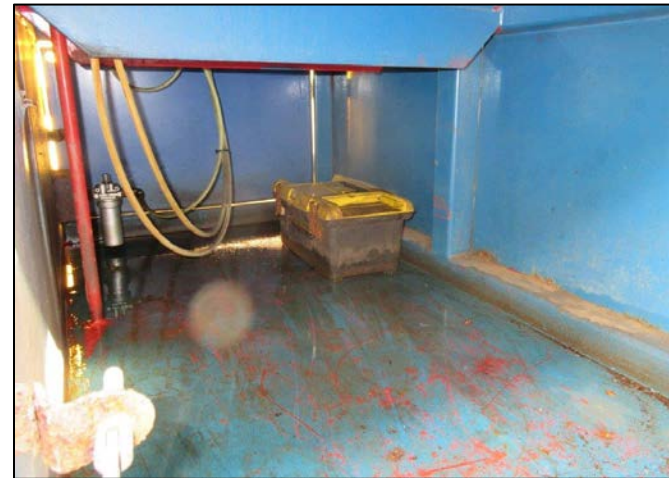
- One door was open when spooler lifted from boat to installation.
- Unsecured toolbox was found inside the compartment.
- Toolbox was supplied by the third party without the knowledge of Expro.

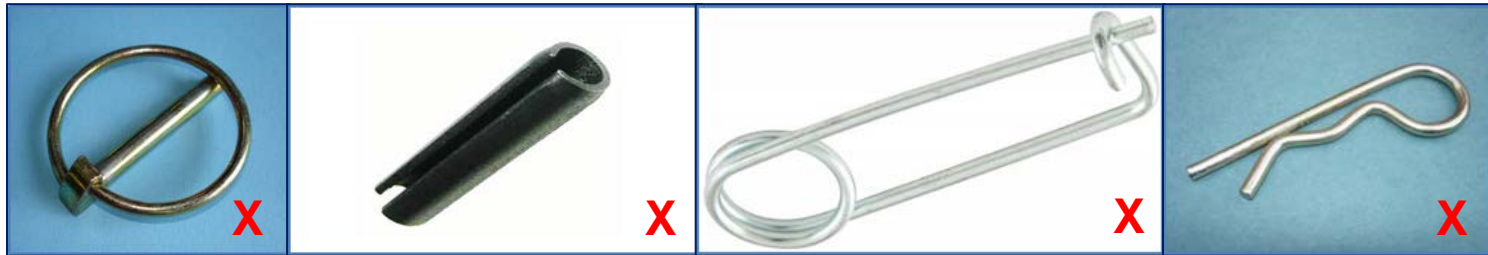
- Considered: lynch pins; r-clips; spring / roll / nappy pins and other options.
- All pictured above could be easily knocked off or spring open at height causing further drops issues.

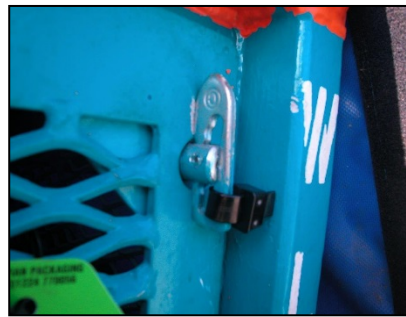
- Current solution is a cable tie.

- At time of incident there was no documented requirement for cable tie or other secondary retention.
- Cable ties had not been applied to the spoolers.
- 2 in-house checks did not pick this up due to lack of documented requirement.

- Following the incident:
- Secondary retention **MUST** be in place on all units with antiluce drop locks for both outward and inward transportation.
- Our third party lifting Engineers have been instructed to check for secondary retention on drop catches.
- Recommended size of the Tie-Wrap is between 4.7mm and 13.2mm for drop locks.
