EXPRO

Potential Dropped Object
Gillian Marr

Potential Dropped Object (PDO)

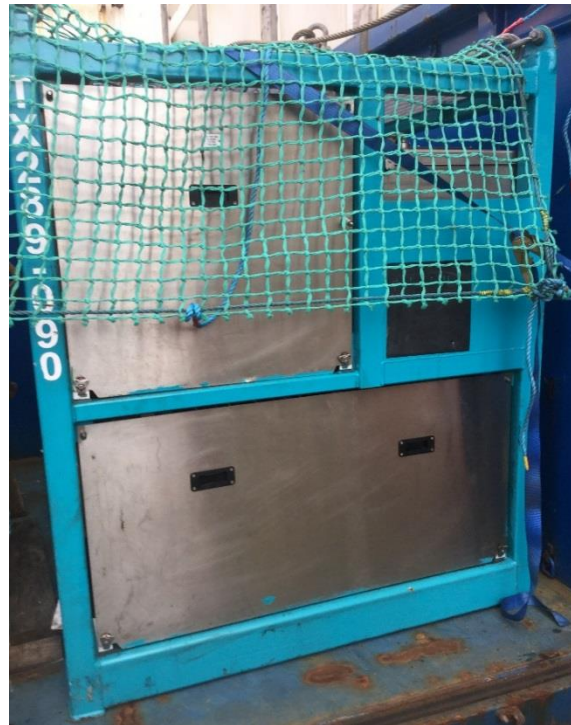
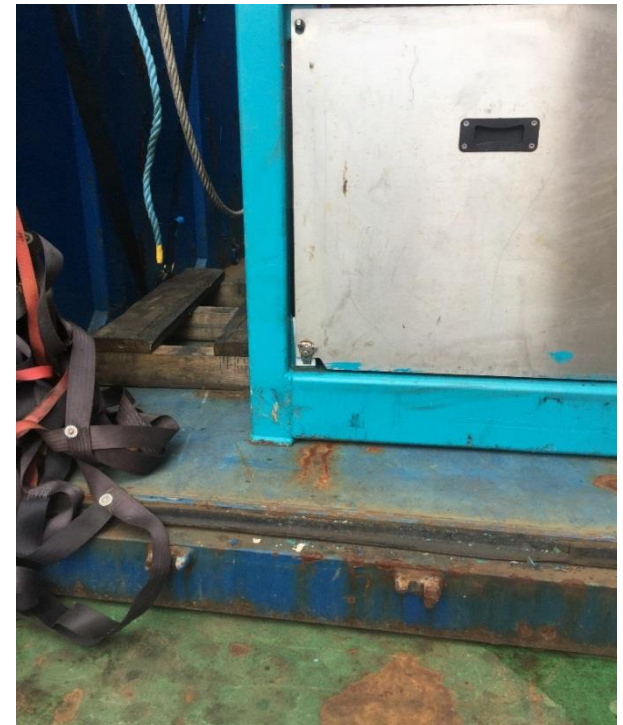
During backloading on a semi-submersible in the North Sea a removable panel (8kgs) on a High Pressure Unit (HPU) dislodged after a moderate hit when it was being lifted. The PDO was noticed when the lift was approximately 15 meters above the deck.

Once the unit was lowered back to deck it was noted that there were 2 removable panels which had come loose.

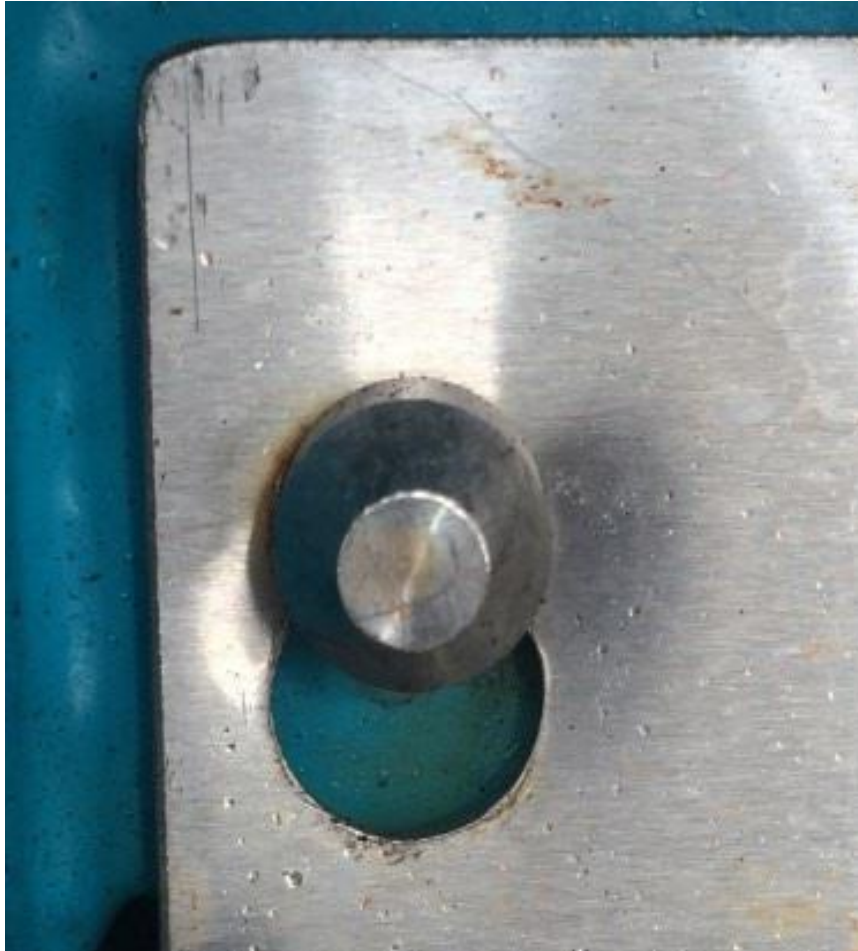
Upper Securing Locating Pin

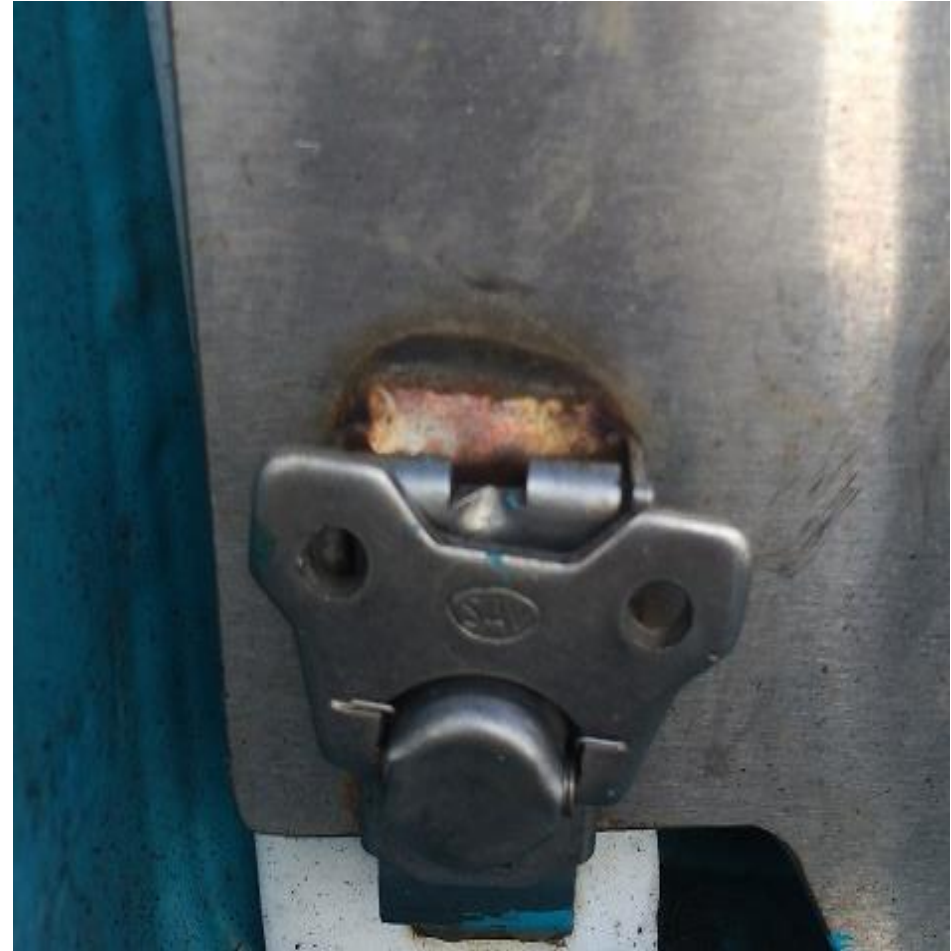
Lower Securing Clasp

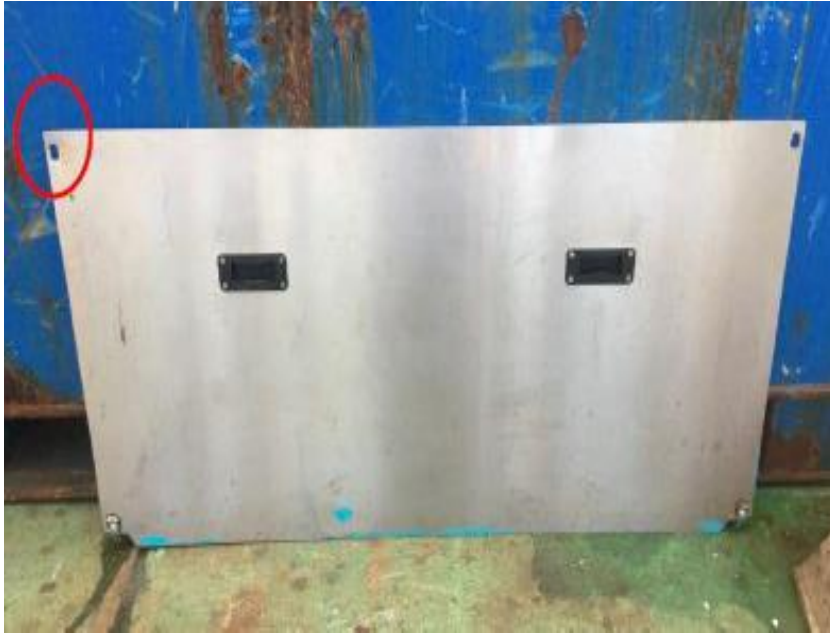
Removable Panel 1 - Stainless steel panel hanging by the upper left locating pin

- Design – inadequate design of removable panel securing mechanisms
- System – the document change request raised for updating an internal procedure after the last event was rejected and the other remedial actions proved ineffective and/or hadn't been completed

- Subsea Product Line to prepare a plan to modify all HPUs globally, due to quick release clasps not being required
- Update maintenance procedure in the interim to detail that Loctite 234 should be used to secure the upper locating pins
- Update the design specification for new units
- Safety alert issued internally and to the client and communication to the DROPs forum and Step Change in Safety
- Review the approval/rejection process of high criticality document change requests

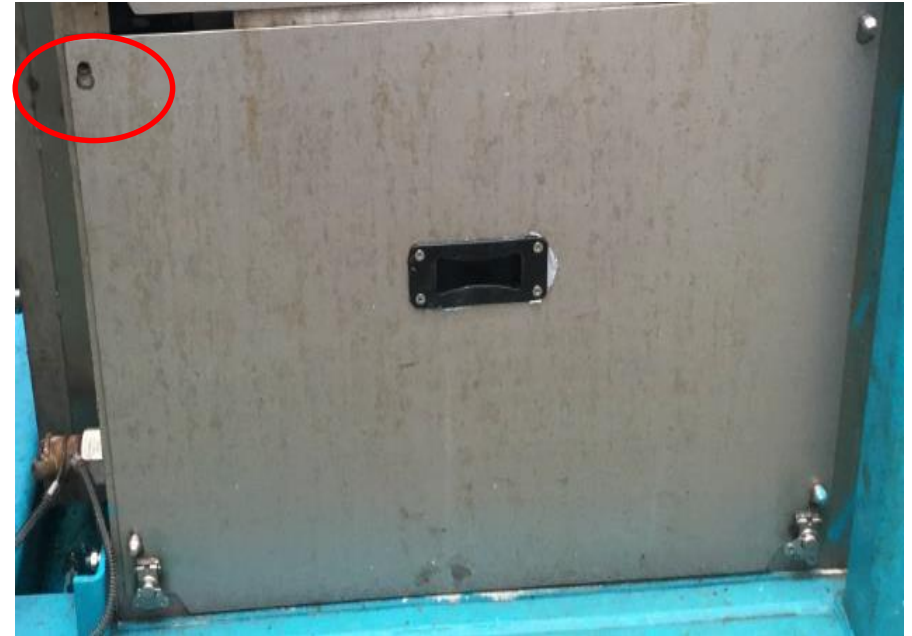
Removable Panel 2 – The upper left locating is missing
