IMCA Safety Flash 02/15

February 2015

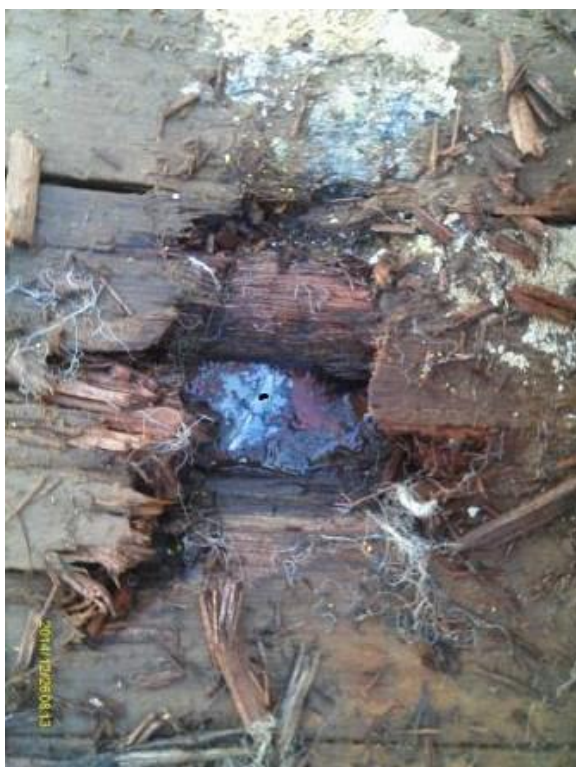
Figure: showing damage to deck

- ◆ Actual damage: the crane block destroyed sections of wood planks on main deck and damaged the bunker tank top underneath;

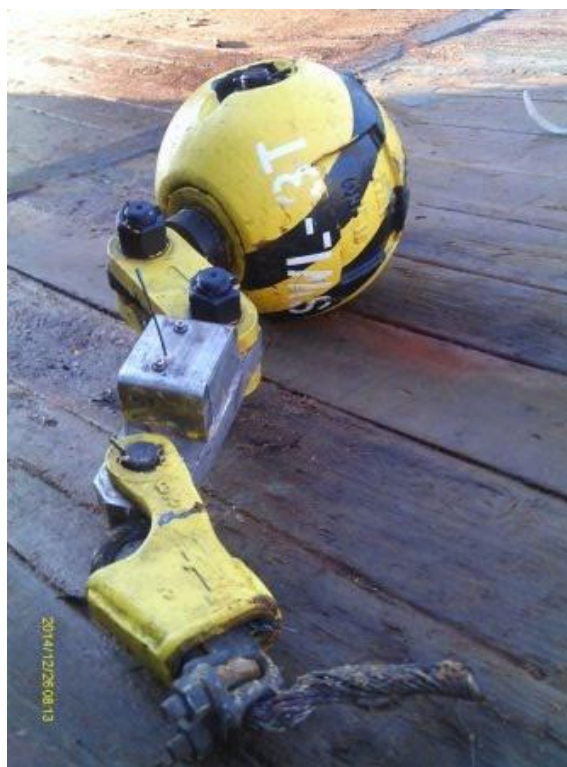
A member has reported an incident in which a crane wire parted and the hook block then fell to deck (approximately 15 metres) landing in close proximity to the deck crew. The incident occurred when a vessel was engaged in cargo operations with an offshore rig, requiring the off-loading of a food container. The rig crane was fitted with two wires; one heavy duty (which was used to off-load the container) and another wire of smaller diameter which was left hanging approximately 6 metres below the crane boom and not connected for the operation.

The rig crane attempted to lift the food container but the container was found to be too heavy, and was immediately returned to deck. Upon safe landing, the heavy duty wire was then disconnected by the deck crew. However, upon disconnection and before the deck crew had cleared the area, the crane driver started to retrieve the smaller wire instead of the heavy duty one. The smaller wire was heaved all the way up to the crane boom, at which point the hook block came into contact with the end of the boom, causing the smaller wire to part. The hook block then fell to deck and landed close to the crew on deck. There were no injuries.

Figure: crane block that fell

- ◆ The rig crane's limit switches/stops were apparently not fully operational, thereby allowing the hook block to be heaved all the way up to the boom.

- ◆ Further inspection and testing of limit switches to ensure that no similar technical failure exists onboard;
- ◆ Emphasised the need to prepare to exercise the Stop Work Policy if third party equipment is not safe, or there are concerns about its condition and/or operation;

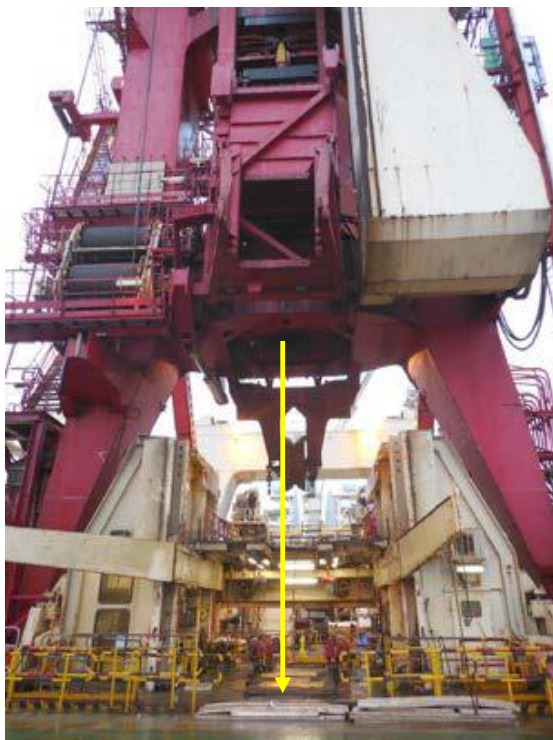
A member has reported an incident in which a wooden hammer shaft failed and the head fell to deck. Two personnel were located at the upper main tensioner level of a pipelay tower, removing dowels from the tensioner gear boxes using a spanner wrench, dowel removal tool and the 2kg lump hammer. During this process the personnel were striking the spanner wrench with the lump hammer. On a downward swing of the hammer and at impact with the spanner wrench, the hammer head detached from the shaft and fell approximately 25 meters vertically through the tensioner to the deck below. There were no injuries. Had the falling hammer head struck a person, according to the DROPS calculator it would have caused a fatality.

Figure: pipelay tower showing where hammer fell

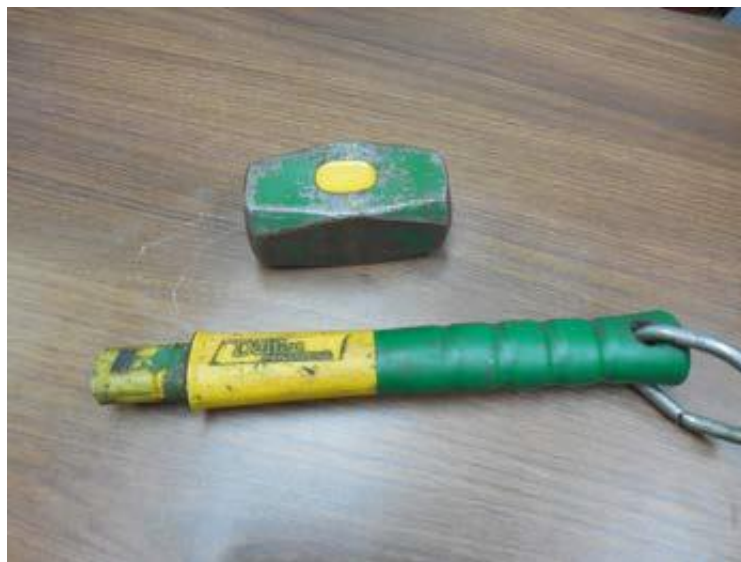
Figure: broken lump hammer

- ◆ The hammer was not specifically designed for use at height, and the head can (and did) separate from the shaft;
- ◆ The reason for the failure was not yet known, the manufacturer claimed to have a design that requires 20% more force to pull the head from the handle than a conventional wedged hammer, but it had nevertheless failed whilst in use;

- ◆ Despite inspection prior to use, the hammer showed no defects. A specifically designed hammer for working at height such as from Stop-Drop Tooling, would not have failed in this way as the head cannot come free from the shaft;

- ◆ The shaft of the hammer was fitted with a lanyard, there was however no way to prevent the head dropping with this type of hammer.

- ◆ Ensured that this particular brand of hammer was NOT used at height subsequently;
- ◆ Supervisors to ensure that tools used for working at height offer complete dropped object prevention, and liaise with their Health & Safety Executive (HSE) Superintendent for advice if new tools are required;
- ◆ Continued liaison with hammer manufacturer regarding the failure.
