# One Pager

Synergi ref:410847, 414450

**Location: Maersk Discoverer Date: 29th December. 2009 Dropped object caused by heliops**

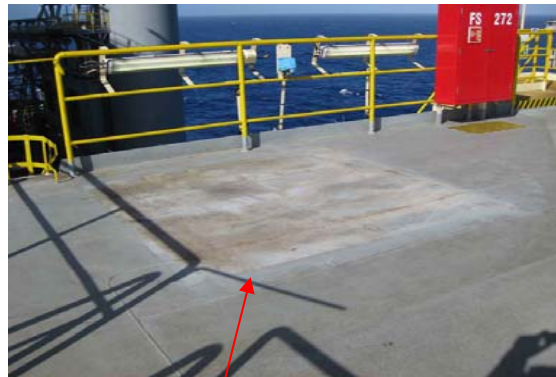
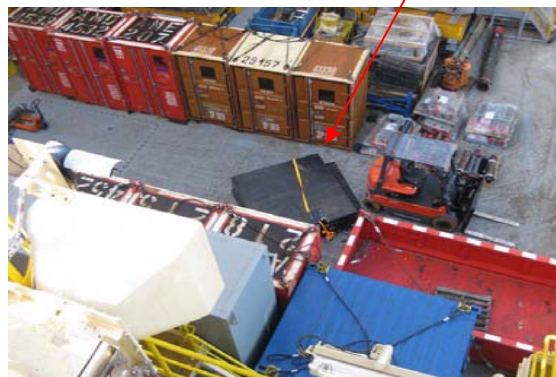
**Facts:** A Billy Pugh personnel transfer basket and fibre glass box were blown from the emergency generator roof to the main deck below. The incident occurred when a crew-change helicopter was landing on the helideck. The box and the Billy Pugh, of an estimated combined weight of 200kg fell a distance of 10.6m, with a potential of 20797 joules. The box struck the corner of a container before reaching the deck. The corner of the box was damaged, but the Billy Pugh was not. No injuries were sustained. The area on the main deck that the box landed on was not a designated walkway and the area was clear for helo ops.

The box containing the Billy Pugh had been deliberately located in position (for approx 5 months) to limit boom movement & for ease of access for previous operations prior to the rigs arrival in Australia.

The box was positioned on 2" dunnage (which provided an air gap).

The lid had been secured to the box, however the box was not secured to the deck.

The design of the box (i.e. large surface area) contributed to it being lifted by rotor wash from the (EC225 aircraft).

Outline of where box was situated & final position where it came to rest

even heavy objects (more than 200 kg), or objects seemingly unlikely to be moved by helicopter downwash should be assessed as potential hazards. Re-inspect helidecks with this scope.
