Experience Transfer

Subject:	Near Miss - Dropped Object – Sheave loading gate	Date:	19/10/2022
Region:	UKAF	Revision:	1
Product Line:	Wireline	Case ref:	19126
		E.T. number:	1283

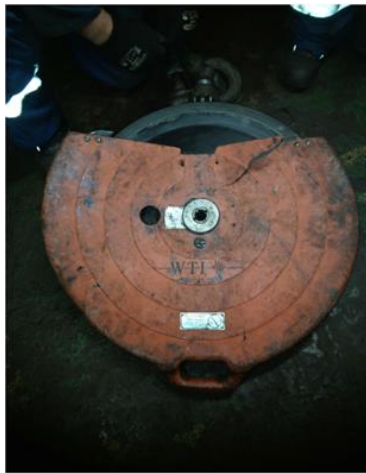
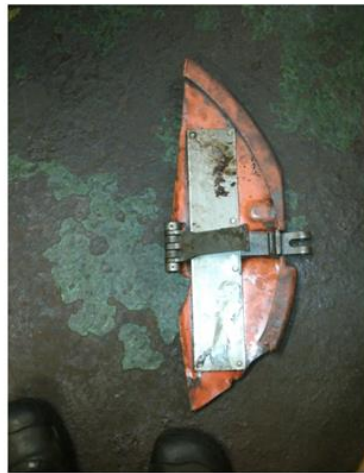
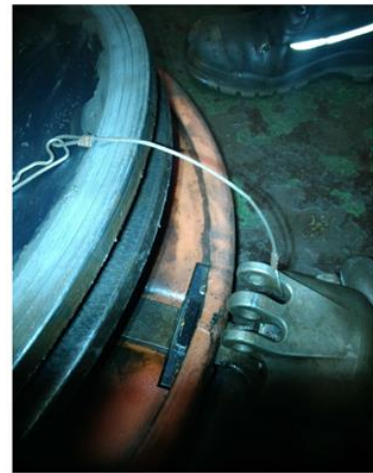
During Wireline operations in the UK North Sea, the crew were carrying out a pickup when they heard a noise, lost weight, and noticed that a section of the upper Wireline sheave had come loose and fallen to the rig floor.

On closer inspection, it was identified that the section which had fallen was the cable loading gate and section of the sheave internal frame.

In discussions with the crews and post incident investigations it became clear that the load bearing pin had not been used to secure the gate in place as it was not present at the time of rigging up the equipment. The crew had discussed this and decided that the gate was not load bearing and was only required to be closed and engaged so a tie wrap was used instead of the correct pin. As the weight on the sheave increased, the tie wrap eventually failed allowing the gate to open and cause a bending moment on the other side of the sheave. This has then allowed the cable to come free from the sheave and drop onto the opened gate causing the failure and subsequent dropped object. The cable also dropped and was damaged as it fell against the top of the grease injection head.

- Lack of knowledge of equipment design and load bearing nature
 - Competent to use the sheave in an operational sense but lacking full understanding of sheave workings

- Lack of design and loading information within current training program but detailed within equipment manuals and operational procedures
- Load bearing pin missing from sheave at time of rig up and not used to secure loading gate

- Lanyard which secures pin to sheave was loose and able to come free easily
- Operational checklists and SV documents incorrectly used and lacked specific detail to ensure valid checks to avoid this type of incident were completed

- Create alert and share with personnel, company, and Industry groups
- Enhance training materials, operational documents, and checklists to ensure knowledge of equipment and additional checks and verification steps
- Enhance maintenance program to include additional focus on lanyards and securing wires
- Communicate with personnel to ensure correct understanding for the use of Control of Work processes and procedures to assess and control operations
- Liaise with Operator to ensure that all learnings and actions from the incident are implemented and verified as correct through future operations

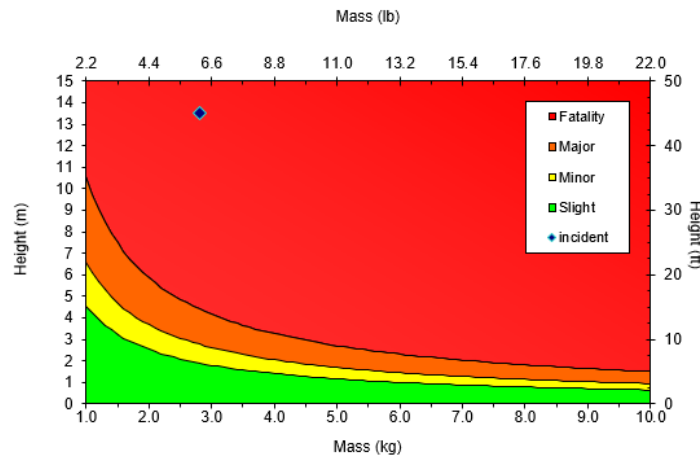
Due to zone management of the working area, there were no personnel within the drop zone. When we look at the potential using the DROP's calculator, we can see that the outcome may have been severe had this not been adhered to. Always ensure that dropped object checks and zones are always discussed and adhered to.

Outcome Calculator		
Height	45	ft
Mass	2.8	kg
Outcome	Fatality	376.62 Joules
