# Flash Safety Alert

ABB - BLOCK – 60 FSA-2021-062

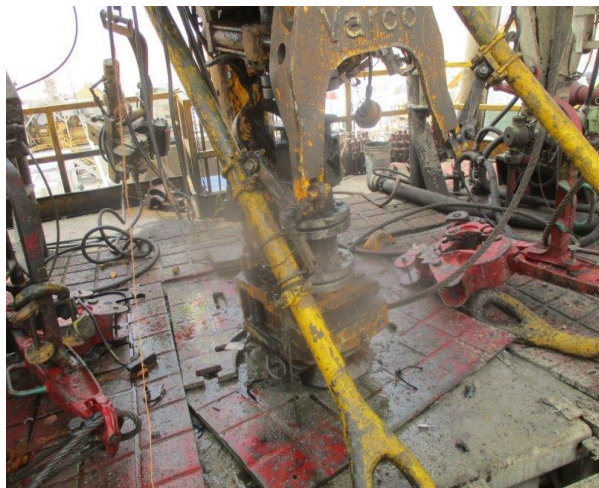
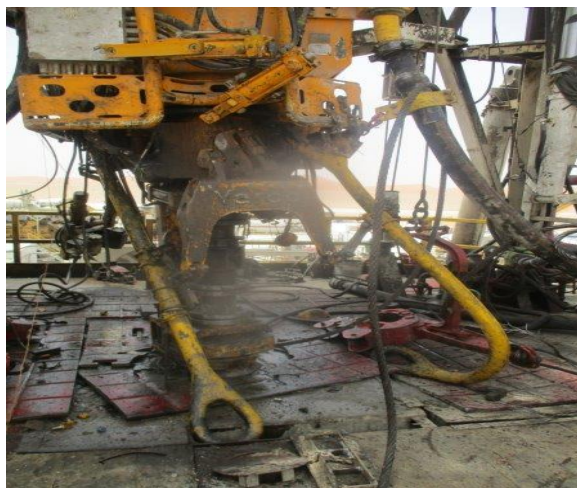
On the 21 June 2021 the drilling of 17 ½" section was in progress. At approximately 13:00 hours, the Driller raised the Travelling Block to pick up a 5" drill pipe stand from the monkey board. The Travelling Block hit the Crown, the Drill Line got parted and the entire assembly (Top Drive System, Travelling Block, Drill Line) fell onto the Rig Floor. The approximate weight of the dropped equipment is 15 tonnes. The height from Crown to the Rig Floor is approximately 40m. At the time of the Incident, the Rig Manager, the Driller and two Floormen were on the rig floor outside the Red Zone. The Derrickman was on the monkeyboard. The zone management was maintained and there was no one standing in the line of fire. No personal injury occurred.

Asset Damage: Top Drive System, Travelling Block and Drill Line fell onto the rig floor and got damaged.

- Ensure that the crown saver device is set in the correct place and tested.
- Ensure the drawworks brakes are fully set after actuation of the crown saver device.
- Never bypass safety devices and follow OEM standard settings.
- Keeping away from the line of fire outside Red Zone saves lives!
- Stop the task if unsafe practices/conditions are observed
