## What Happened

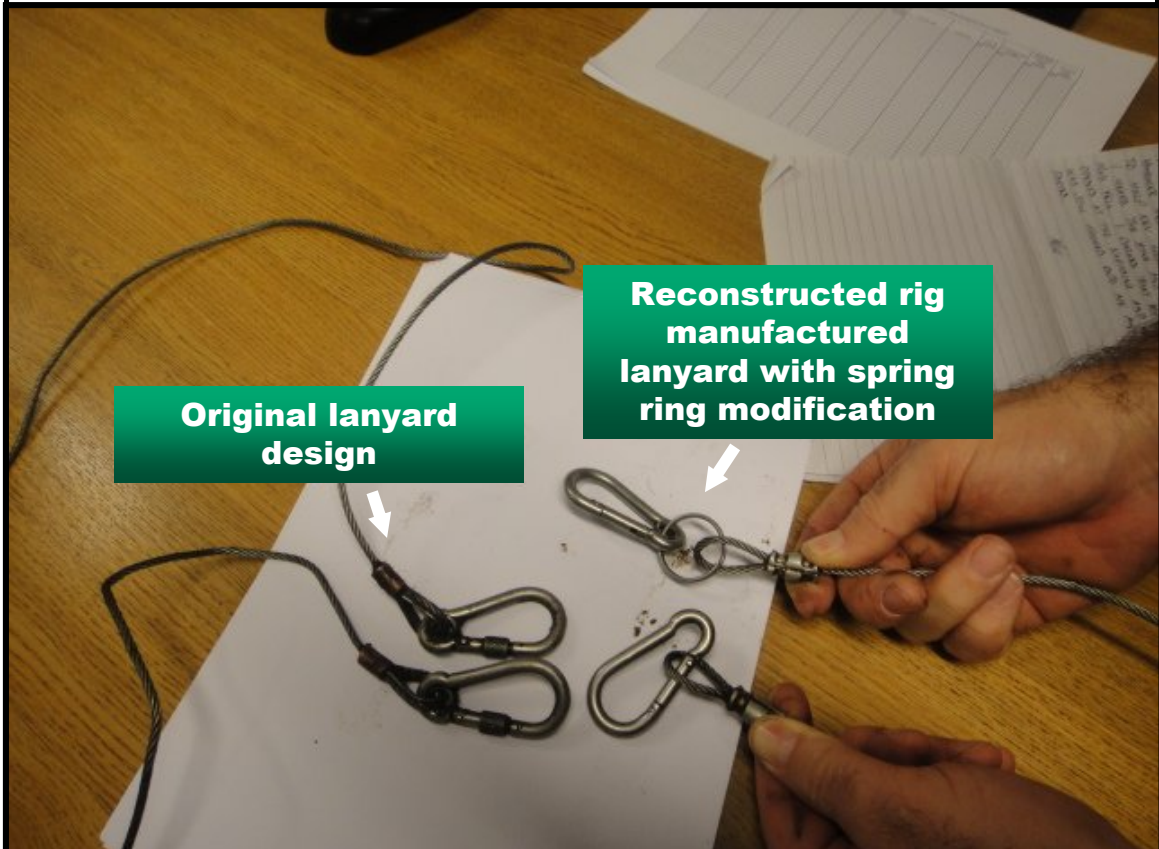
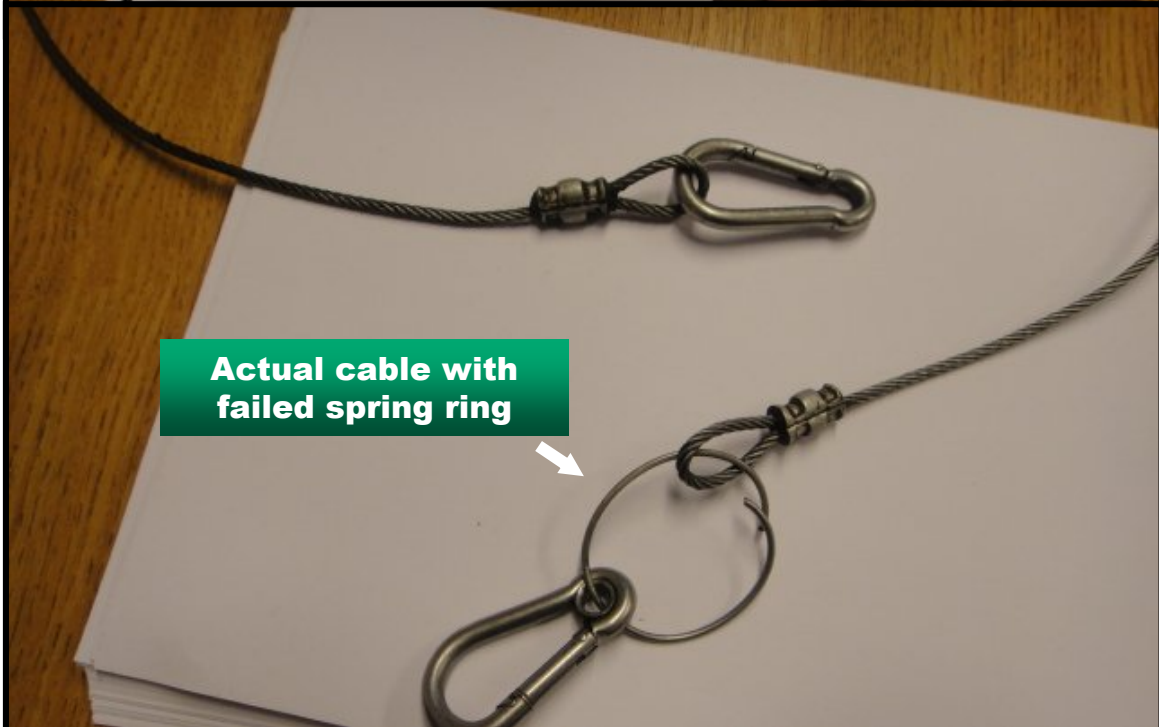
**Details of failed equipment**

- A 10lb sledgehammer was dropped approximately 40ft to the rig floor. The area was barriered off and controlled therefore no personnel were on the rig floor at the time.

- A roughneck was using the sledge hammer to loosen the cement hose connection from the side entry sub. Once this was completed the roughneck lowered the sledge hammer to hang from his lanyard and the tool dropped to the rig floor.
- On closer examination it was evident that the Tools-Aloft kit had been supplemented with rig manufactured lanyards. The lower karabiner is normally attached directly to the cable, in this case a spring ring was used to connect the components. The spring ring failed when subjected to the weight of the hammer.

- Checked Tools-Aloft safety equipment inventory and removed rig manufactured / modified items from inventory.
- Incorporated inspection of Tools-Aloft equipment into routine weekly derrick inspection checklist process, to ensure long term mitigation.
- Segregated lanyards for light weight Tools-Aloft equipment and heavier weight equipment.

- All sites advised to consider implementing the above actions.
