Energy Safety Canada is the national safety association for the oil and gas industry. We develop and support common industry safety standards, deliver effective learning systems, share data analysis and safety expertise with workers and employers, and advocate for worker health and safety. Our goal is the same as industry's – zero injuries, zero incidents.

SHOULDER EYE BOLT FAILURE DURING EQUIPMENT LIFT

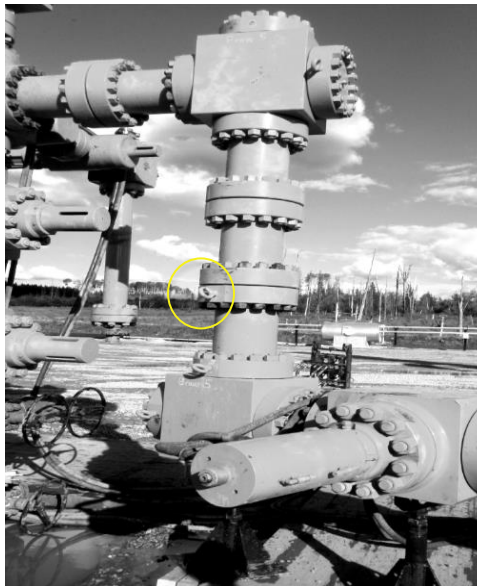
A fracturing (“frac”)/ wellhead assembly was lifted approximately half an inch to adjust a support (levelling jack) stand. The lift was conducted using the horizontally - attached shouldered eyebolts on the equipment. The orientation of the eyebolts required an angular lift. The lift took place and the eyebolt shanks sheared off. The wellhead equipment was secured and no other damage occurred.

EYEBOLT LOCATED ON WELLHEAD

The lift exceeded the angle load capacity which caused excessive strain on the eyebolts resulting in failure.

Angular lift significantly reduces lifting rated capacities.

- » Pre-plan each lift and understand engineering limitations of each component, including eyebolts
- » Before lifting, check with manufacturer specifications for rated load capacities and guidelines of eyebolt angle. Investigate appropriate methodology if using angled lifts. ie. safety swivel hoist rings

- » Shoulder eyebolts should not be used for angular lifts greater than 45°
- » Before use, inspect eyebolts for damage or alterations (grinding, nicks, gouges, distortions, worn, bent, etc.)

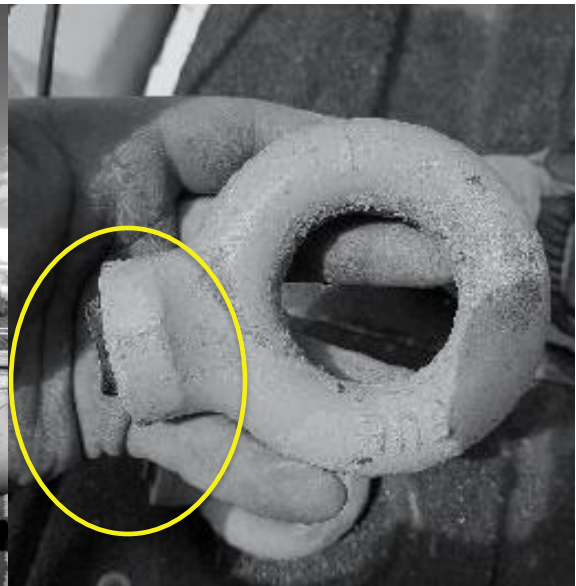
BROKEN PORTION OF EYEBOLT SHANK
