**Talisman Energy (UK) Limited**

**Synergi Number 76917, UK Safety Alert TLM 24-10**

**Tartan Platform**

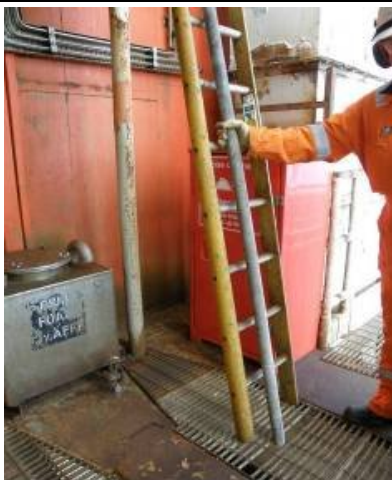
Location of drop point

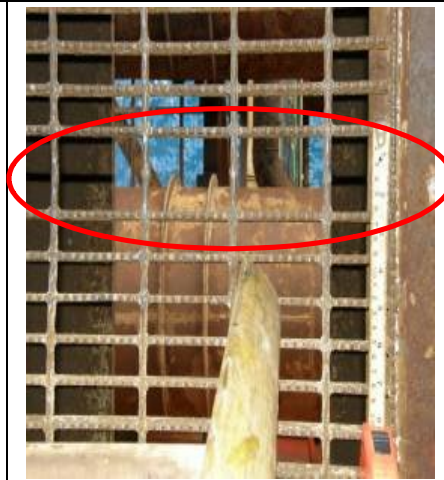
- Cross member removed as drop hazard, but gap left as is with no controls
- No tracking document raised to record the defect and drive repair/replacement
- All other causes will be subject to outcome of TapRoot analysis

Gap in grating

- All sites to consider similar scenarios, communicate potential for dropped objects through gaps, defects or other means where not immediately obvious.

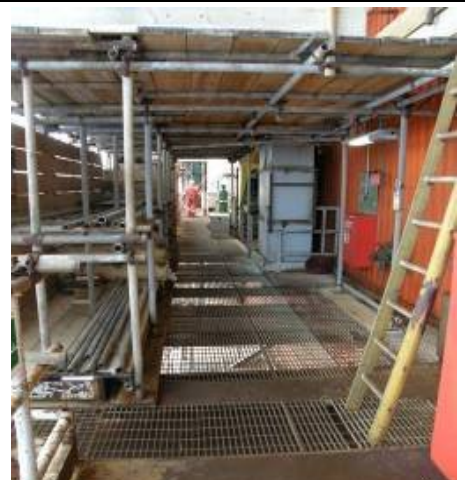
Worksite showing scaffold rack
