Reliable Bolt Securing For The Prevention Of Dropped Objects

Richard Waddington

Nord-Lock Ltd

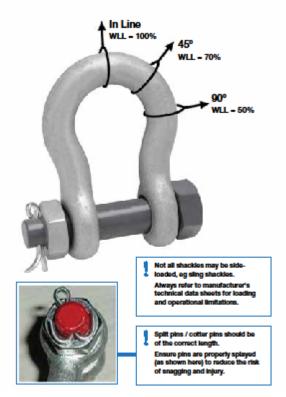
- · Side loading of shackles should always be avoided as this reduces the WLL factor. If it is completely unavoidable then the figure opposite may be used as guidance although manufacturers' guidance may differ.

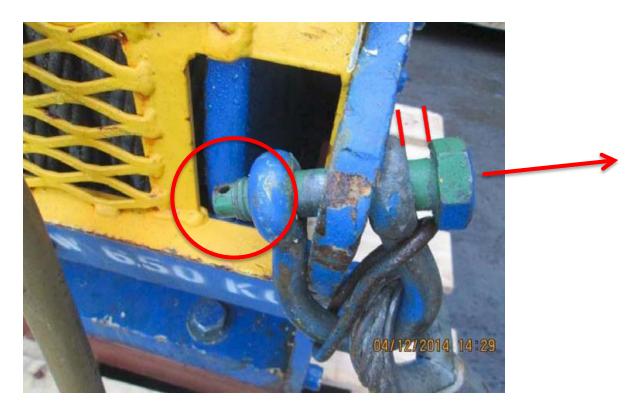
Near Miss: Missing Nut and Split Pin on Shackle

"it was possible that the split pin and nut worked themselves loose as a result of vibration"

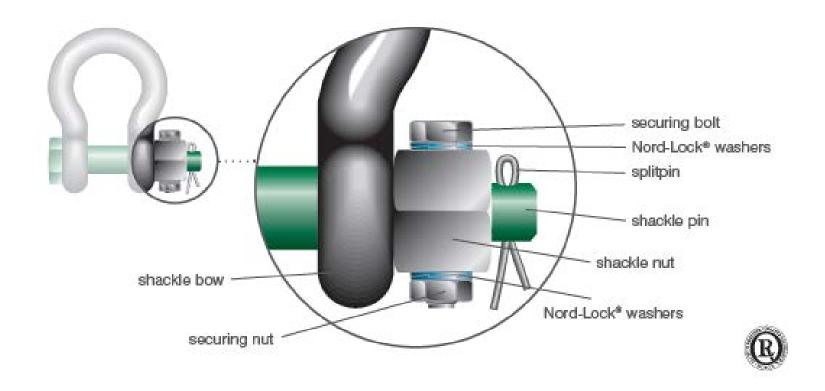
G-4143

Green Pin® Standard, Polar and Super shackles can be equipped with a feature that consists of an extra AISI 316 securing bolt which is drilled through the nut and shackle pin. This securing bolt is fastened with two sets of Nord-Lock® washers and a securing nut. This will keep the shackle nut in position. The Nord-Lock wedge-locking washers lock when subjected to extreme vibration or dynamic loads.

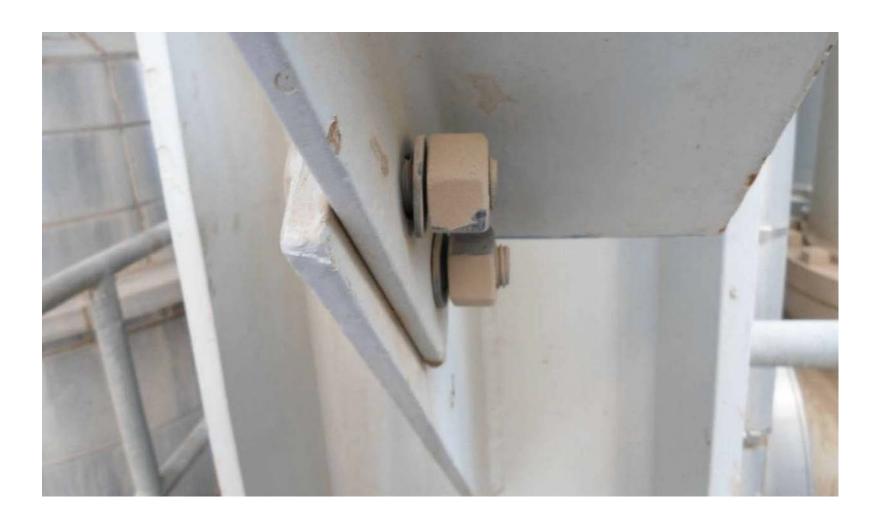
Loose Nuts & Bolts 1

On 6th June 2013 at 04:45 a sheared bolt with a nut fell in the red zone. Upon investigation, it was found that it was from the dolly track flange 15m from rig floor. All personnel were out of the Red Zone at the time of the incident.

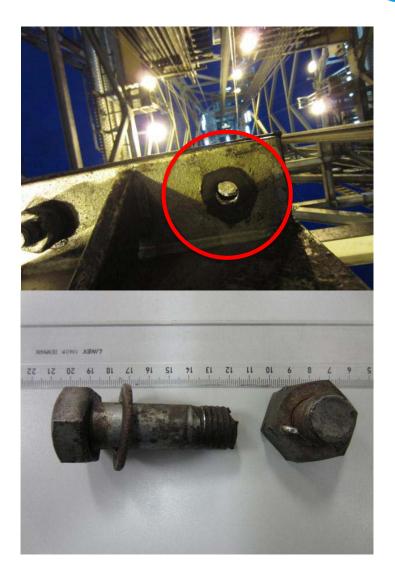
Dropped Nut & Bolt

Dropped Object - Bolt from Dolly Track - Fell 15m to Rig Floor

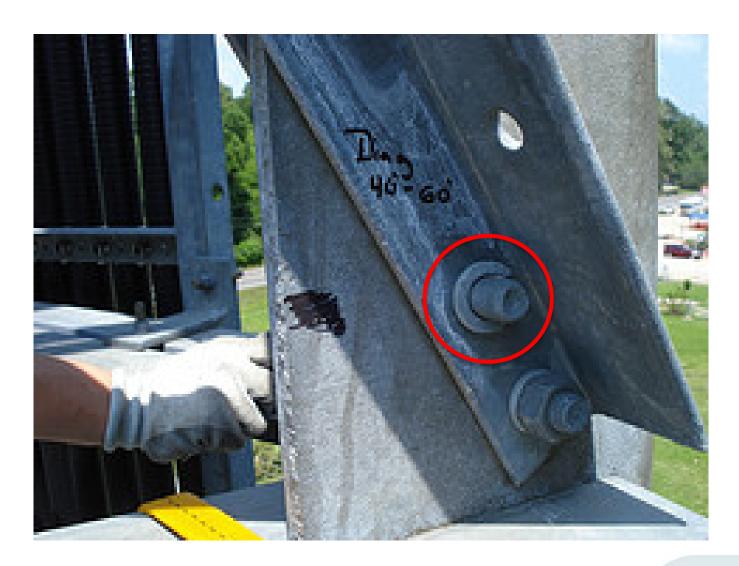
Loose Nuts & Bolts 2

FPSO SKARV was shutdown to replace 3,000 Bolts and Nuts because of poor quality fasteners.

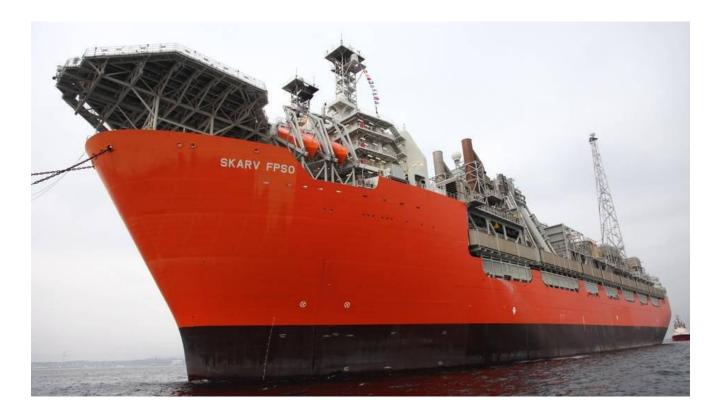
Poor Quality Fasteners

Estimated cost in excess of £25,000,000.
