Reliable Securing Presentation
Prepared by; -
Richard Waddington
Nord-lock Bolt Securing Systems
October 2012

The Security of Bolted Joints

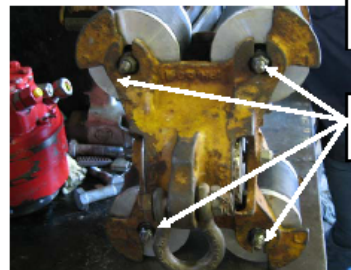
Fast Line Stabilizer Guide
with 6 rollers.

Lock nuts to be torqued only
once. Replace lock nuts if
broken out.

The locknut on the bottom outside roller had backed out allowing the roller to fall out. The stabilizer assembly had recently been rebuilt. Investigation revealed that some of the lock nuts had been loosened and re-tightened. All six rollers are seldom changed out at the same time, but it is necessary to loosen all lock nuts in order to re-install the assembly on the fast line. When a locknut is loosened and re-tightened, its break-out torque is reduced (and continues to be reduced further each time the nut is loosened and re-tightened.) To prevent this reduction in breakout torque, the lock nut must be replaced with a new one from the manufacturer and the old one discarded.

1. All self-locking nuts on all rollers are to be replaced. Do not re-tighten a lock nut once it has been loosened. Discard all used lock nuts.
2. Do not torque up the nuts fully until the stabilizer assembly guide is squared on the fast line.
3. Ensure the assembly is inspected regularly (as well as subjected to Preventive Maintenance protocols).
4. Have a JSA for rebuilding, servicing or replacing one or more rollers in which the above points are specified.

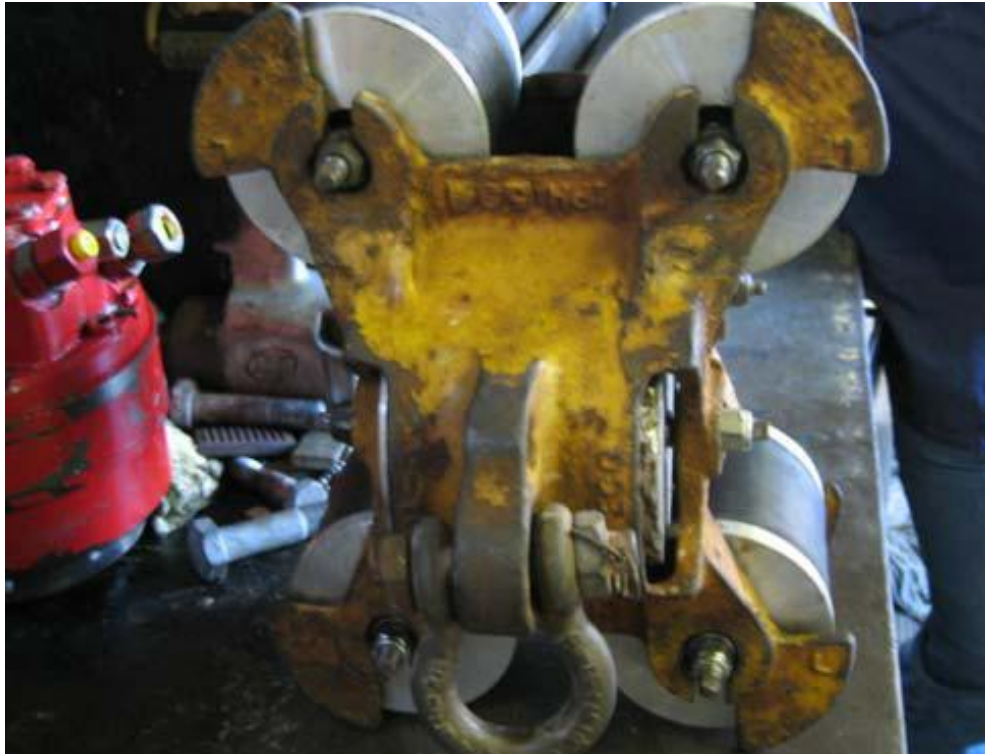
The locknut on the bottom outside roller had backed out, allowing the roller to fall

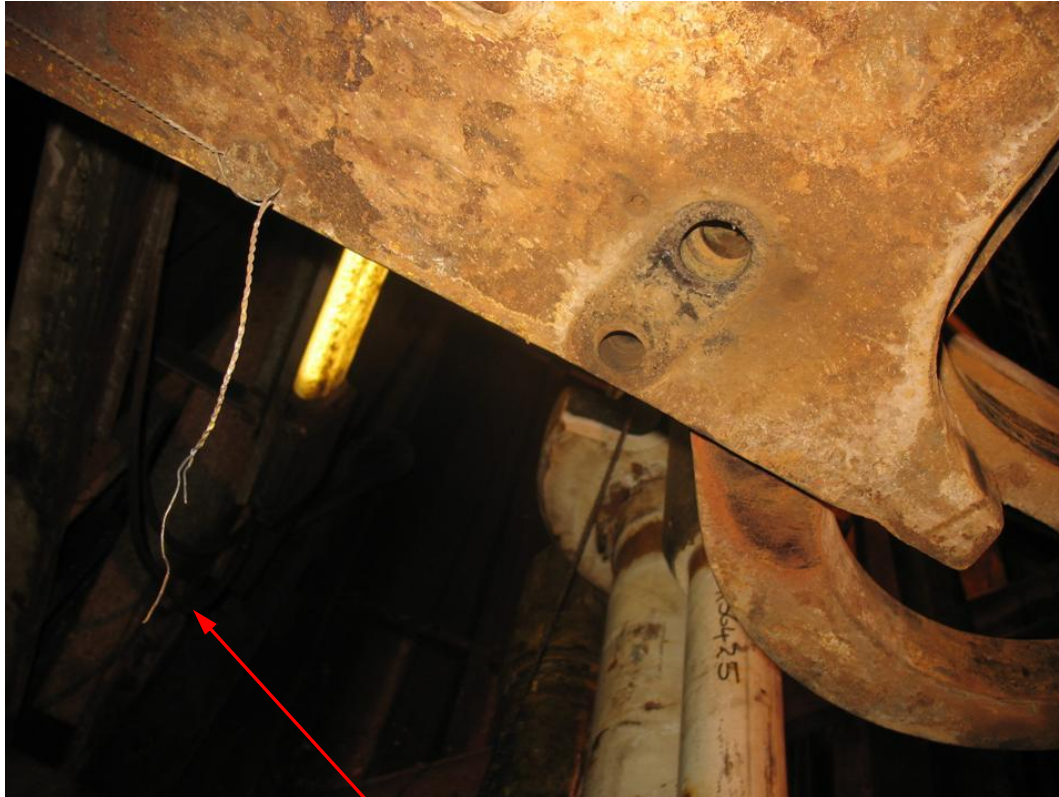
Note the broken locking wire

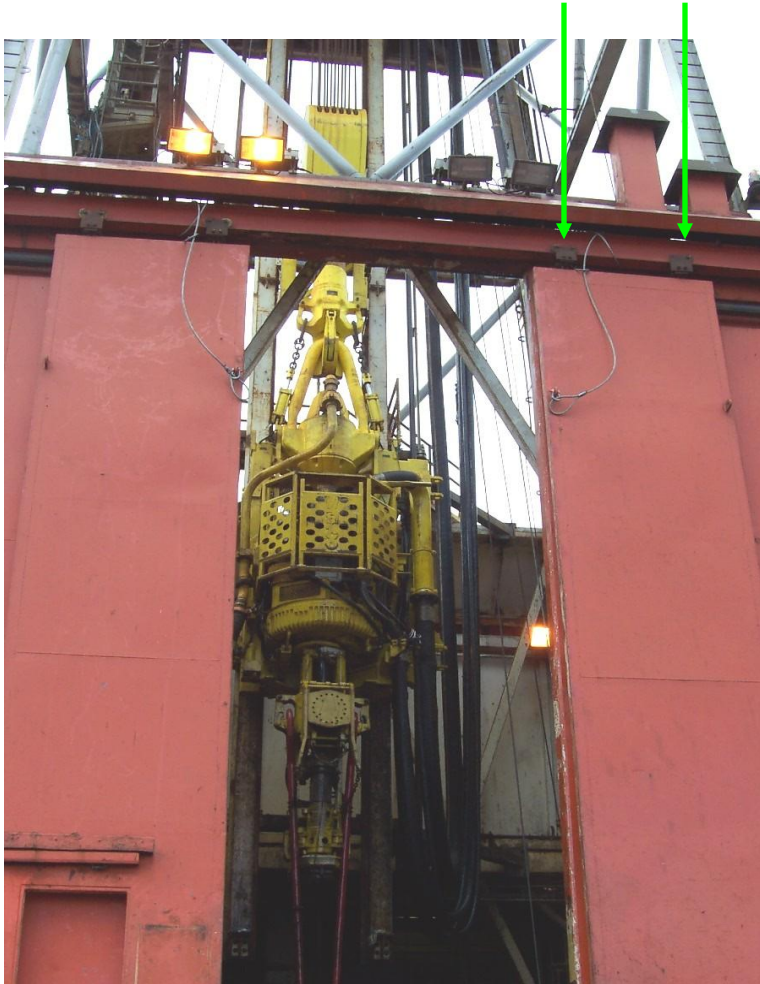
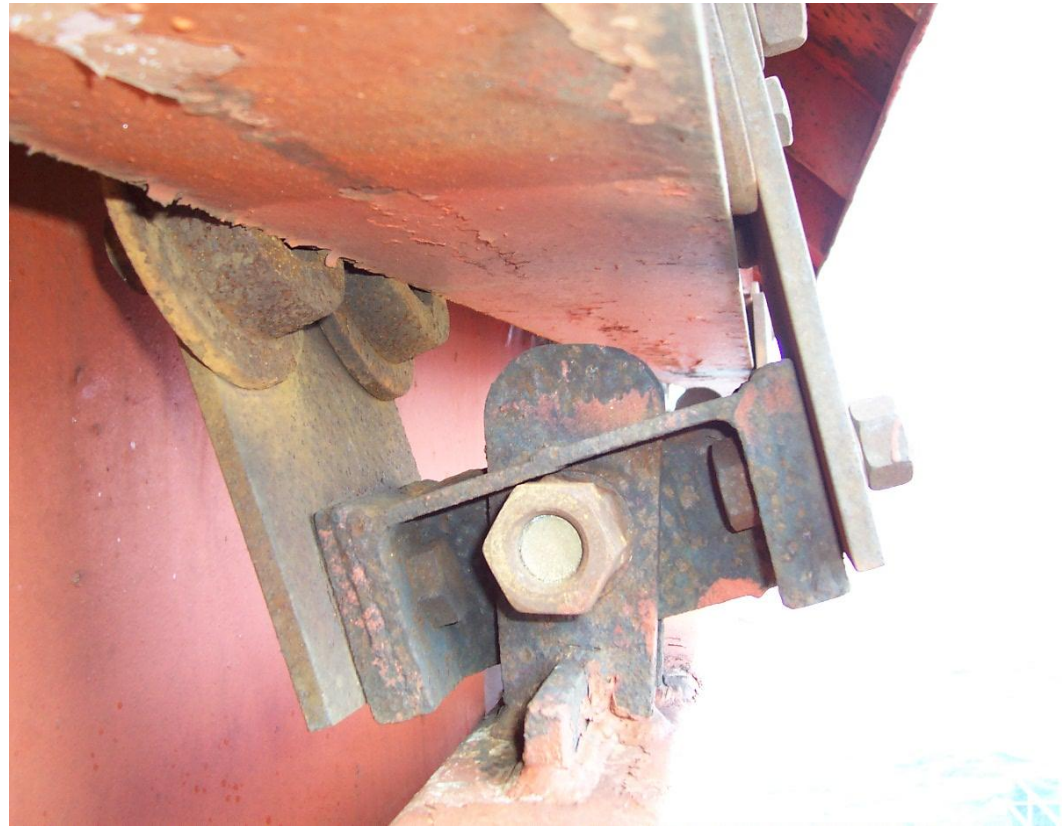
Trolley wheels are dislodged from runway beam.
Nuts and bolts are loose.

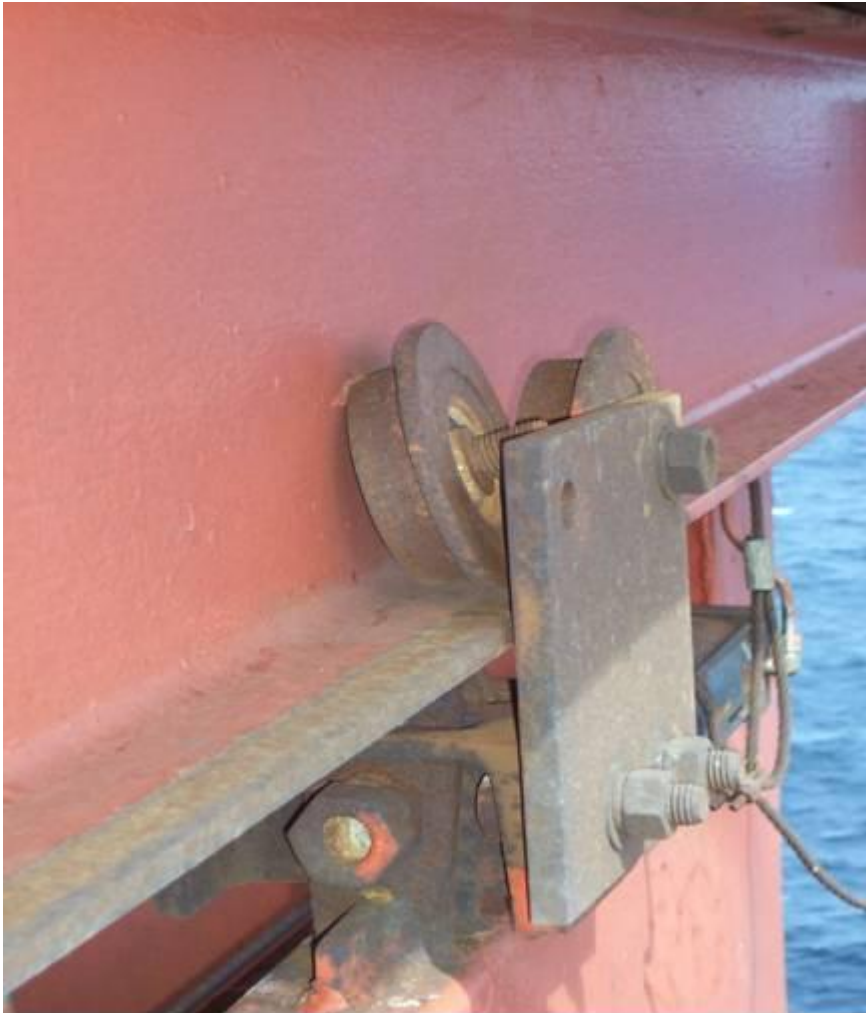
Wheel
Disconnected.

Nut missing.

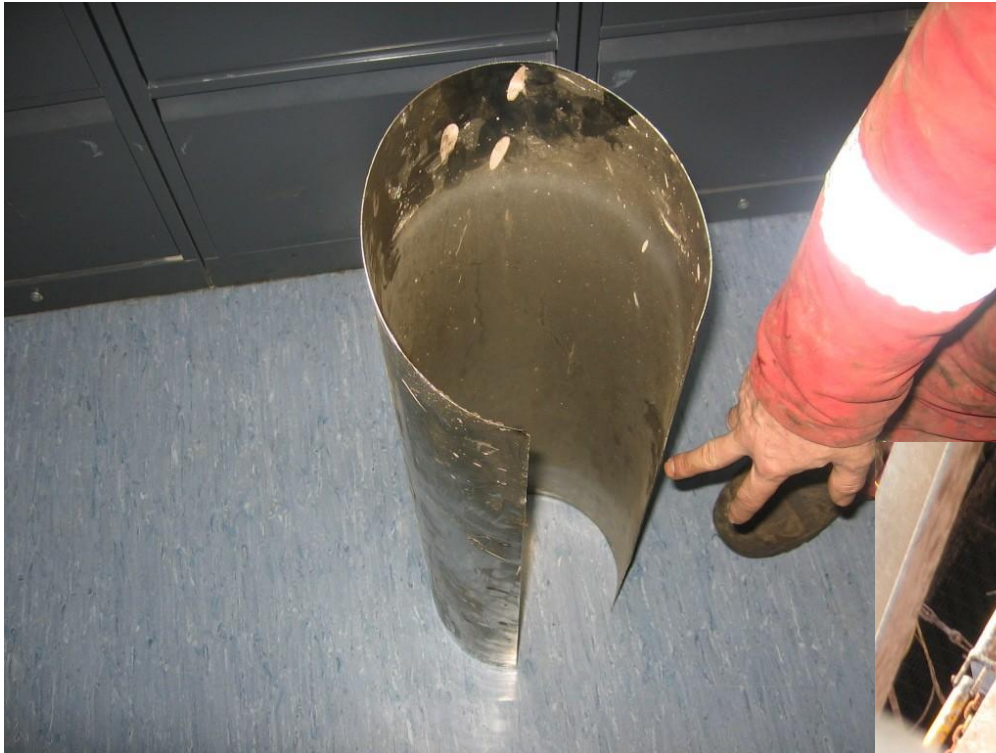
3.5 kg derrick camera shroud
fell 5 ft to stabbing board.
Potential to fall 50 ft.

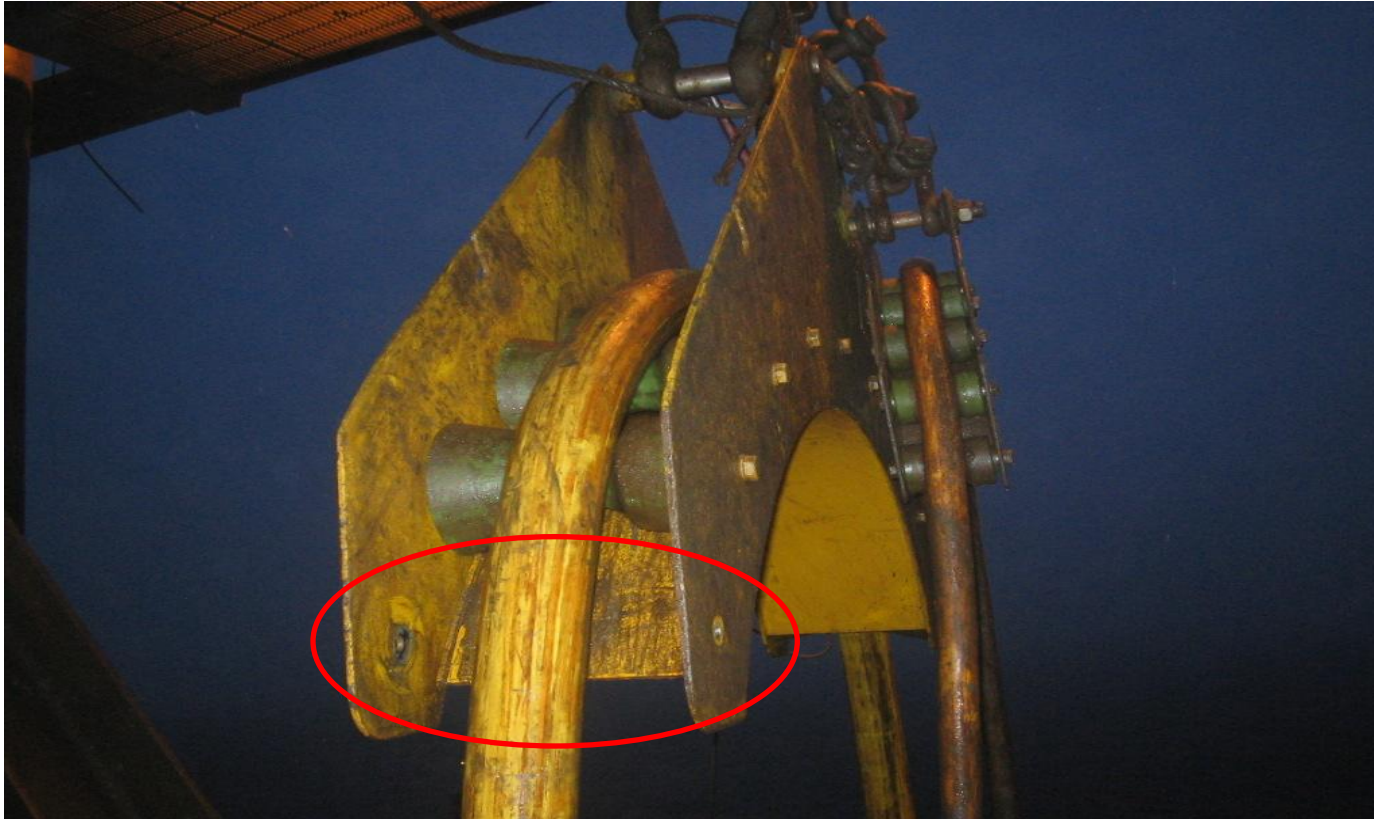
Weight of dropped roller
4.5kg, Height 24m

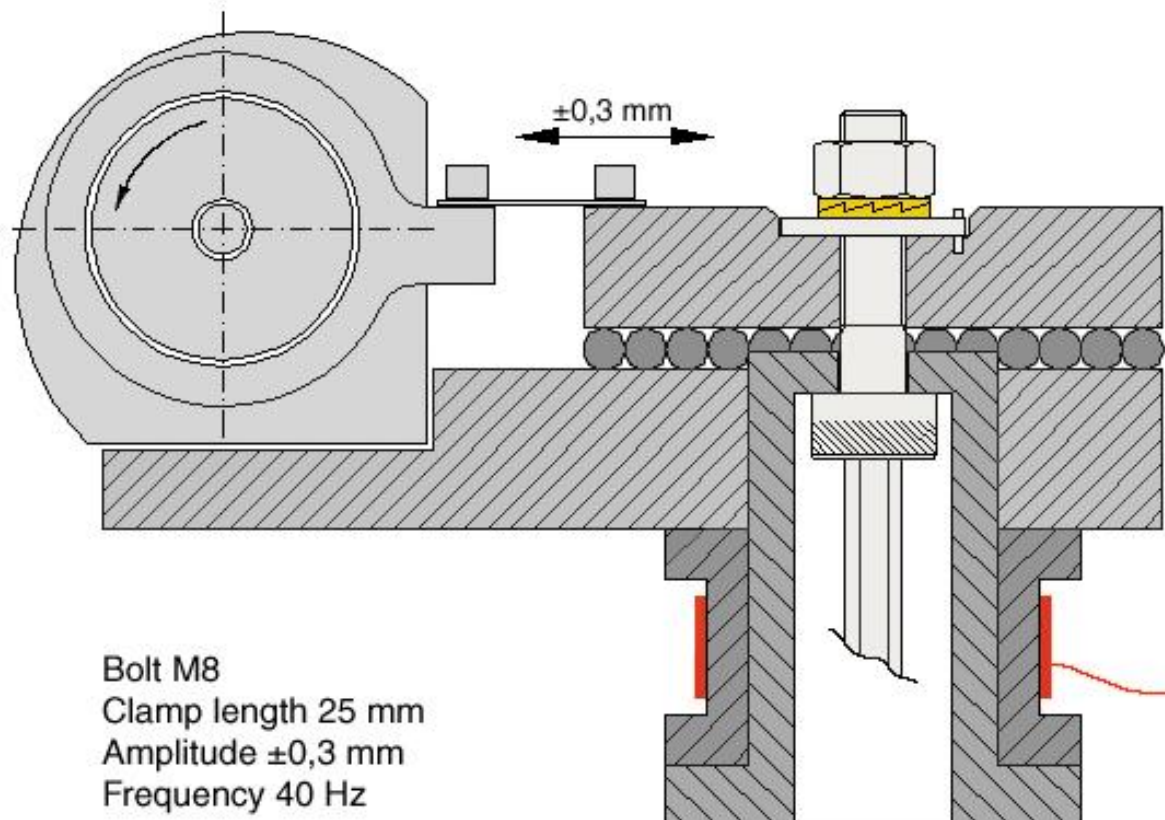
Junker vibration test (DIN 65151)

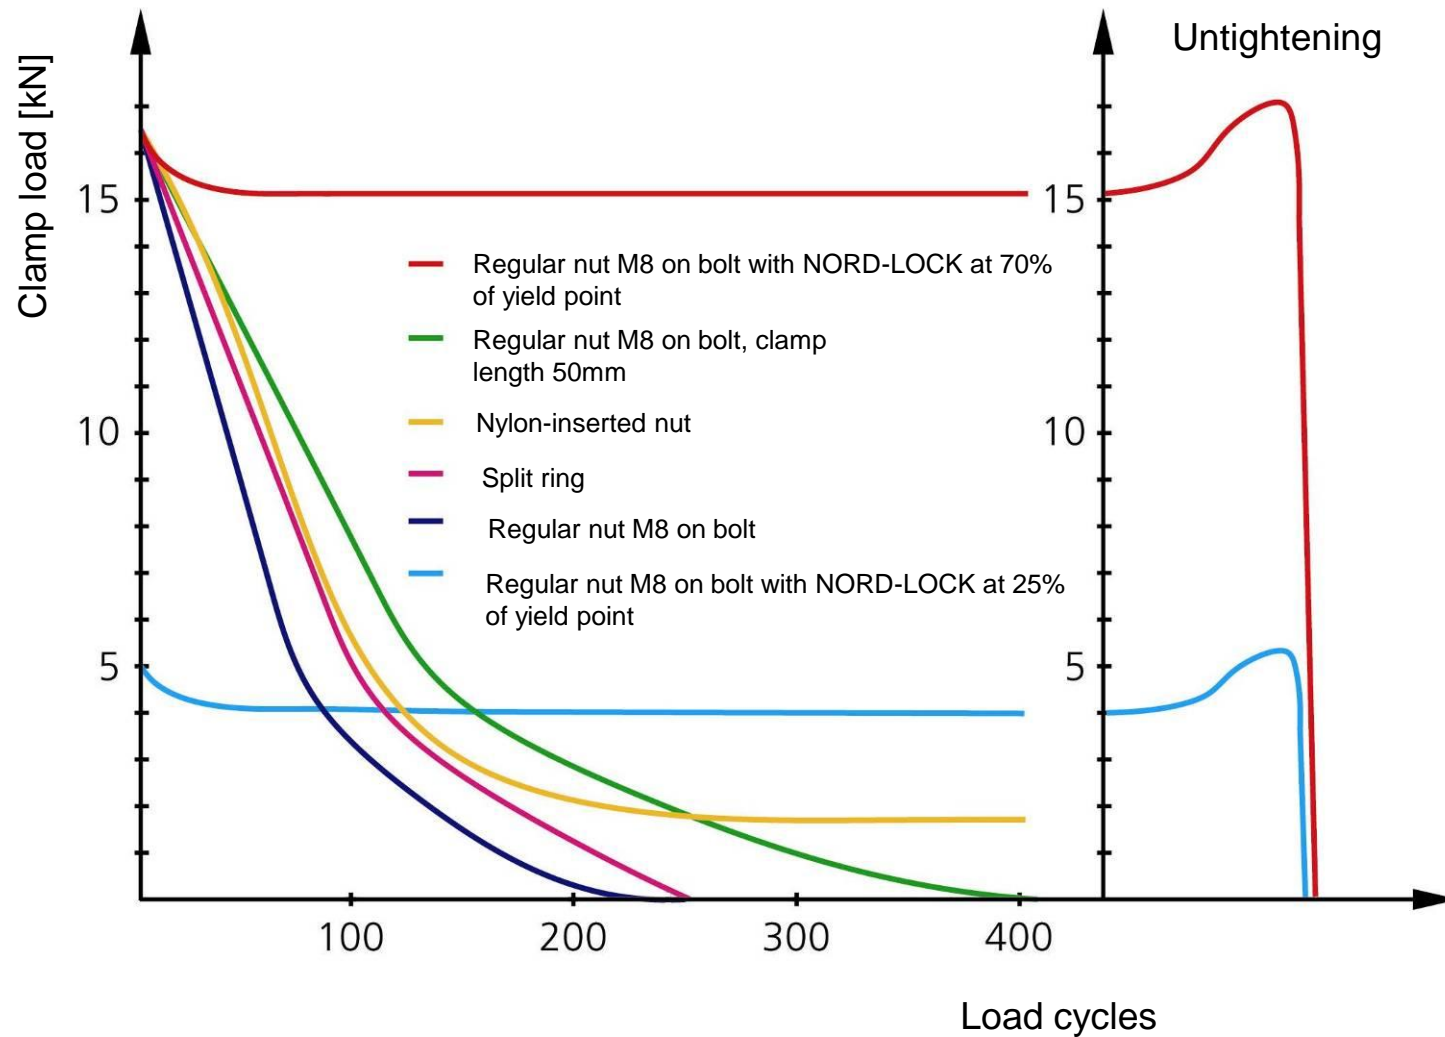
**Testing exposes the limitations of
traditional bolt securing methods**

Junker Test Graphs

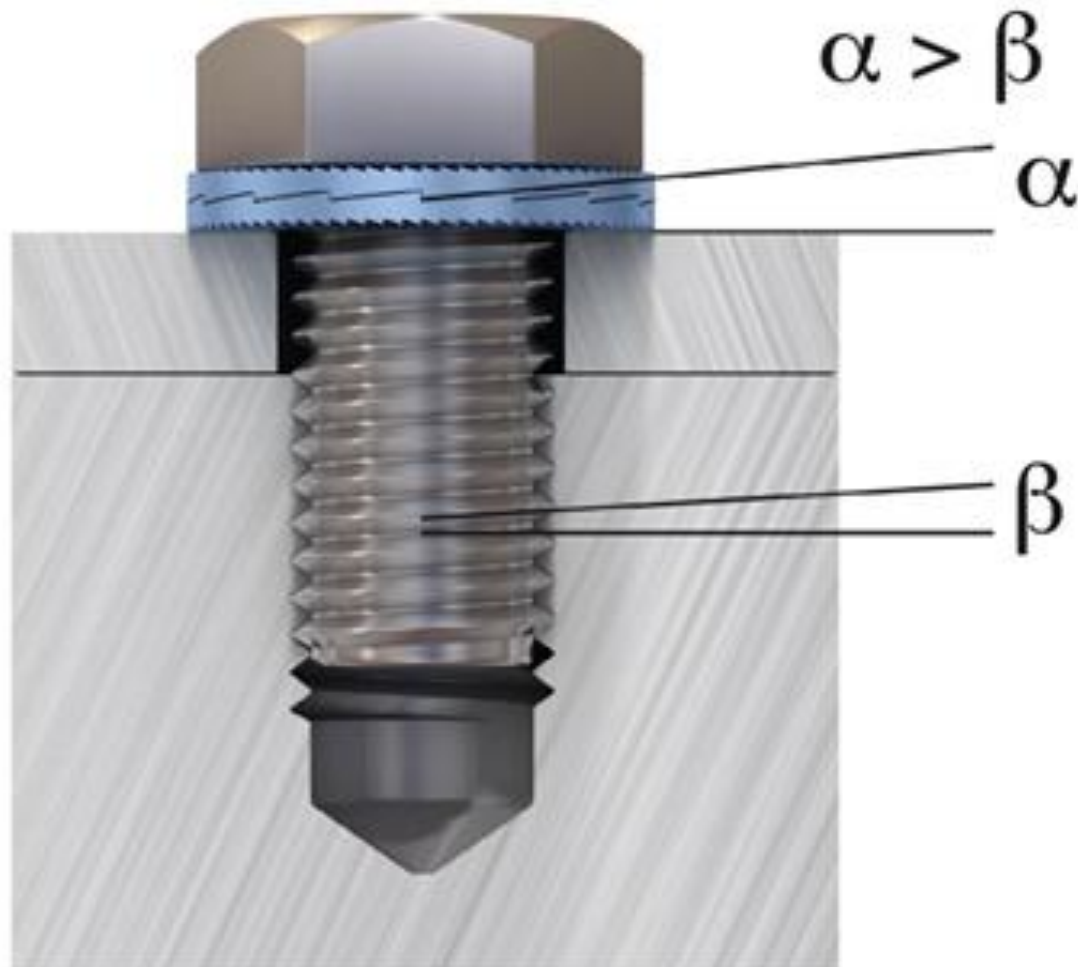
Use Geometry To Lock The Joint

Description: Each locking washer consists of two pre-assembled washers with cams on the inner mating faces and radial teeth on the outer faces of the washers. The rise of the cams is greater than the pitch of the thread on the fastener.

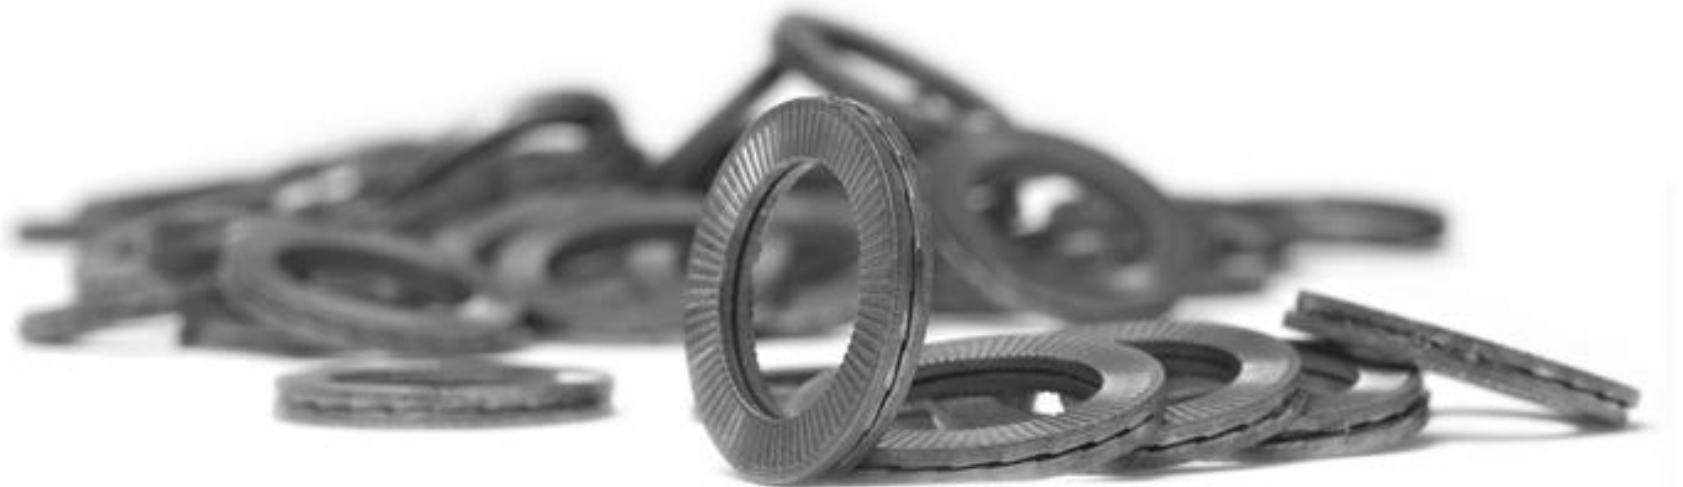
Dörken's Delta Protekt® zinc flake coating, performed in-house by dip-spin
2 layers of base coat (KL100) and 1 layer of top coat (VH302GZ)

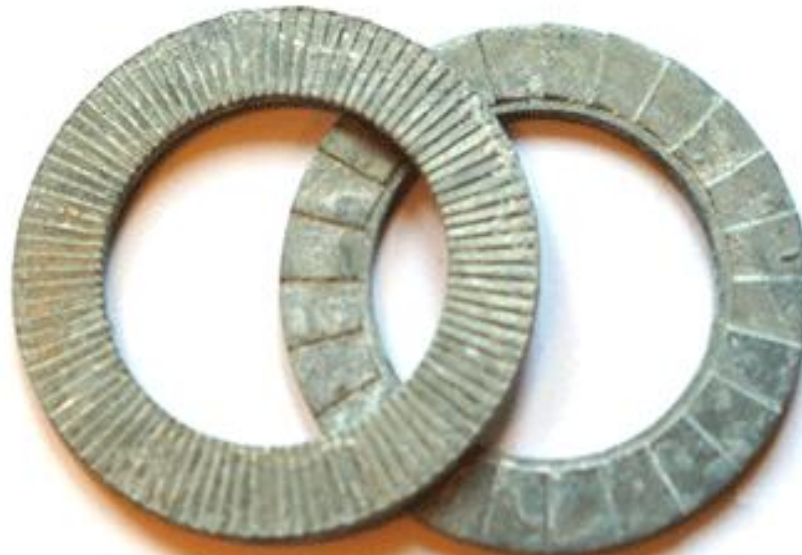
***After 1000 hours of
salt spray testing***

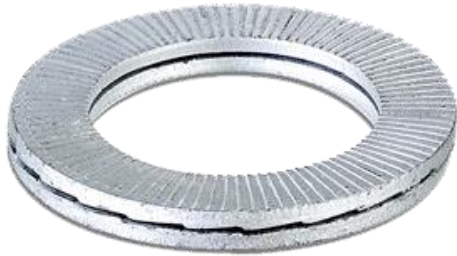
Standard

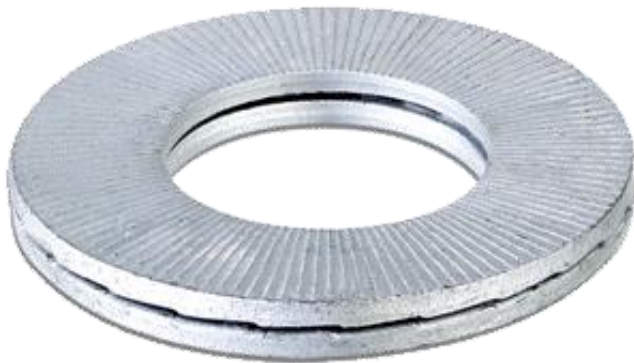
SP – enlarged outer diameter

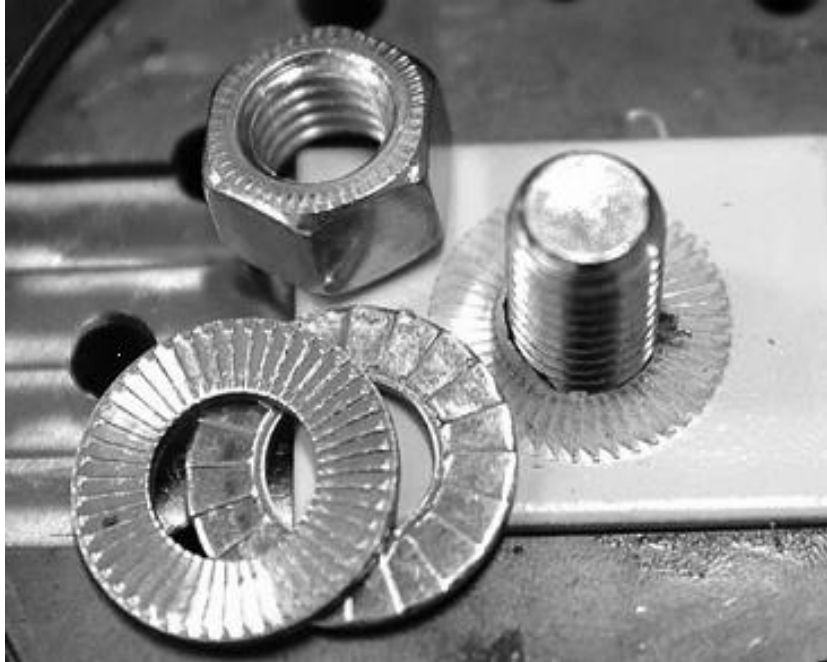
NORD-LOCK washers are designed to create impression marks without scoring the mating surface.

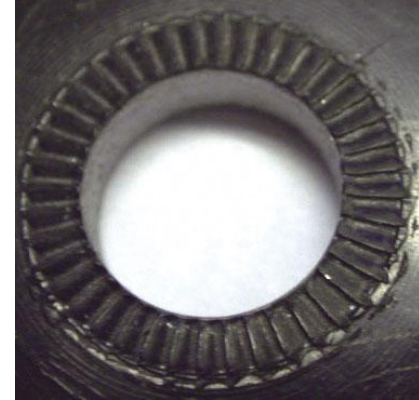
NORD-LOCK washers with standard outer diameter.

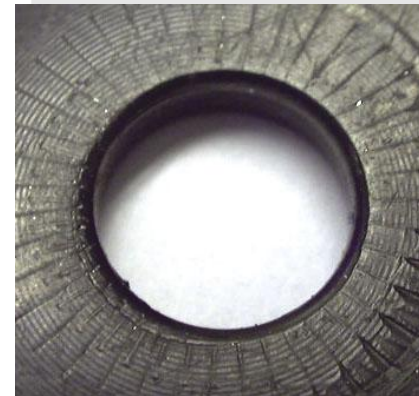
NORD-LOCK washers with increased outer diameter (sp).

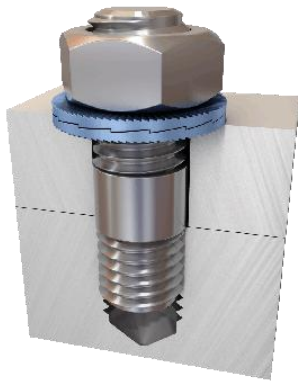
Studded assembly

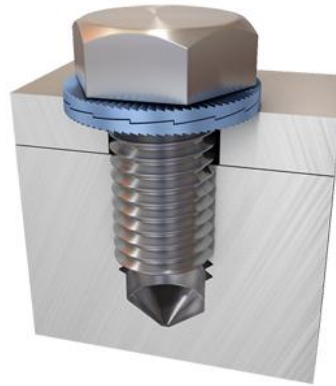
Tapped hole

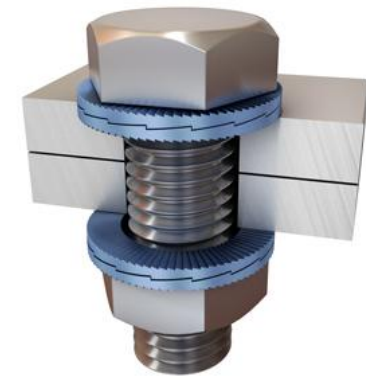
For through holes
use two washer pairs

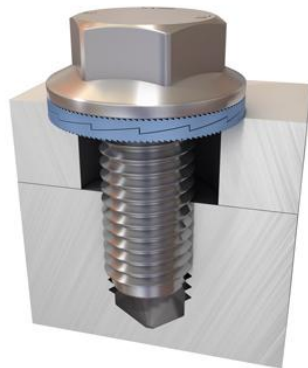
Large holes, slots & soft
materials, use sp washers

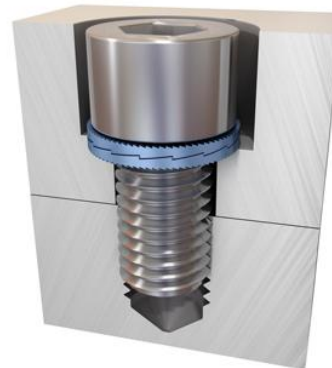
Counter bore hole

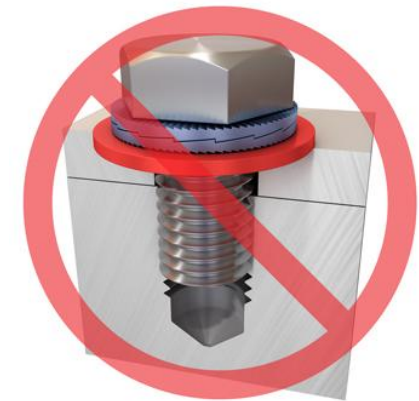
Do not use on washers that
are not locked in place
