# **DROPS Forum Meeting**

# Safety Moment – Actual Dropped Object

## Dropped Object with Very High Potential

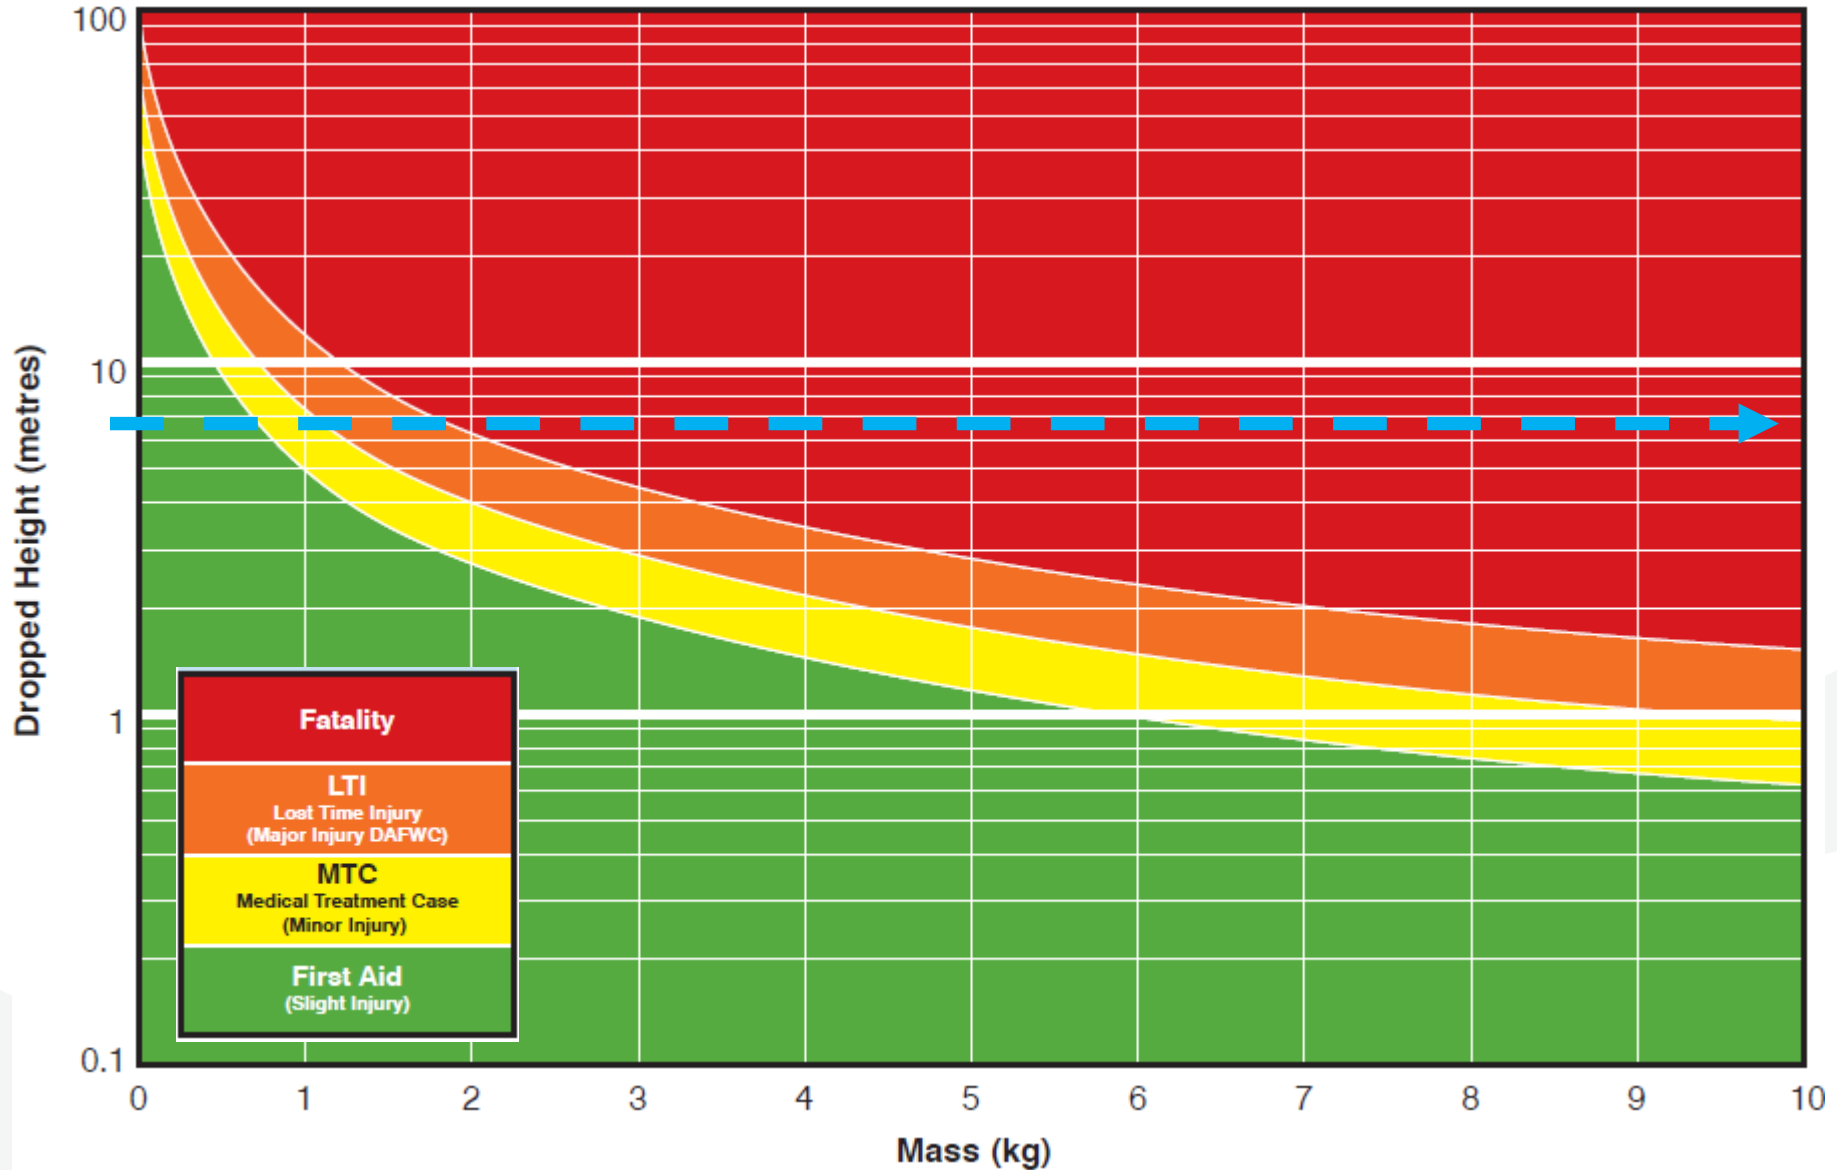
# Safety Moment – Actual Dropped Object

- A request by the vessel Master to permit effective cargo-securing.
- Cargo to be round-tripped.
- Rig's starboard crane asked to re-position a tank on the vessel aft deck.
- Piece of grating fell from top of tank 6 to 7 metres to deck.
- Both deck crew well clear (15 metres forward)
- Dropped Object weighed 17 kilograms.
- Potential consequence is fatality.

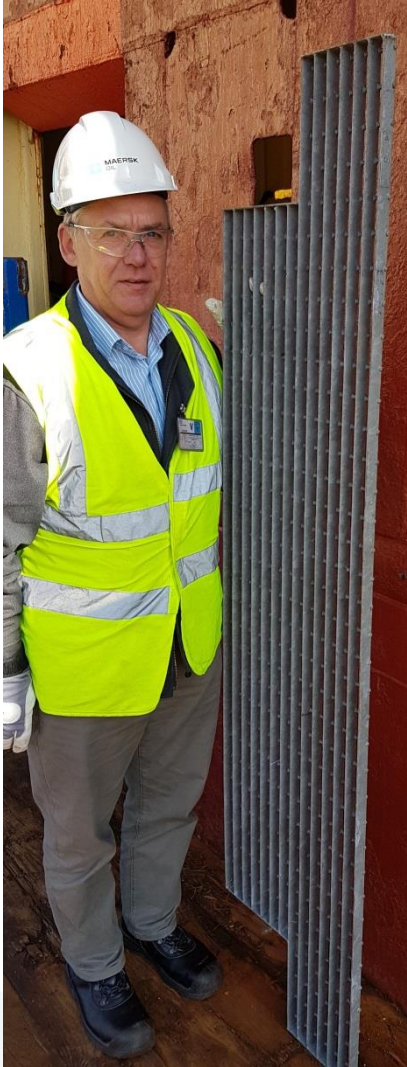
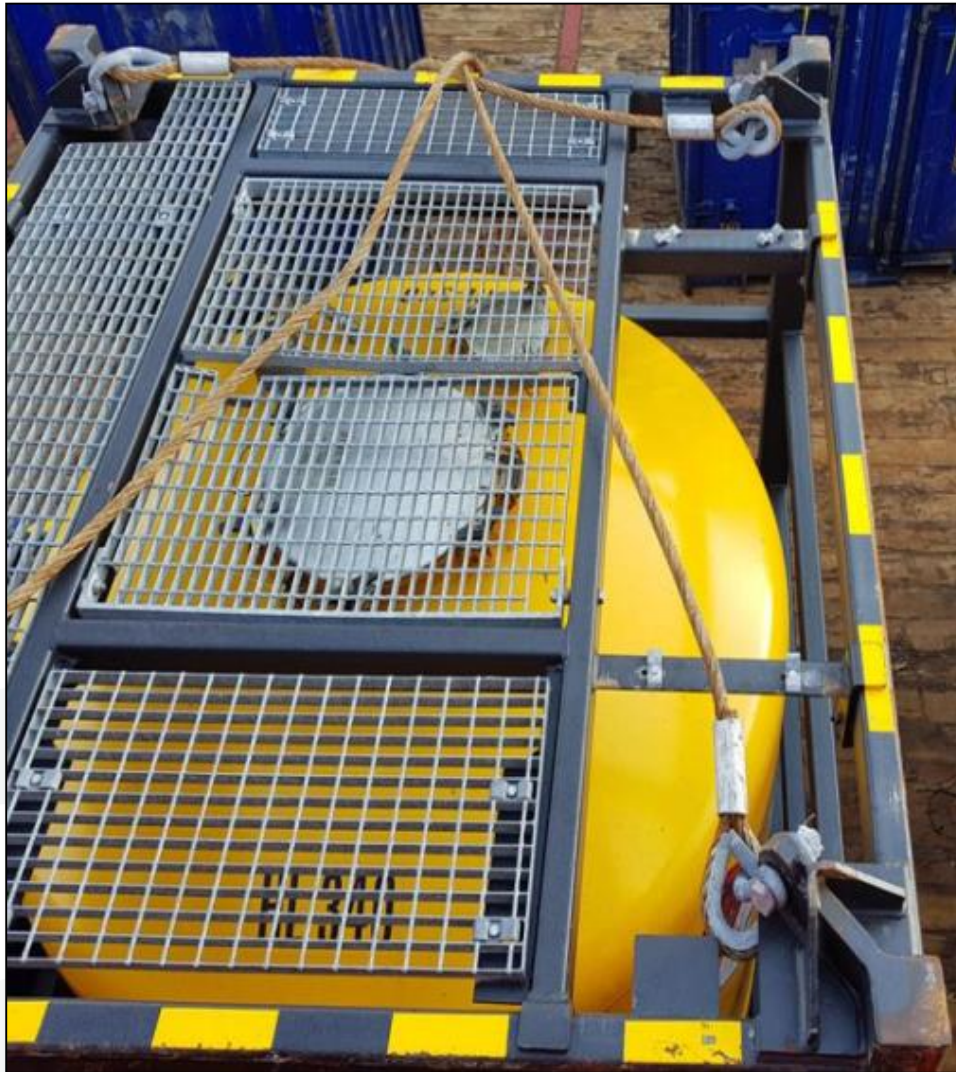
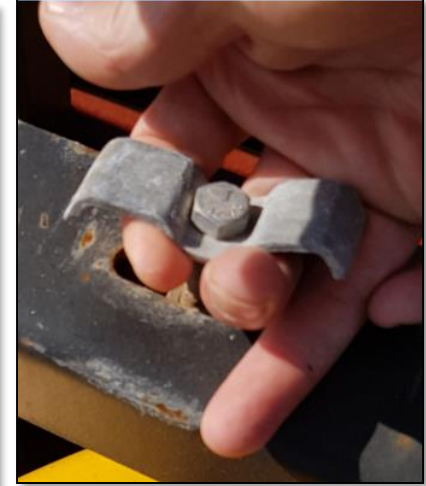
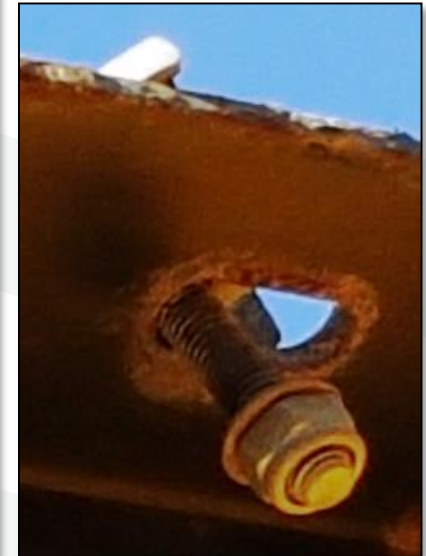
# Safety Moment – Actual Dropped Object

- Grating Securing clips on top of tank not engaged properly
  - Only smaller gratings on tank container secured effectively
  - Only one 'butterfly' clip out of four engaged on side-gratings.
  - All vendors reminded to check all container securing arrangements.
  - Logistics provider requested to add to pre-load checklists.
- Vendor not aware of dynamics of offshore vessel/crane cargo operations
  - Vendors staff invited onboard supply vessel to witness load operations.
  - Vendors staff surprised at dynamics of cargo operations in port.
  - Explanation given regarding increased dynamics due relative motions.
- Ships crew correctly stayed well clear of the suspended lift.
  - This aptly demonstrates the importance of keeping clear.
  - It is better to be cautious than sorry – assume the worst
