## Skandi Caledonia Dropped Object

PSV 2019

#### **Dropped Object (Near Miss) – 10/09/2019**

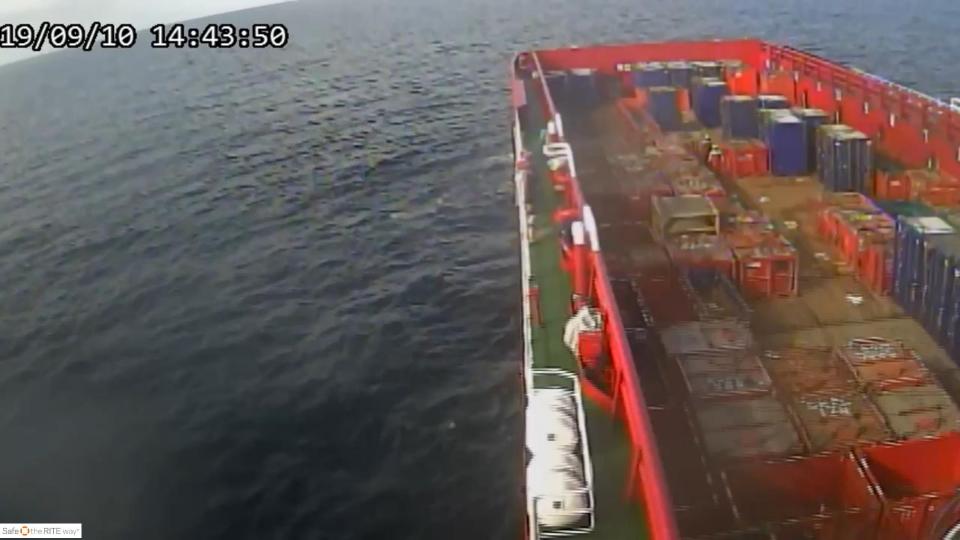
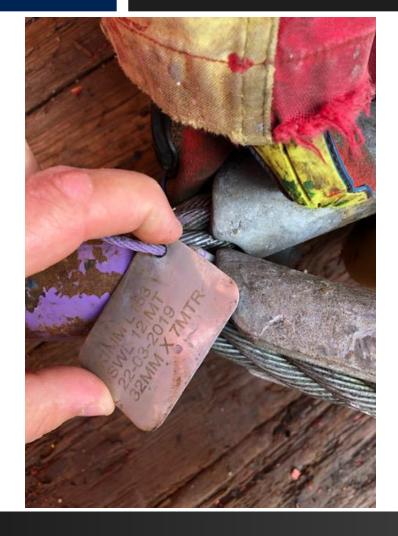
During cargo ops with an installation in the North Sea crane the pennant wire came out of the hook from the installation crane and fell to main deck on the Skandi Caledonia.

The crane came down with an empty hook for the AB's to hook on to an empty mud skip.

As soon as the hook touched the deck the master link jumped out of the main block and fell to the deck 2m from where the 2 AB`S were standing. We were fortunate it didn't fall towards the personnel on deck.

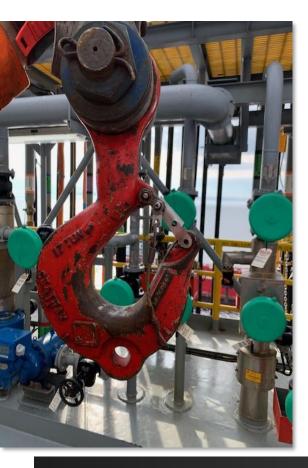
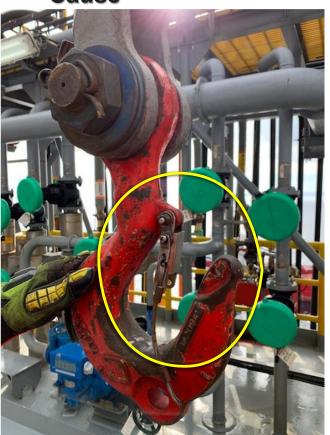
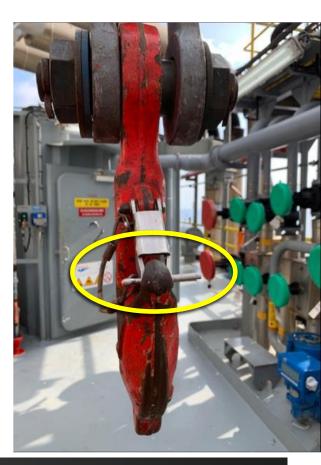
### Cause

The rigger onboard the installation did report the defect however they carried on using the crane and failed to check if the gate was closed and locking pin was inserted.

Installation management have ensured training is given to all deck crew on stopping the job and ensuring safety barriers are in place.
