NM: broken U-Bolt fell from stand pipe bracket to rig floor

Date:
15 January 2010

Location:
Egypt

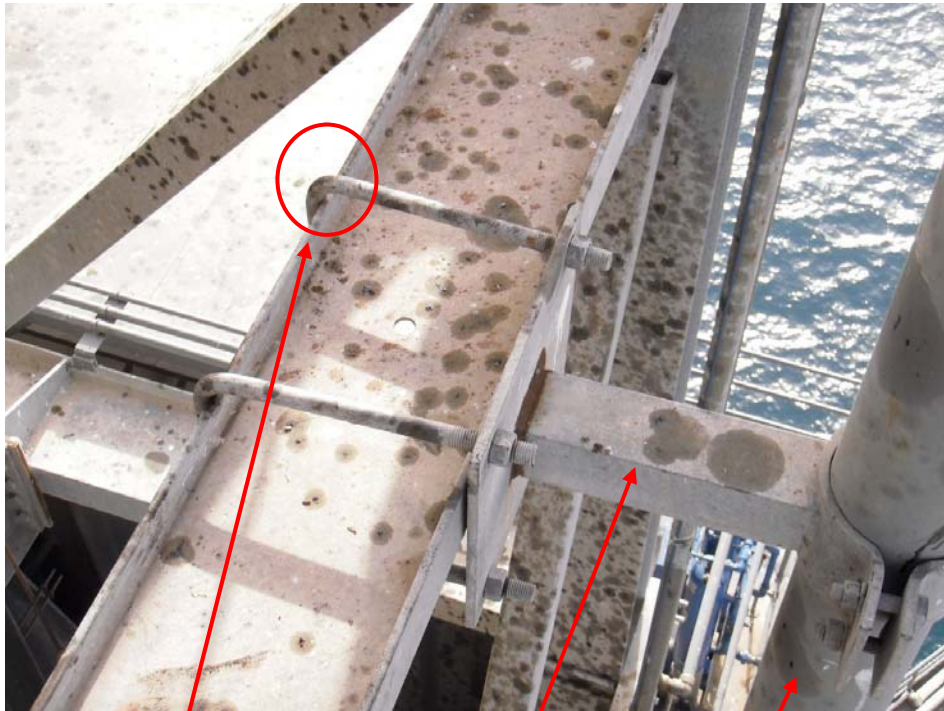
What happened: Operations ongoing: dropped PBL closing ball, pressured up with rig pumps to 2000 psi. As the ball was blown through the closing chamber, the surge pressure caused the mud hose to vibrate. A section of a 'U' bolt (weight 2.3kg) of a stand-pipe bracket attached to the derrick beam, fell from 20m to the rig floor. The U-bolt section landed 3-4 m away from a roughneck. Note: a full DROPS inspection was done when the rig came on contract in Oct 2009.

U-bolt failed position

Bracket

Stand-pipe

- Rig is just over 12 months old – bracket design does not seem fit-for purpose (tbc).
- Teams are advised to check for similar designs installed on their rigs
