Dropped Object Seriously Injures Worker

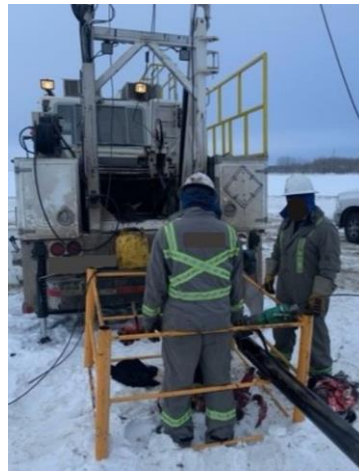
The wireline crew heard the line part and tried to get clear of the falling equipment, but the wellhead impact guard prevented them from moving outside the strike zone.

Crew's position before the incident

- Address identified hazards. The wellhead impact guard was not removed after being identified as a hazard during pre-job planning.
- Reduce the risk. Work was conducted under a suspended load that could have been laid down.

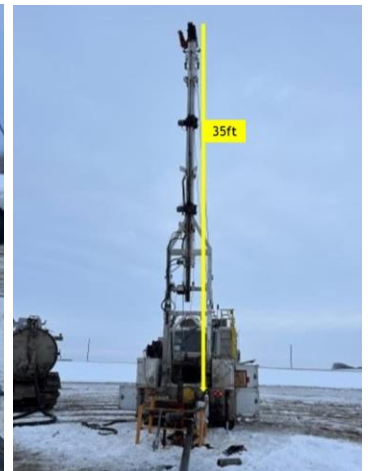
The third party operated the mast extension control lever instead of operating the winch line control lever in the hoist mode and the tool assembly lifted from the well. The wireline crew continued their task assuming that the winch was being operated correctly.

A secondary winch held the pack off and crossover sub near the top of the mast. As the mast telescoped, the ball on the winch line was pulled into the sheave. The secondary winch line parted and the suspended equipment fell.

View of the lifting equipment mast

- Do not authorize third parties to operate equipment.
- Improve communication. The wireline crew supervisor was on site but unaware that a third party was operating lifting equipment.
- Redesign the winch control panel with clear labelling of all controls and add a mast extension lock out.

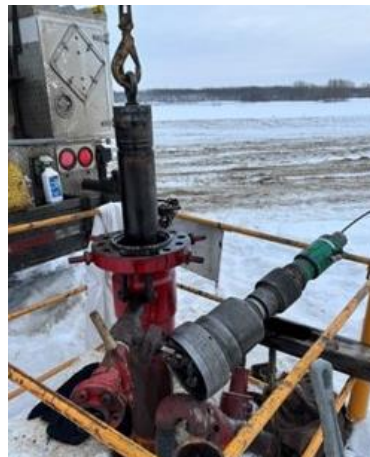
A wireline operator's forearm was struck by the falling pack off/sub-assembly. The result was a serious injury and hospitalization.

View of the dropped equipment

Using the [DROPS calculator](#) to estimate the potential severity if someone were directly struck, the mast height of 10.7 m (35 ft.) and equipment mass of 54 kg (120 lb.) equals an outcome of 5,666 joules, which would cause death from injury or trauma.
