**ROWAN Gorilla VI
Dropped Dolly Guard
16th April 2012**

**Alan Johnson
HSE Specialist
Drops Forum
6th December 2012**

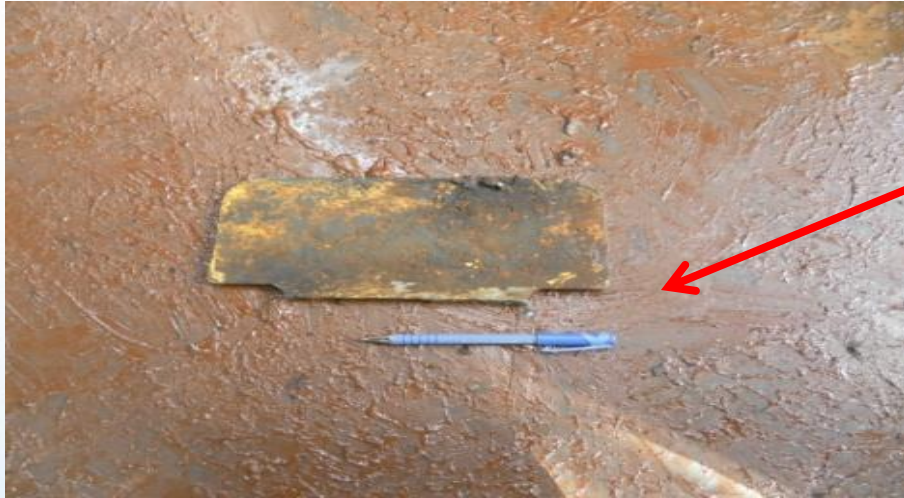
Dropped Dolly Guard Plate

Whilst running in the hole to tag cement plug, a metal plate that protects the dolly roller on the lower bow side of the dolly track became detached falling to the rig floor.

The plate fell 35ft coming to rest under the dolly track beside the iron roughneck. No persons in the area as the Red Zone procedure were being adhered to.

The plate weighed 1.7 kg and the plate size was 4" x 10" x 1/4".

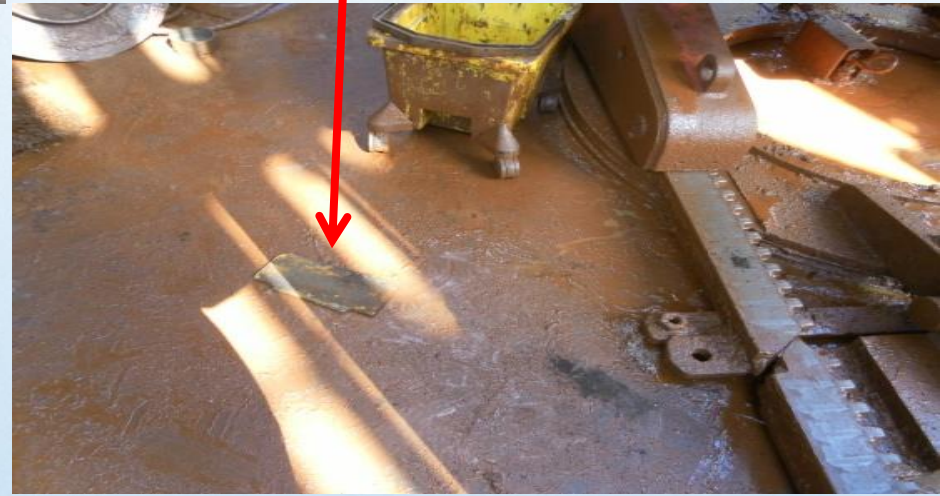
Position Plate Came to Rest Beside Iron Roughneck

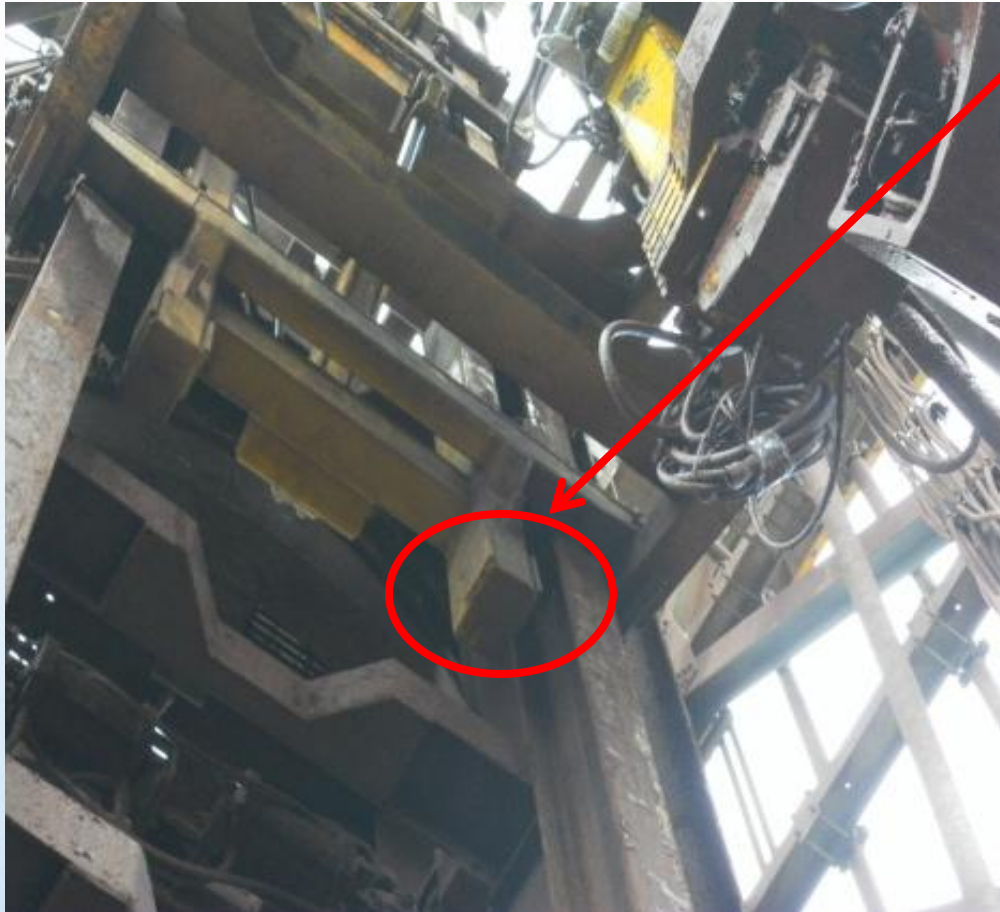
Dropped Dolly Guard Plate

Dolly rollers and Plate Position Before Plate Fell.

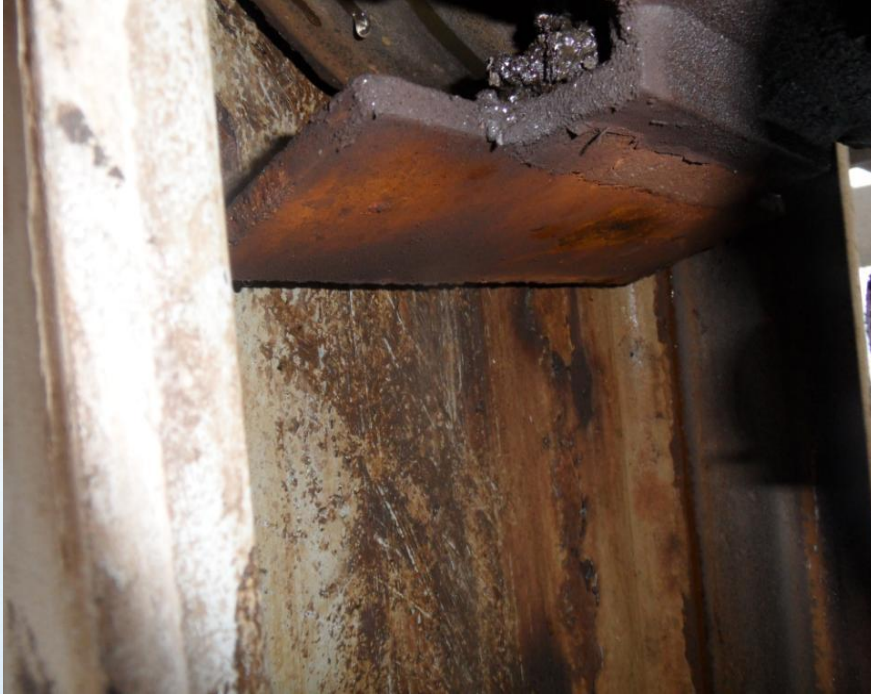
**Dolly Roller Plate
Position Before**

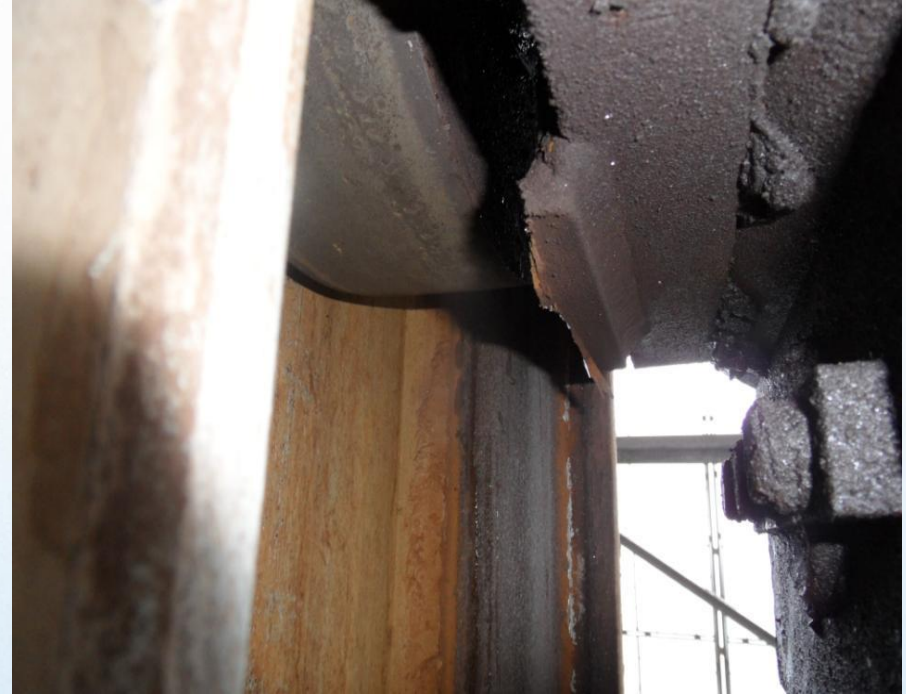
**Dolly Roller Plate
Position After.**

Cyclic Fatigue Cracking (Repeated Reverse Bending) on Plate

Impact Damage During Operations

Worn Dolly Roller Through Transition Point of Tracks

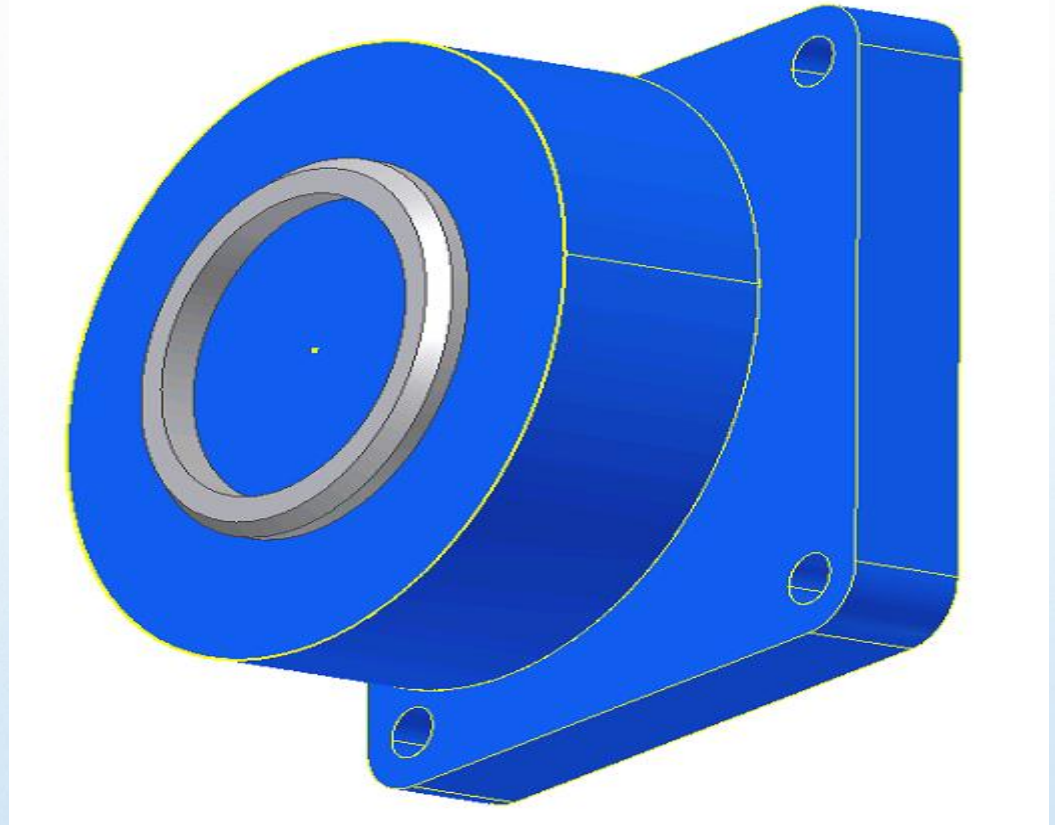
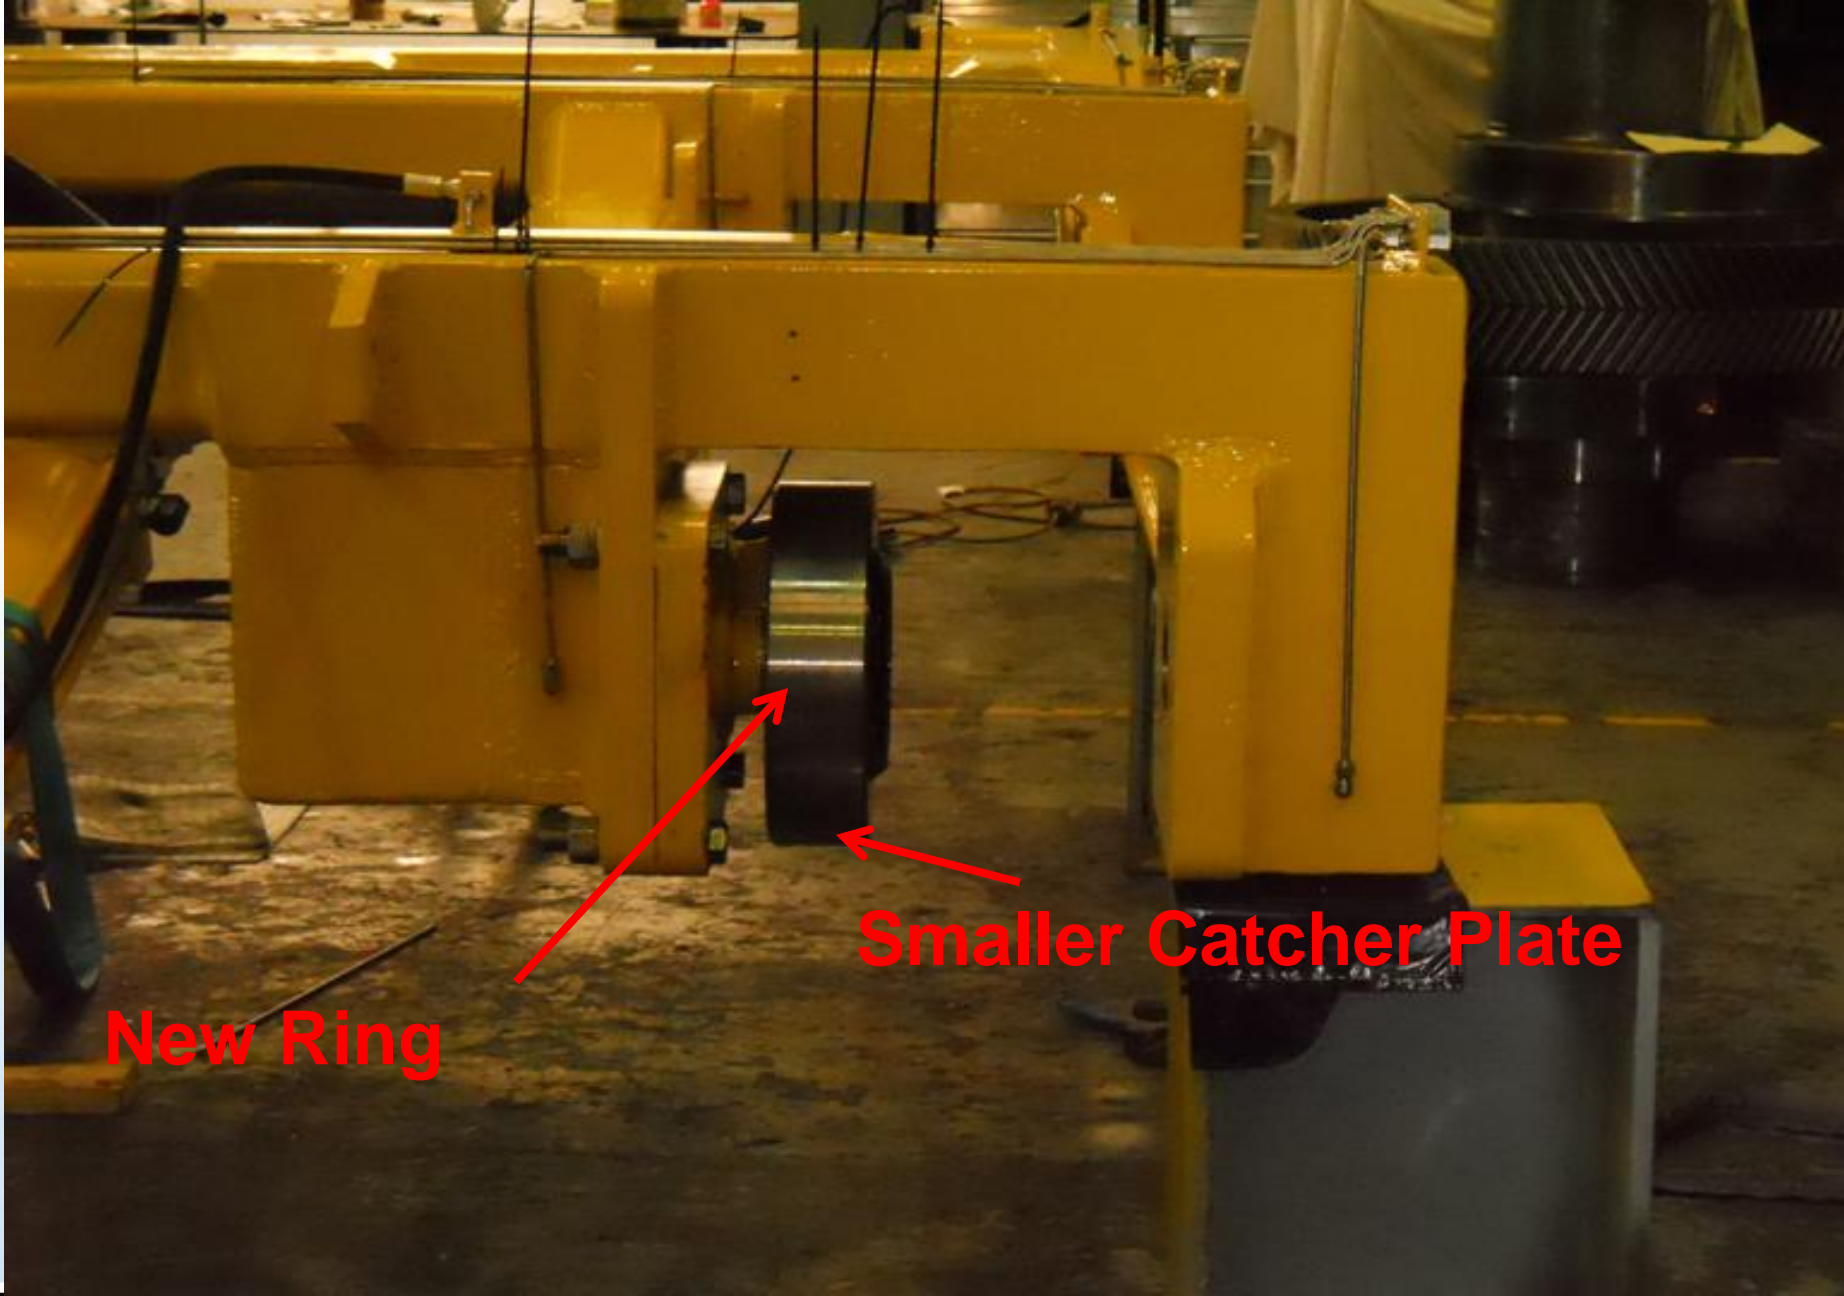
New Roller Design

**New Roller Design,
Developed by Rowan
and approved by OEM**

New Ring

Smaller Catcher Plate
