# TANK CRADLE ARM FAILURE

## DESCRIPTION:

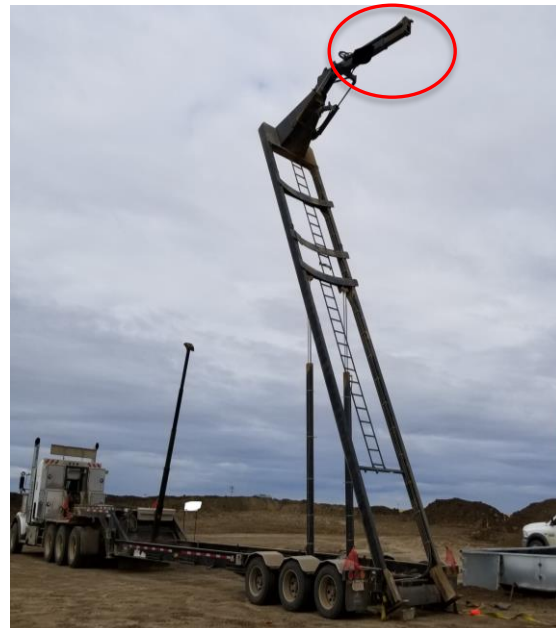
**The main mast pin slid out of the bracket**

**Failed bracket at the top of the tank cradle arm**

The cotter pin was either not put in place correctly, or shifted during the move.

- No previous inspection records were available
- Equipment was not visually inspected prior to use
- Cotter pins used in this application are prone to damage while being transported
- The cotter pin used may not have been made from the correct material for the equipment

- Revise existing policies/procedures to include specific equipment inspection points prior to use
- Cotter pin holding the main mast should be replaced with a grade 8 capture pin  
(Note: the manufacturer of the equipment has not suggested an upgrade to the cotter pin design, however, it is possible that without frequent inspections of the current cotter pin design, this failure could happen again)

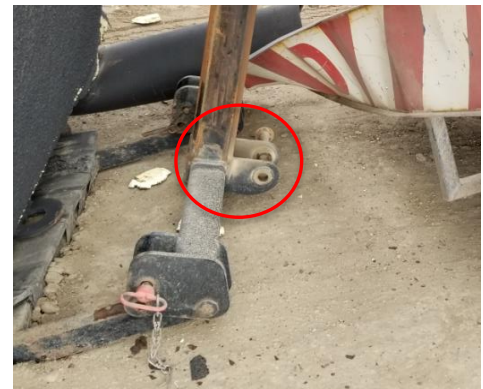
**Close-up of the failed bracket with the Main mast pin out of position**
