# ONE PAGER

Incident: Dropped object, steel wedge  
Synergi Case: TBA  
Location: Maersk Completer, AMDP-24  
Date: Saturday October 24<sup>th</sup> 2009

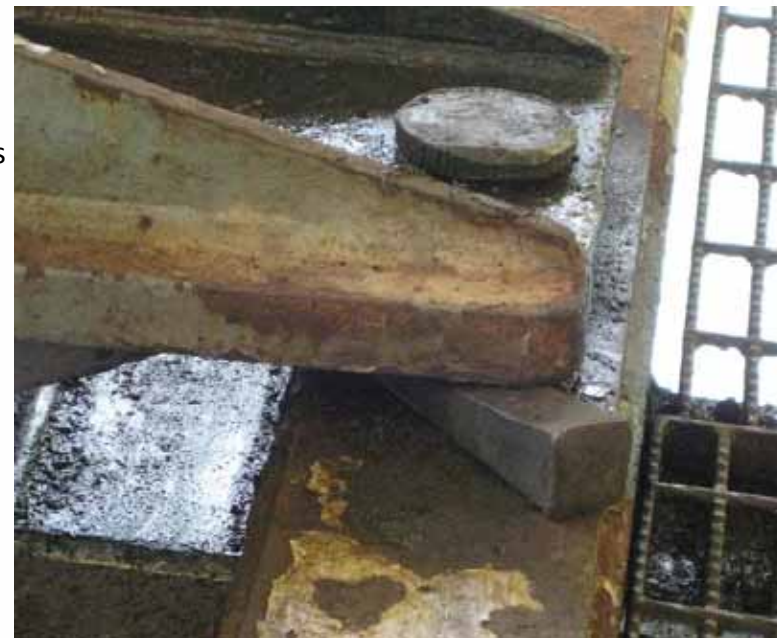
Area below the job site was secured with barrier tape and job was selected to proceed at the time where there were no personnel on the platform. The wedge had been inserted as shown and hammered in. This released the lock pin now the wedge had to be removed. It was knocked out sideways when it released it fell down through a gap in the walkway side plates to the platform.

Steel wedge, weight 800g, fall height estimated at 13m. No body was hurt and nothing was damaged.

- Better planning at the risk assessment stage, quality of the SJA needs to be improved to prevent drop object.
- Need to identify if there is a steel wedge that can be purchased and added to the work aloft tool box.
