Seawell Limited (UK)

# Seawell High Potential Incident

Derrick Drilling Machine (DDM) collision with stand of drill pipe – link tilt protection bar dropped to drill floor.

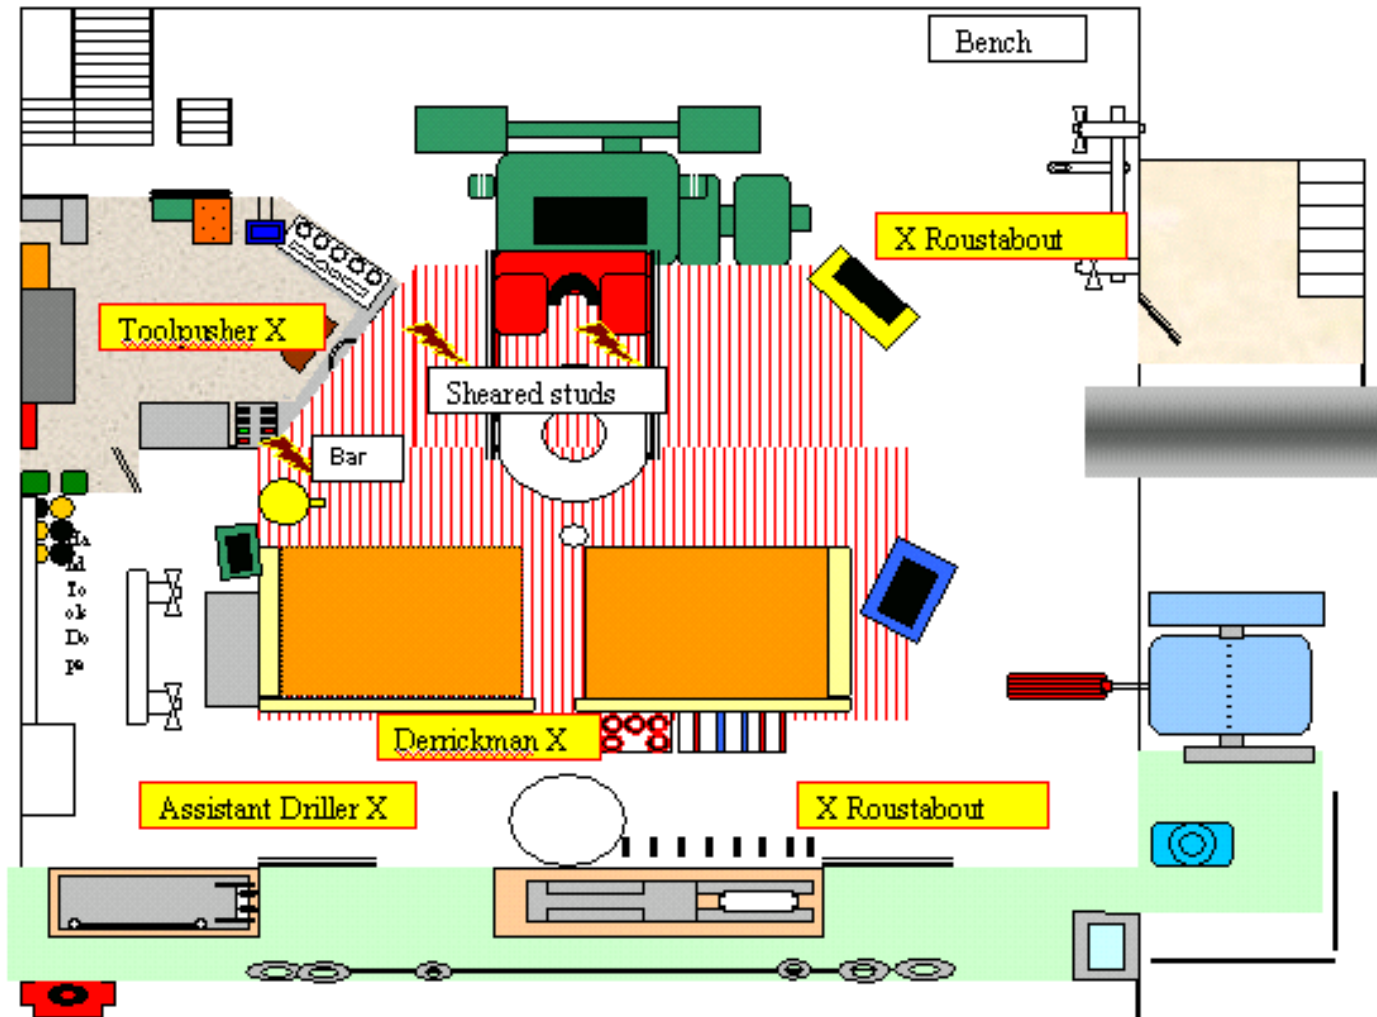
- At this time the DDM was being lowered as the Toolpusher (DDM operator) had viewed by remote camera, that the top of the stand had been pulled into the clear zone for the DDM to descend. The stand collided with a link-tilt protection bar on the DDM, shearing the bar mounting bolts.

- The bar (4.25kg), and sheared securing bolts fell 94ft to the drill floor. The top of the stand came to rest against the pipe-rack fingers.
- No one was injured as all drill floor crew were positioned outside of the drill floor 'red zone' (no-go area when there is equipment equipment moving overhead).
