EXPRO

Potential Dropped Object -13
September 2017

UK Area

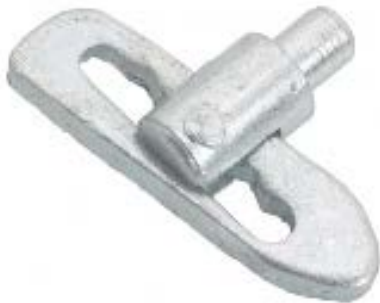
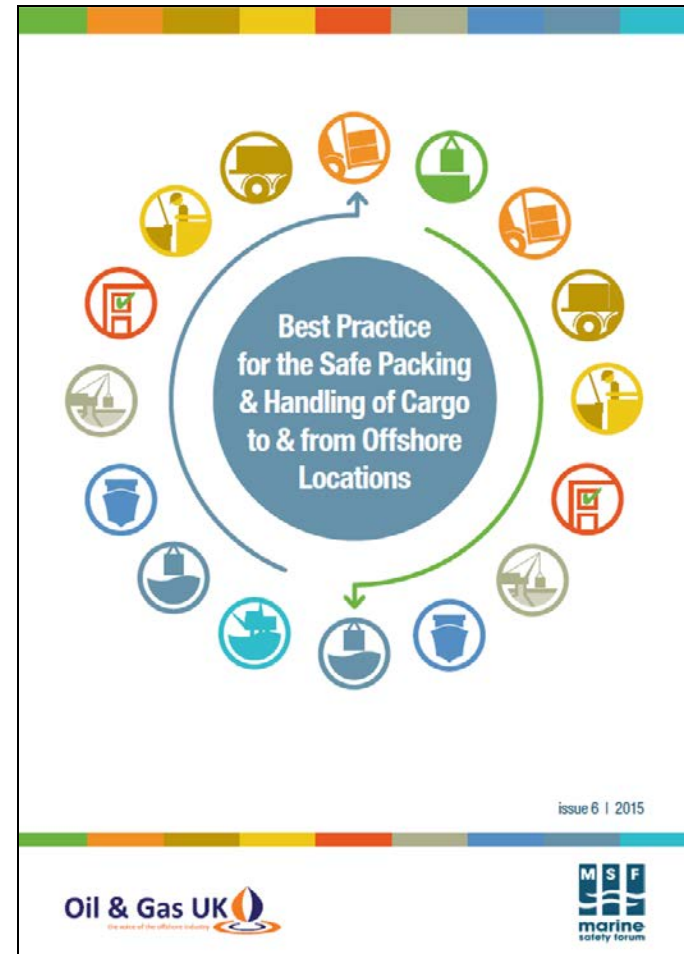
Antiluce Drop Lock

- The antiluce drop catch is designed not to require secondary retention.
- It does not appear in the O&G UK best practice as requiring secondary retention.

- Following the incident:
- Secondary retention **MUST** be in place on all units with antiluce drop locks for both outward and inward transportation.
- Our third party lifting Engineers have been instructed to check for secondary retention on drop catches.
- Recommended size of the Tie-Wrap is between 4.7mm and 13.2mm for drop locks.
